# WOOD DESTROYING PESTS AND ORGANISMS INSPECTION REPORT

Building No.	Street	City	Zip	Date of Inspection	Number of Pages
12747	El Camino Bodega	Sebastopol	95472-8238	01/29/2018	1 of 12

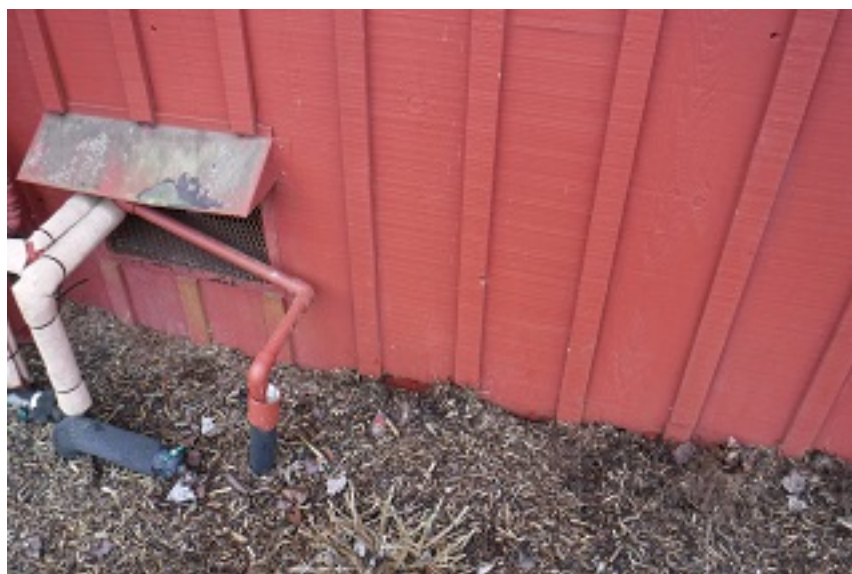
Item 1D **FINDING:** Landscaping was noted to be in contact with the privacy fence. Fungus damage was noted to exterior siding.

**RECOMMENDATION:** Remove landscaping away from privacy fence. Repair or replace fungus damaged wood members with new materials to match existing as close as practical. This firm will prime paint only wood members replaced.

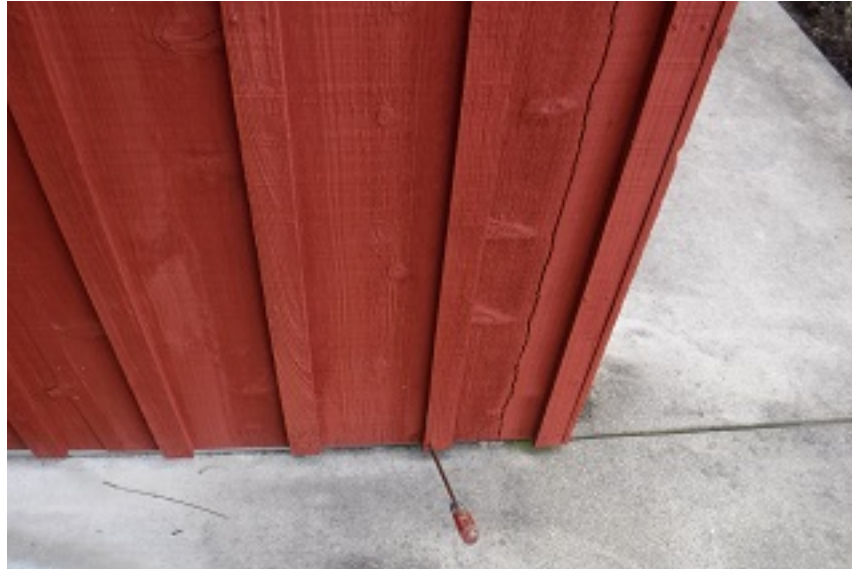
Item 1E **FINDING:** Landscaping was noted adjacent siding and trim of building and has caused fungus damages.

**RECOMMENDATION:** Remove landscaping away from siding and trim. Repair or replace fungus damaged wood members with new materials to match existing as close as practical. This firm will prime paint only wood members replaced.

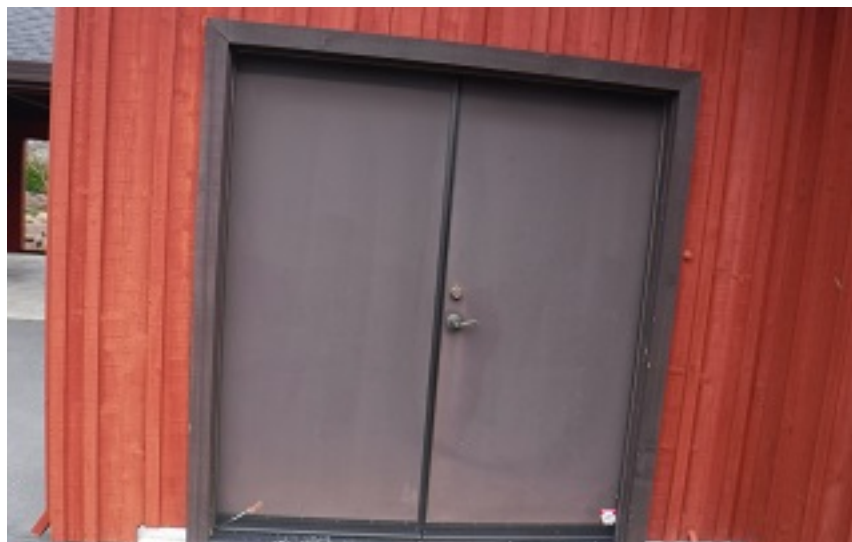
Item 1F **FINDING:** Fungus damages were noted to exterior siding and trim.

**RECOMMENDATION:** Repair or replace fungus damaged wood members with new materials to match existing as close as practical. This firm will prime paint only wood members replaced.

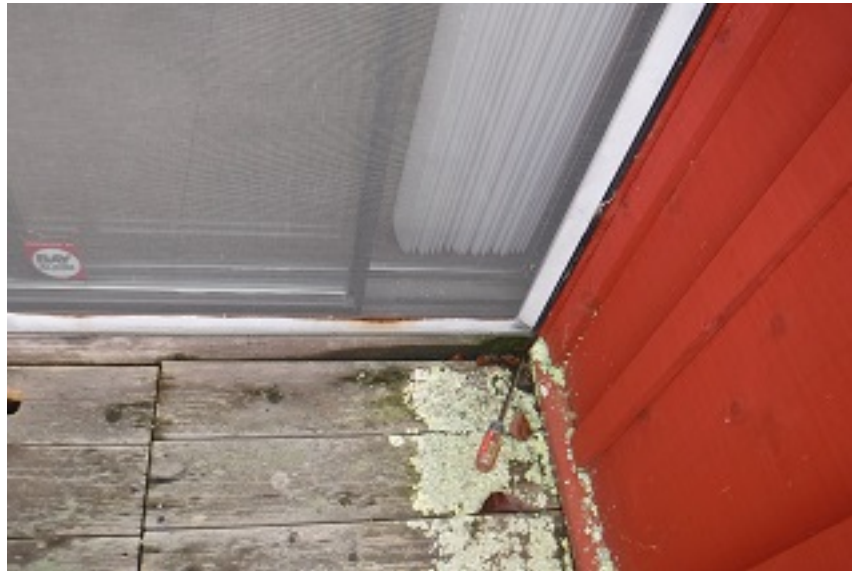
Item 1N **FINDING:** Fungus damage was noted to the base of support post for the upstairs deck at the approximate area indicated on the diagram.

Item 1O **FINDING:** Downspout exits onto post which has caused damages as discussed in Item 1N.

**RECOMMENDATION:** Remove, replace, or patch fungus damaged wood members with new materials and treat adjacent wood members with Tim-bor (disodium octaborate tetrahydrate) if applicable. This firm will prime paint wood members replaced.

**RECOMMENDATION:** Divert downspout away from these areas to prevent future damage.
