# *Gage Inspection Services*

## Property Inspection Report

121 Mary Paige Ln, Santa Rosa, CA 95404  
Inspection prepared for: David Phillips  
Real Estate Agent: Mary Haufler - Sothebys

Date of Inspection: 3/27/2018 Time: 9:00 AM  
Order ID: 66

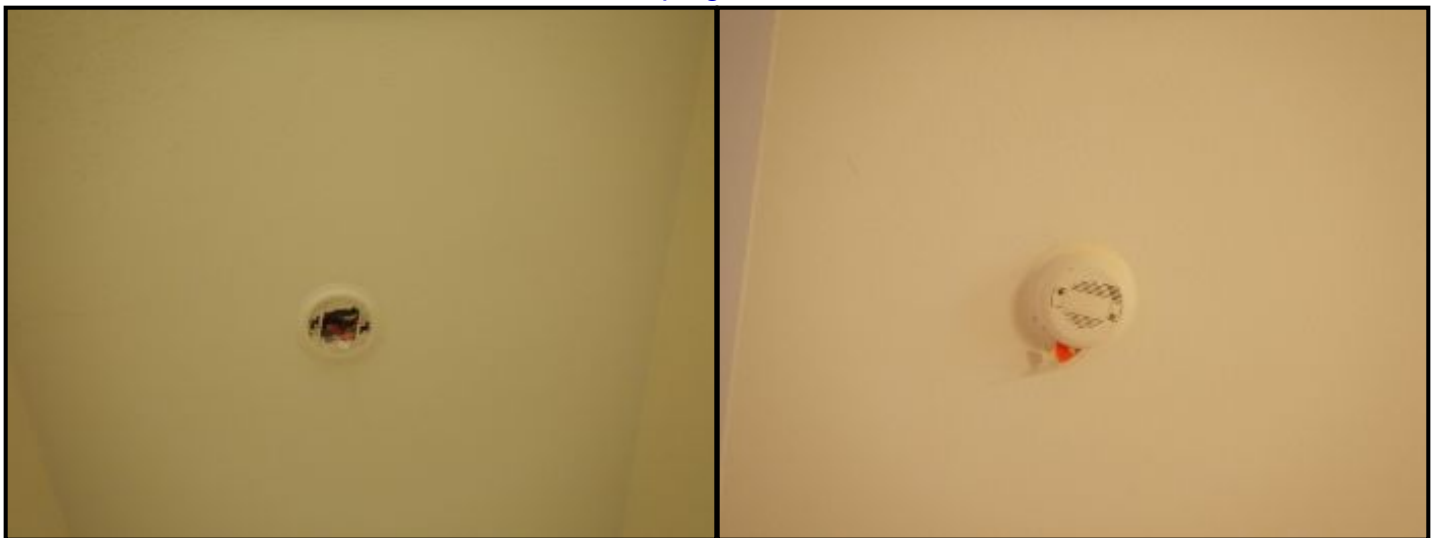
Inspection Details		
Page 26 Item: 10	Smoke Detectors	<b>Maintenance</b> There is a missing smoke detector in the main hallway and a missing battery for a detector in the first bedroom. It is advised to installed smoke detectors in the hallway outside of the sleeping areas as well as each bedroom.

Missing smoke detector at hallway.

Missing battery at smoke detector.

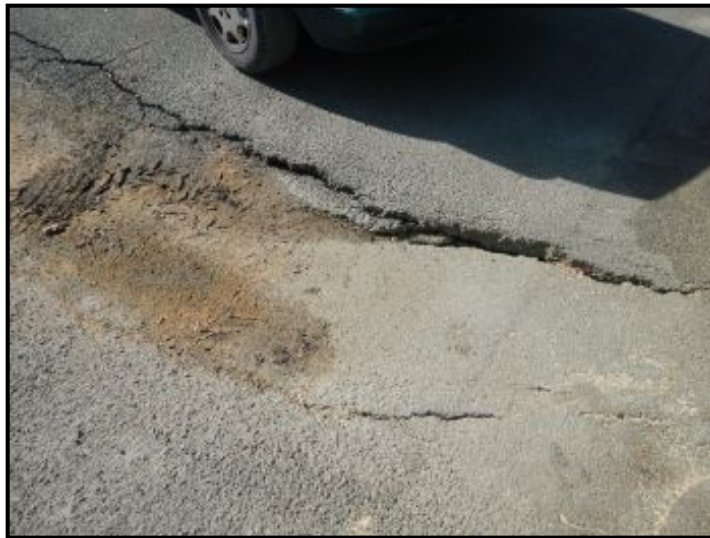
Site concrete and paving		
Page 27 Item: 1	Driveway/Parking	<b>Maintenance</b> There is cracking/settling noted at the driveway. Repairs are advised to prevent any potential tripping hazards and maintain proper drainage away from the home.  The driveway slopes to the home and evidence of ponding water was noted. Inquire with owner disclosures for any past moisture intrusion or ponding water.

Cracking/settling to driveway.

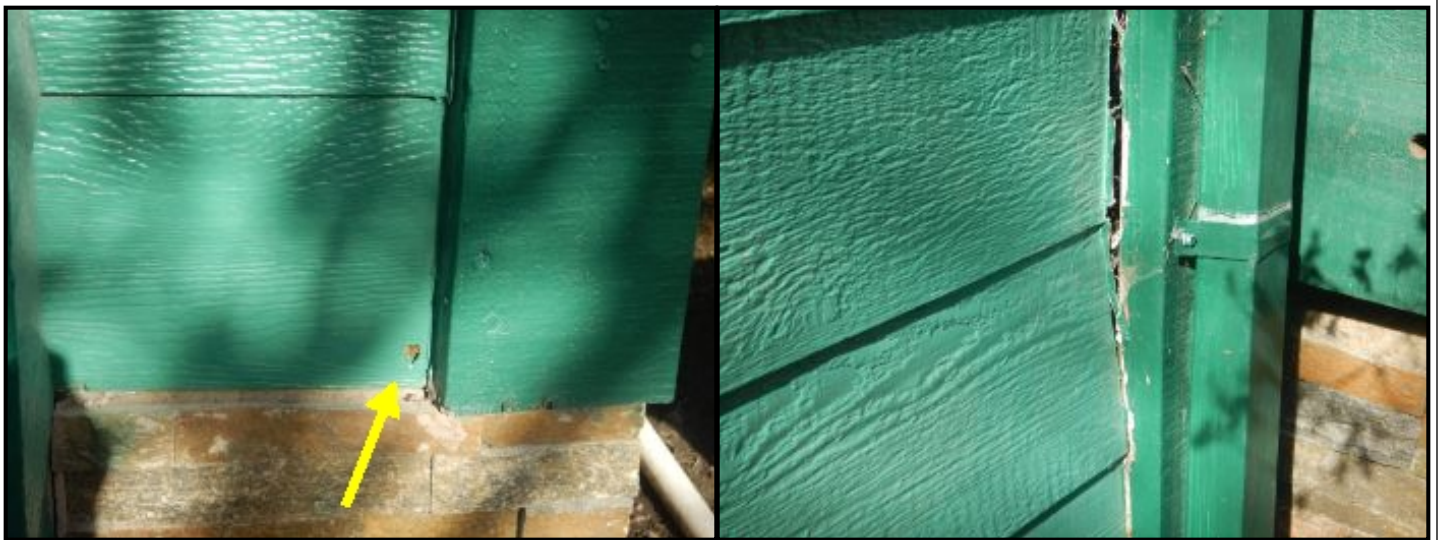
Page 28 Item: 2	Siding Condition	<p><b>Maintenance</b></p> <p>Siding damage was noted to areas at the exterior of the home. We recommend referring to the pictures and contacting a qualified contractor to review the current pest report and make needed repairs.</p> <p>There is warped/bulging siding at the right side of the home. This appears to be caused by a structural issue. Recommend contacting a qualified contractor for evaluation/recommendations.</p>
-----------------	------------------	--

Siding damage to right of garage door.

Bulging siding at right side of home.

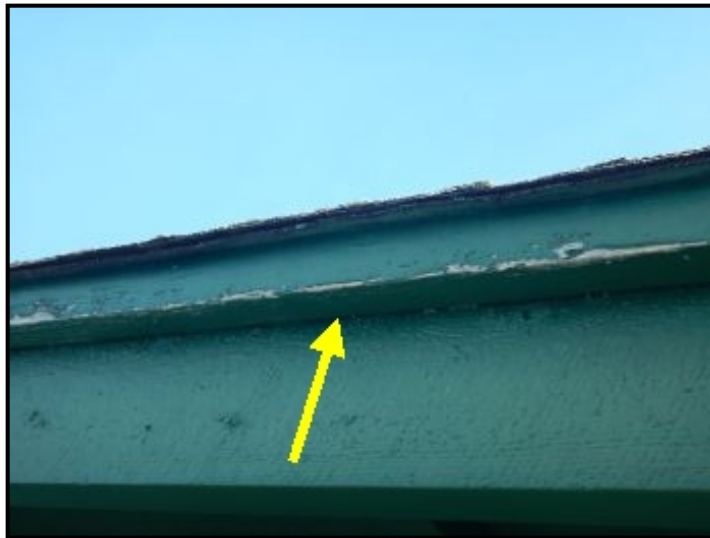
Page 29 Item: 3	Painted Surfaces	<b>Attention</b> The paint on some of the exterior fascia boards are showing wear. Touch up painting is recommended to prevent potential damage and deterioration.
-----------------	------------------	---

Repaint exterior fascia boards as needed.

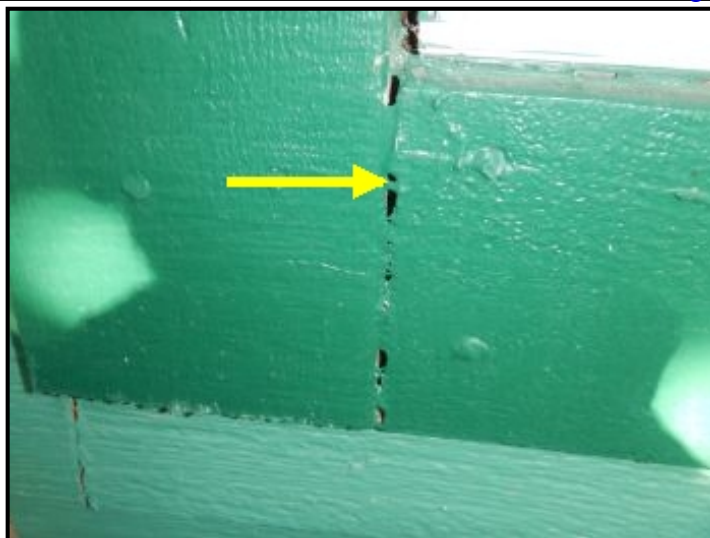
Page 29 Item: 5	Caulking/Structure	<b>Maintenance</b> The exterior caulking is in need of touch ups to various areas at the exterior of the home. As part of preventative maintenance it is recommended to maintain the caulking around the windows, trim and siding material as needed.
-----------------	--------------------	--

Recaulk exterior trim as needed.

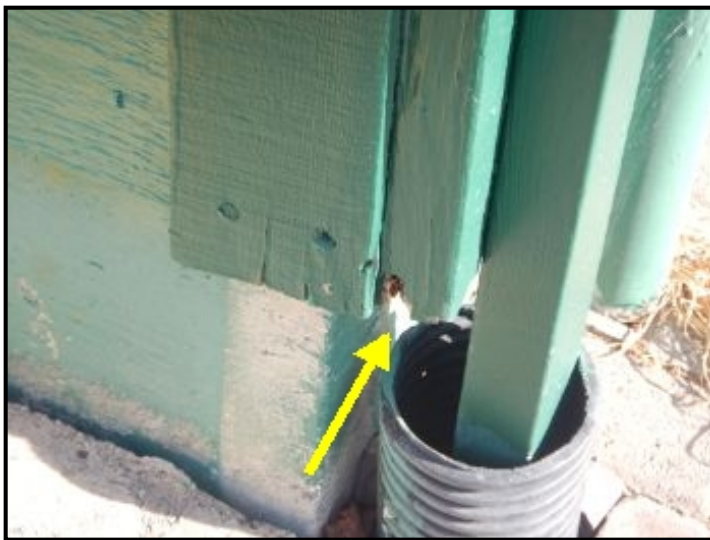
Page 30 Item: 7	Fascia Boards/Trim	<b>Maintenance</b> Trim damage has been noted at the exterior of the home. We recommend referring to the pictures and contacting a qualified contractor to review the current pest report and make needed repairs.
-----------------	--------------------	---

Trim damage at left of garage.

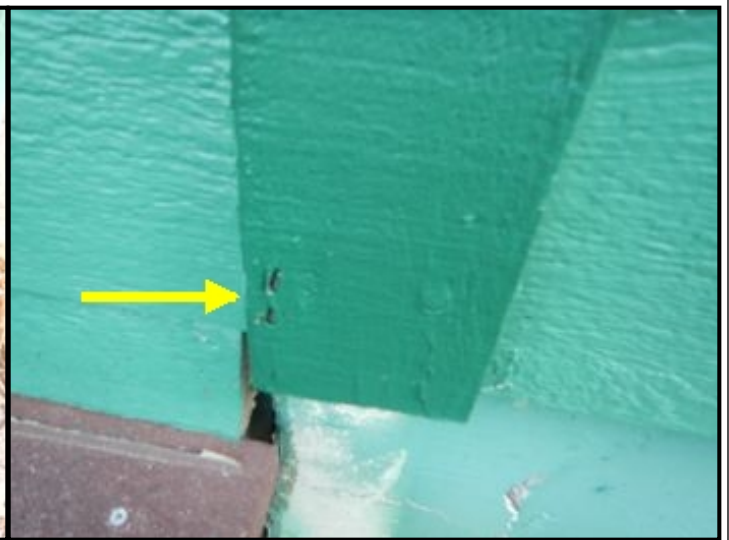
Trim damage at the left side of the home.

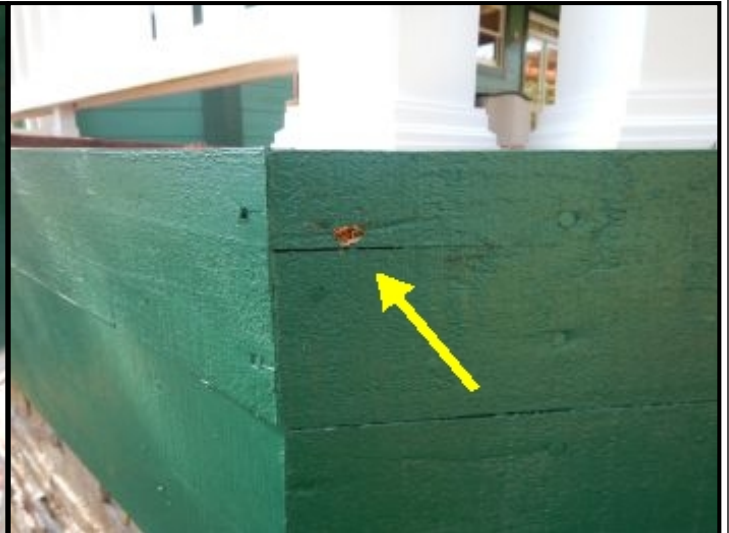
Fascia damage to areas at rear decks.

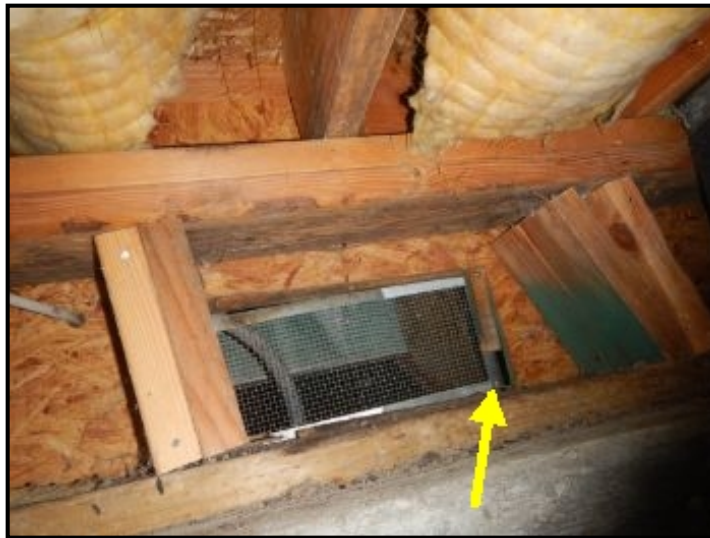
There are gaps noted to some of the under house vents under the rear deck noted from the sub area. Measures should be taken to keep the vent screens properly sealed to maintain intended drainage and prevent rodent access into the sub area.

Gaps around vent screens under rear decks.

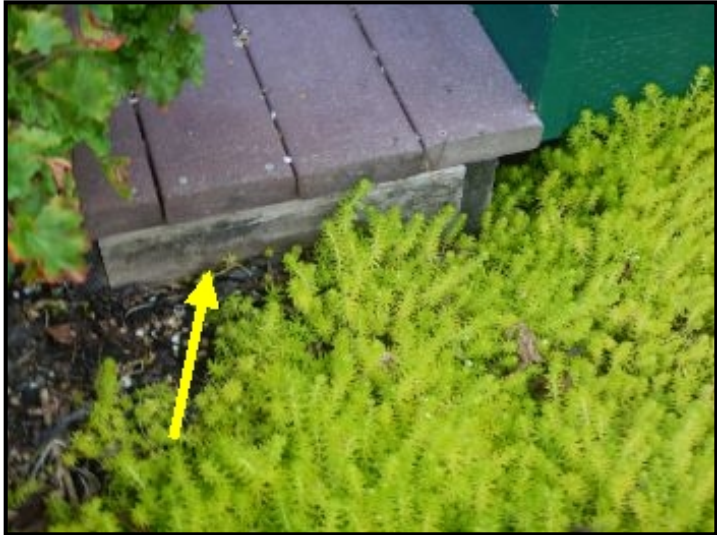
Page 33 Item: 8	Proper earth/wood clearance	<p>No</p> <p>The inspection has revealed earth to wood contact to the steps at the rear deck. There should be no contact between the earth and the exterior wood members. Recommend providing at least 4-6 inches of clearance between the earth and wood material as a preventative maintenance measure</p>

Earth/wood contact at rear deck steps.		
Decks		
Page 34 Item: 1	Surface	<p>Composite</p> <p>There are a couple of deck surface boards that are backing out. Recommend refastening to the deck framing to prevent potential tripping hazards.</p>

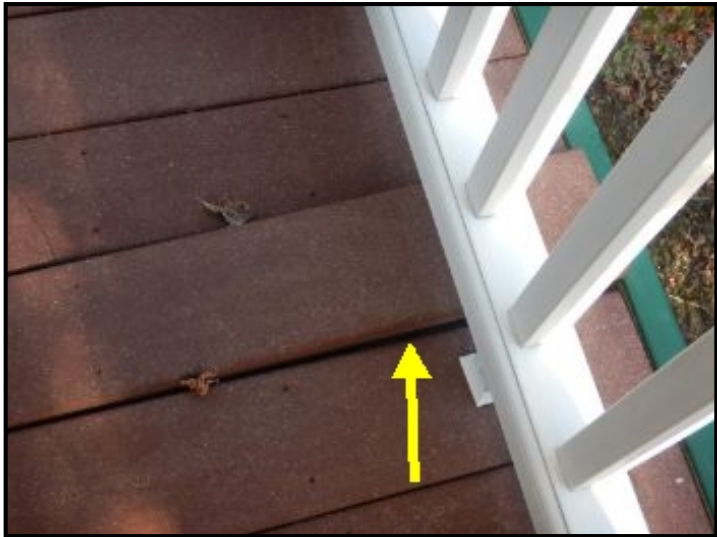
Lifted deck surface board,		
Page 34 Item: 4	Foundation/Framing	<p>Maintenance</p> <p>There was damage noted to the ends of girders at the rear deck. We recommend referring to the current pest report for further comment/recommendations.</p>

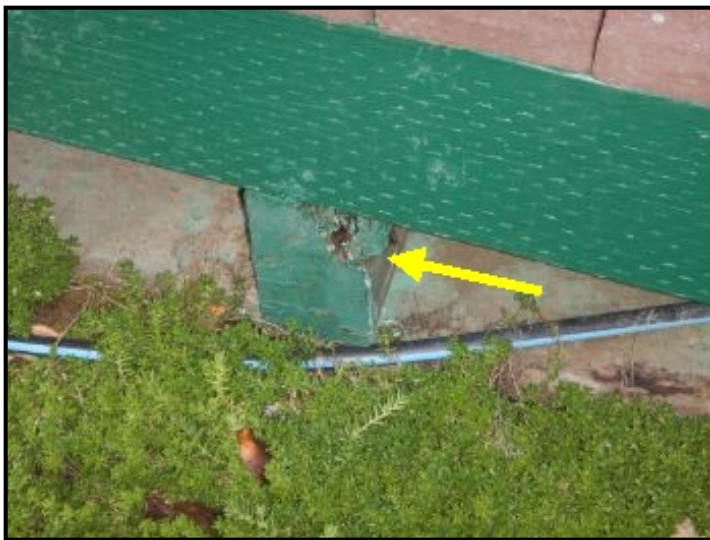
Damage to ends of girders at rear decks.

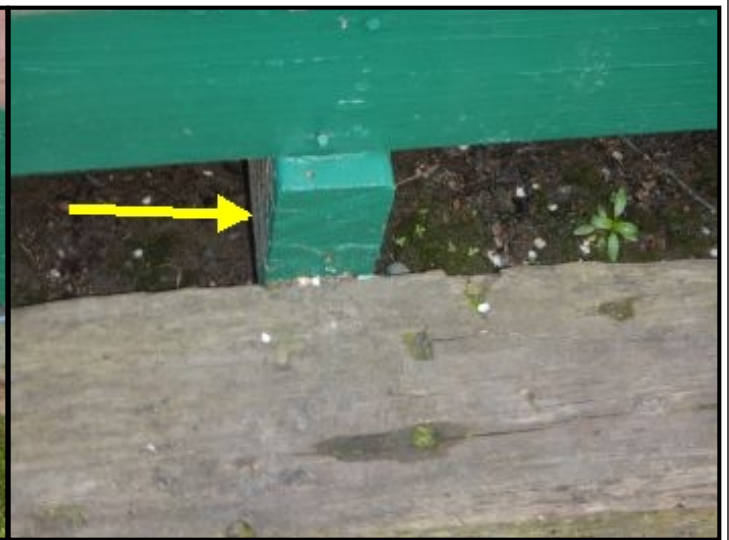
Damage to ends of girders at rear deck.

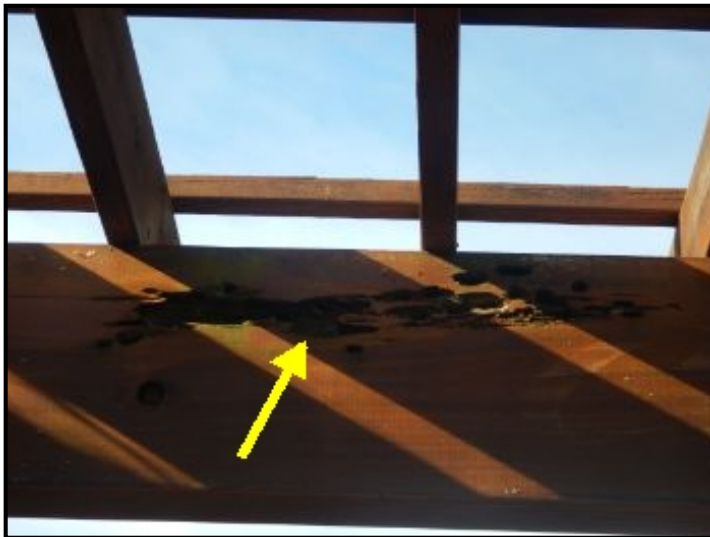
There was wood damage noted to multiple areas to the exterior trellis. Recommend referring to the current pest report for further comment/recommendations.

Damage noted to various areas of trellis.

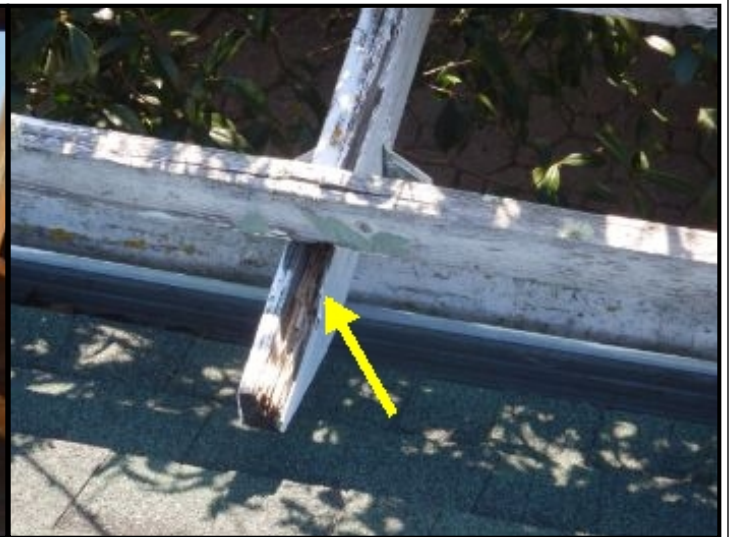
Deterioration of front trellis.

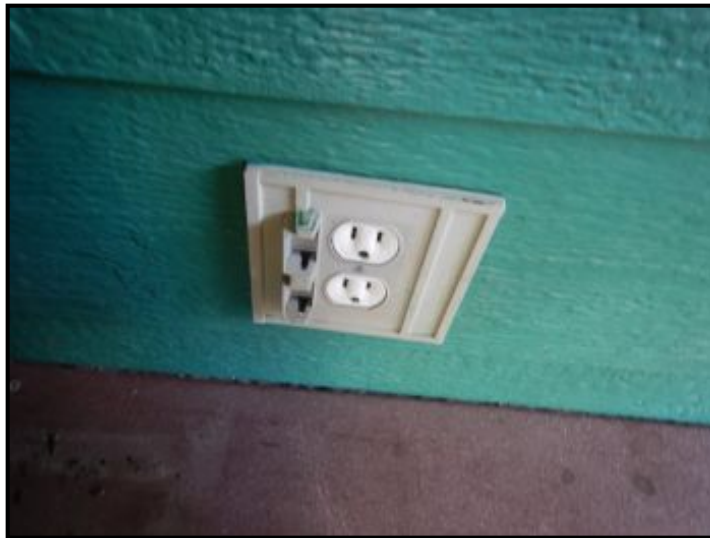
There is a damaged weather protective cover at the rear deck. Replacement of the cover is recommended as a health and safety consideration.

Replace weather protective cover at rear deck.

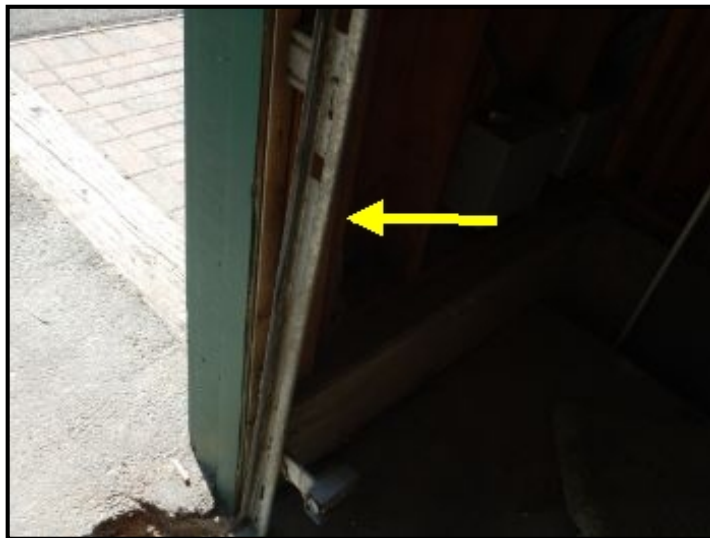
Page 36 Item: 2	Garage Door	<b>Maintenance</b> The single car garage door would not completely close and the track is bent/warped. Contact the appropriate specialist for evaluation.
Page 36 Item: 4	Automatic Opener	<b>Maintenance</b> The automatic garage door opener for the single car garage would not close. It appears due to past settlement of the concrete floor and the track that is bent/warped the automatic reversing eyes are not lining up properly. Contact a qualified garage door specialist for evaluation/recommendations.
Page 36 Item: 5	Springs/Mounts	<b>Maintenance</b> One of the tracks for the single car garage door is bent/warped causing the door to malfunction. Contact a qualified garage door specialist for evaluation/repairs. Installation specifications is not within the scope of this inspection.

Bent/warped track at garage door.

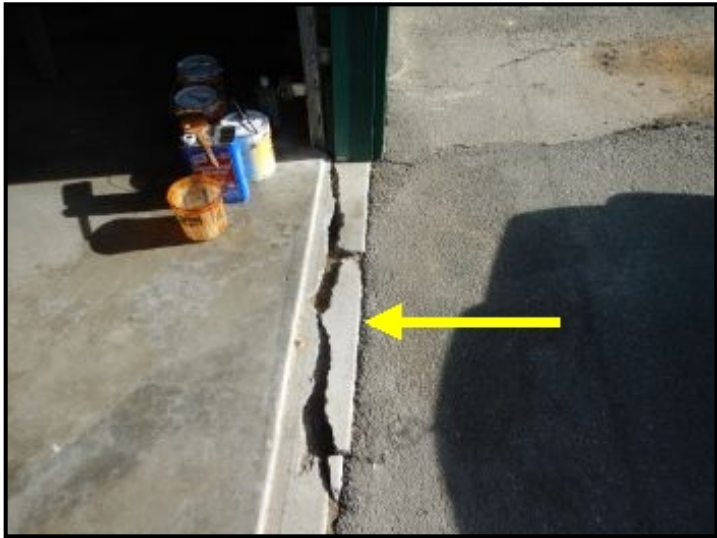
Page 36 Item: 7	Floor Foundation	<b>Maintenance</b> There is excessive cracking noted to the concrete garage slab. We recommend contacting the appropriate specialist for evaluation/recommendations for repairs.

Cracking at garage.		
Page 37 Item: 9	Firewall	<b>Maintenance</b> There is no firewall installed between the garage and interior living space. Recommend installing a proper 5/8" fire rated wall properly taped and sealed as a health and safety consideration. Contact a qualified contractor for evaluation/repairs.
Page 37 Item: 10	Door(s) Garage-Building	<b>Maintenance</b> The door from the garage to the interior of the home is not a fire rated door. Recommend installing a proper self closing fire rated door between the garage and living space.
Roof		
Page 38 Item: 3	Moss/Mildew	<b>Attention</b> There is a small amount of moss growth at the roof top. The amount of moss growth does not warrant immediate attention at this time. The inspector recommends removing the moss growth at some time in the future and treating the roof to prevent growth. Chemicals for preventing moss growth can be purchased at a local home improvement store. There are companies who will clean the roof and apply a material that will prevent moss growth for a number of years.

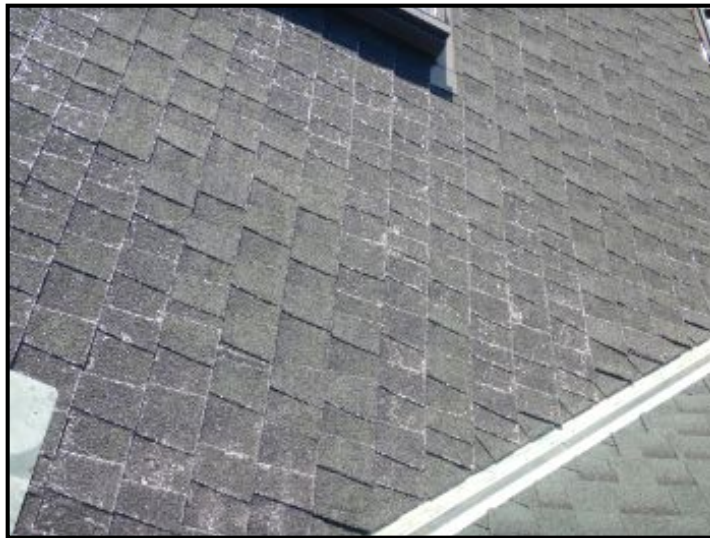
Page 38 Item: 6	Cover Material Condition	<b>Attention</b> The roof cover for the main structure appears to be newer and in serviceable condition. The roof cover material over the sun room and garage is older showing wear indicating it is nearing the end of its useful life. Contact a qualified roofing contractor for evaluation/recommendations.

Older roof cover material over addition.

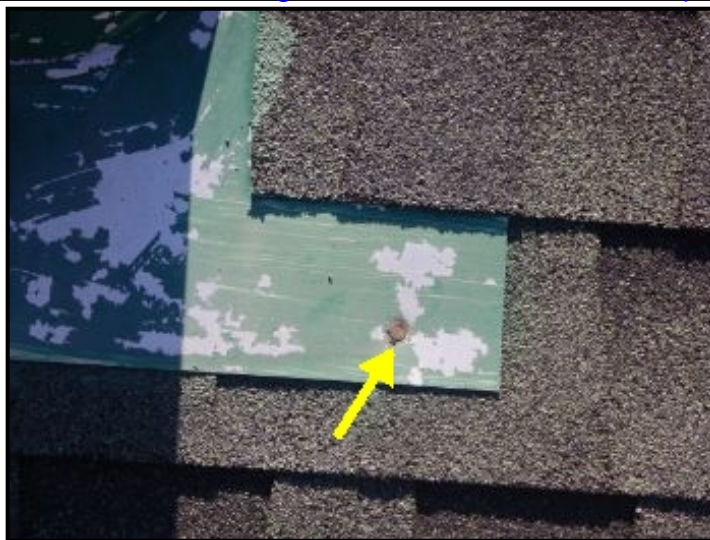
There are some exposed fasteners at the roof top flashings. It is recommended to keep these areas properly caulked and sealed to prevent potential leaking points. Contact a qualified roofing contractor for evaluation/repairs.

Seal exposed fasteners at roof top flashings.

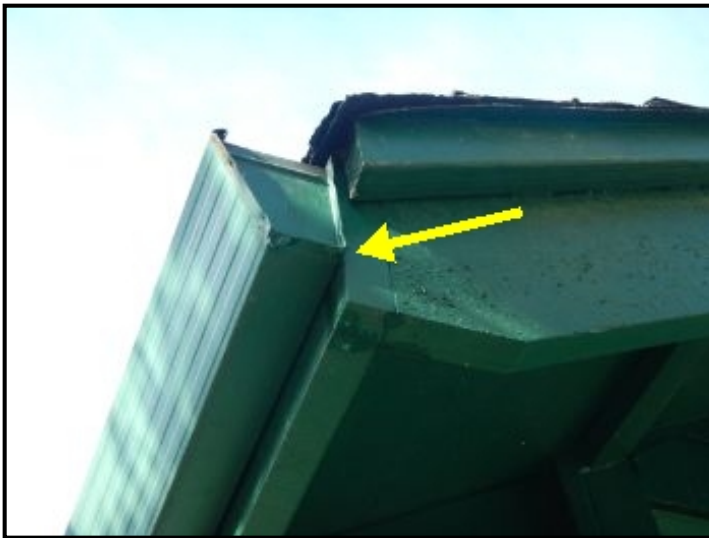
The gutters over the garage door are leaking. Contact the appropriate trades person for evaluation and recommendations for repairs.

Leaking gutter over garage.

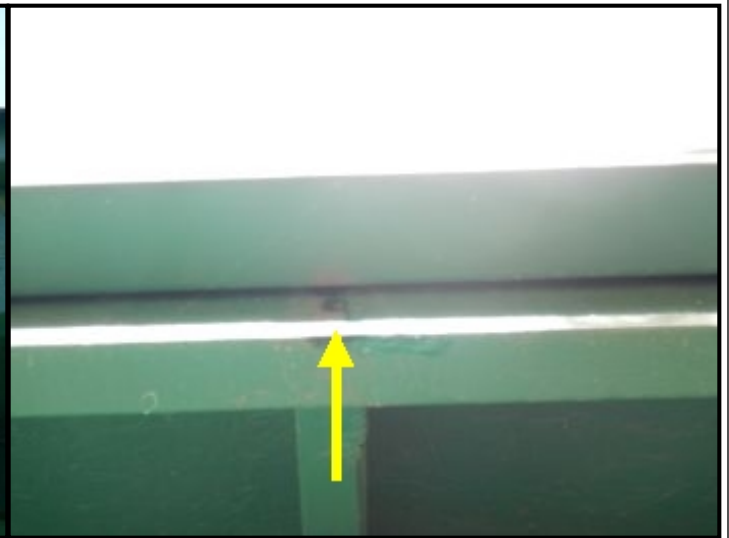
Leaking gutter over garage.

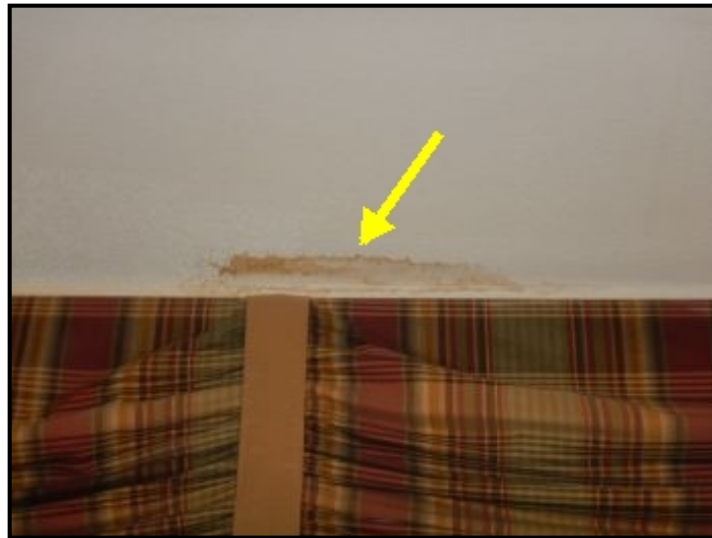
Page 40 Item: 12	Indications of leaking	<b>Yes</b> There is moisture staining at the ceiling over the family room window indicating past moisture intrusion. The area was dry at the time of the inspection and no major adverse conditions were noted. Recommend monitoring this area and taking corrective measures if needed.
------------------	------------------------	---

Moisture stain at living room ceiling.

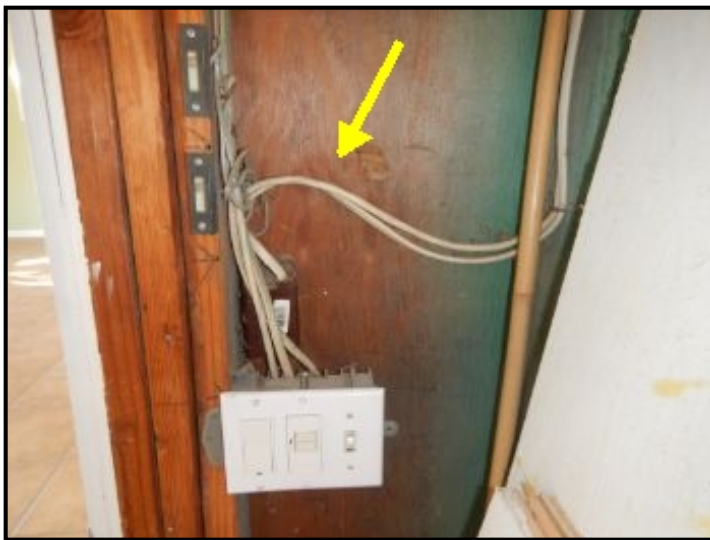
Unprotected non metallic sheathed cable was noted at the garage. Electrical cable is subject to physical damage and is typically installed in attics and inside walls. Repairs should be made to properly protect the wiring system inside conduit. Contact a qualified electrician for repairs.

Unprotected electrical at the garage.

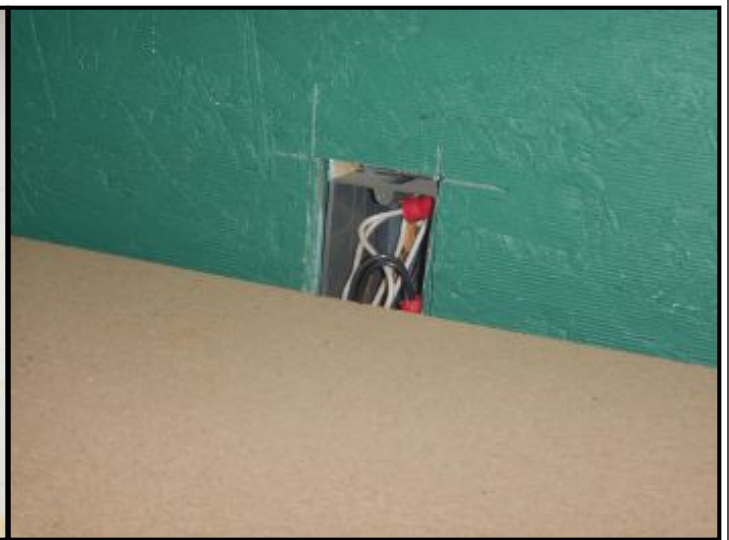
All spliced wires should do so inside of an appropriate covered junction box. There are spliced wires that do not meet this requirement in the garage. We suggest adding the appropriate sized junction boxes with covers as needed.

Missing junction box cover in garage cabinet.

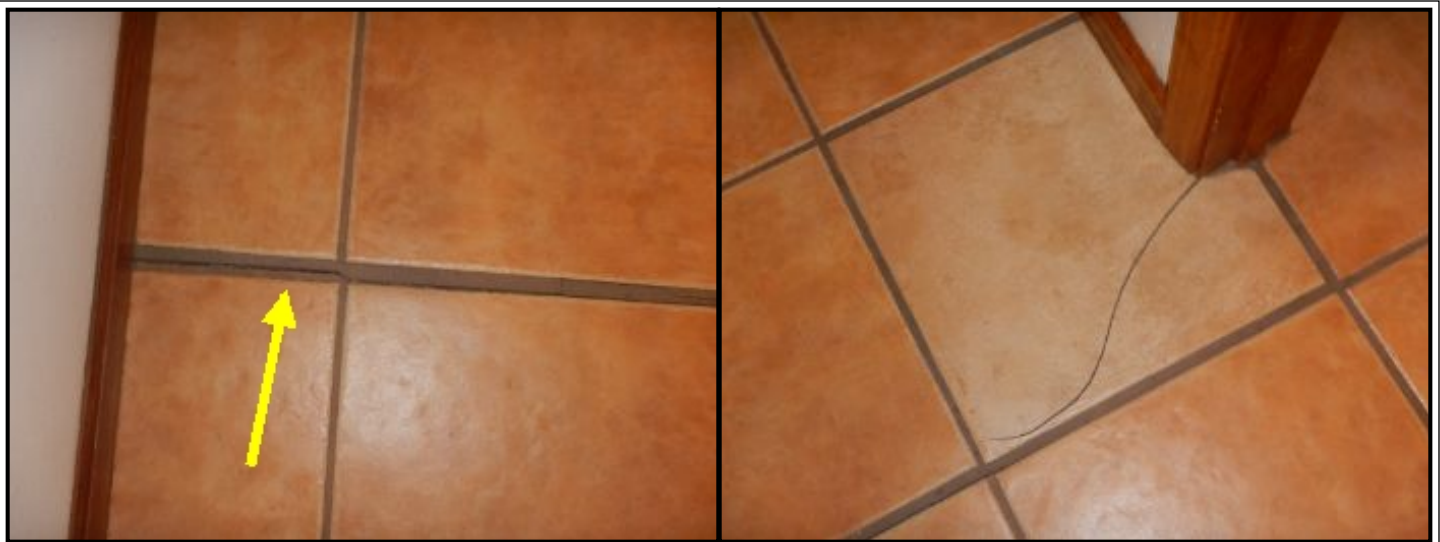
There are cracked tiles at the main hallway of the home. Recommend contacting a qualified tile specialist for evaluation/repairs.

Cracking grout at hallway tile.

Cracked tile at hallway.

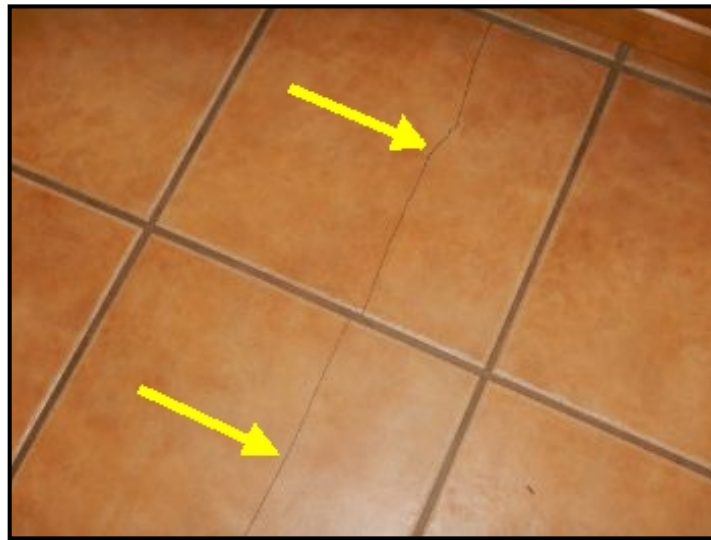
Page 50 Item: 1	Floor Cover Material	<b>Attention</b> Cracked tiles were noted at the kitchen. Contact a qualified tile specialist for evaluation/repairs
-----------------	----------------------	---

Cracking tiles at kitchen floor.

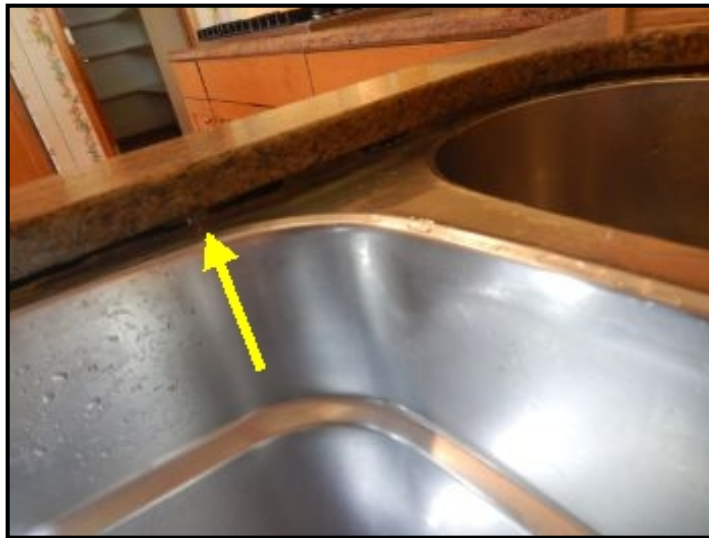
Page 50 Item: 7	Sink/Faucet Leak	<b>Yes</b> The kitchen sink fixture is currently leaking into the under cabinet at the main sink due to a lack of caulking around the lip of the sink. Contact a qualified plumbing contractor for repairs.
Page 51 Item: 9	Stove exhaust Fan	<b>Maintenance</b> The stove top exhaust fan was not functioning when tested.
Page 51 Item: 17	Counter Tops	<b>Attention</b> There are caulking voids around the kitchen sinks. Touch up caulking is recommended to keep these areas properly sealed to prevent potential moisture intrusion.

Recaulk and seal around kitchen sink.

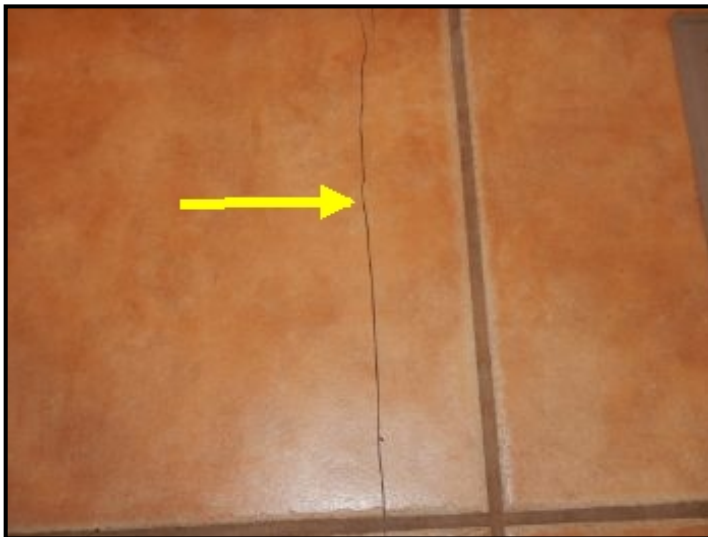
There are cracked floor tiles and grout at both bathrooms. Repairs are advised to maintain a proper water proof seal. Contact a qualified tile specialist for evaluation.

Cracked tiles at bathroom floor.

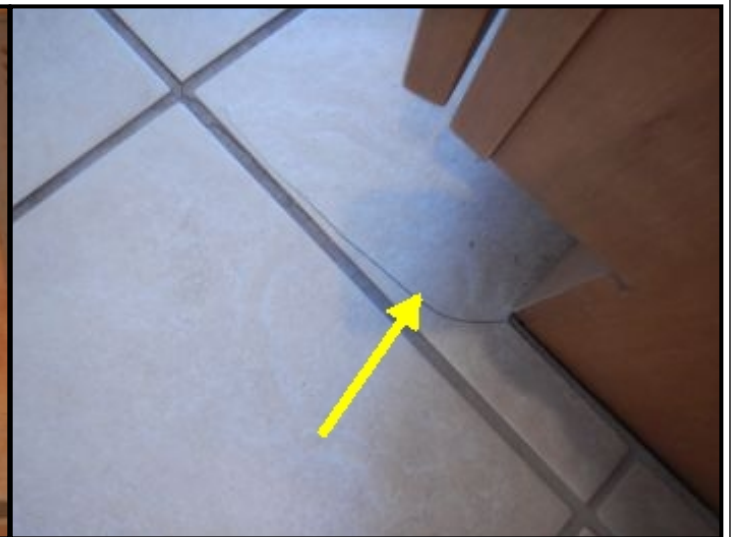
Cracked tiles at master bathroom.

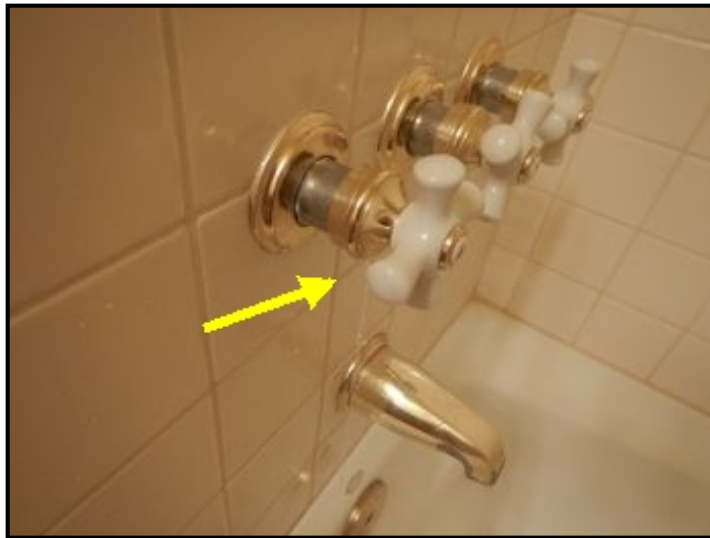
The hot water fixture at the hall bathroom shower is leaking during operation. Contact a qualified plumbing contractor for evaluation/repairs.

Leaking shower fixture at hall bathroom.

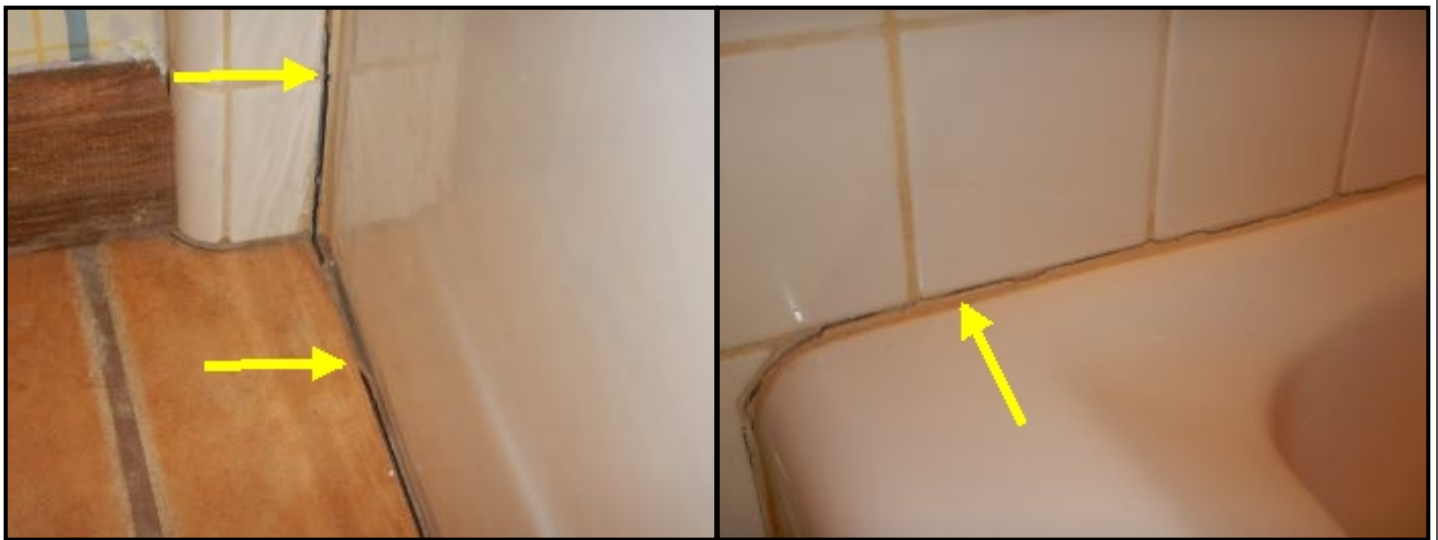
Page 56 Item: 9	Water Resistant Wall Cover	<p><b>Maintenance</b></p> <p>Grout voids were noted around the hallway bathroom shower tile wall as well as the tile floors at the base of the master bathroom tub and shower. This is a condition that can lead to moisture intrusion and deterioration. Regrouting is recommended. These areas should be inspected and touched up on a regular basis as part of preventative home maintenance</p>
-----------------	----------------------------	---

Grout voids at tub/wall in hall bathroom.

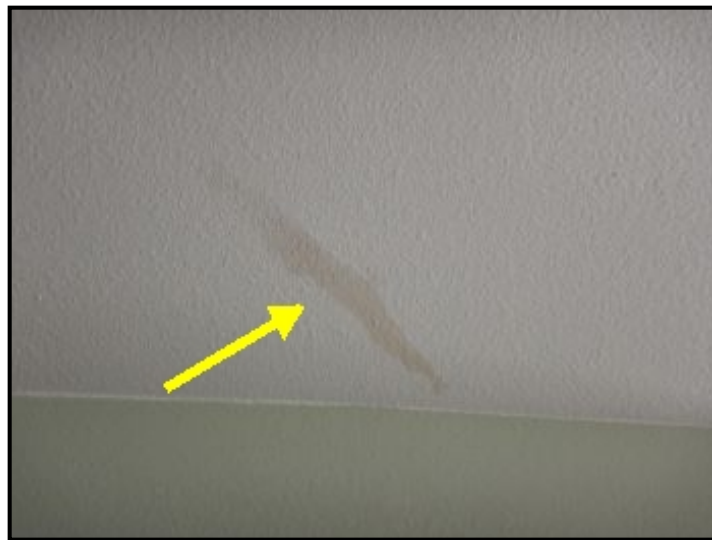
Stain at master bedroom ceiling.

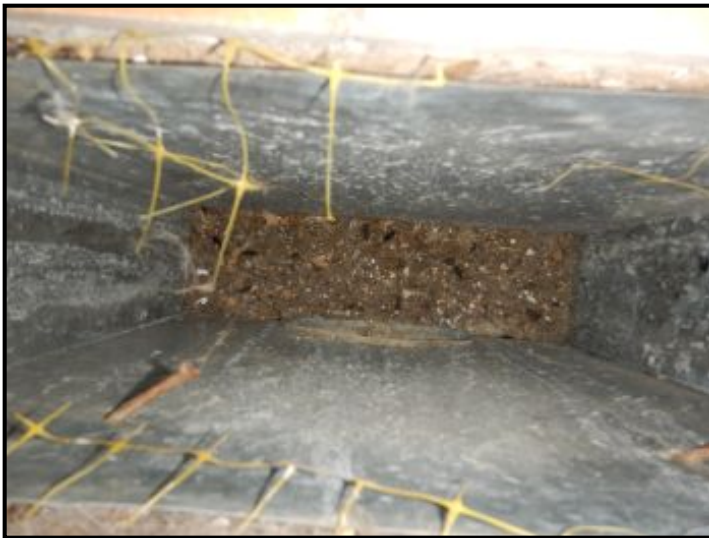
Debris build up in heat registers.

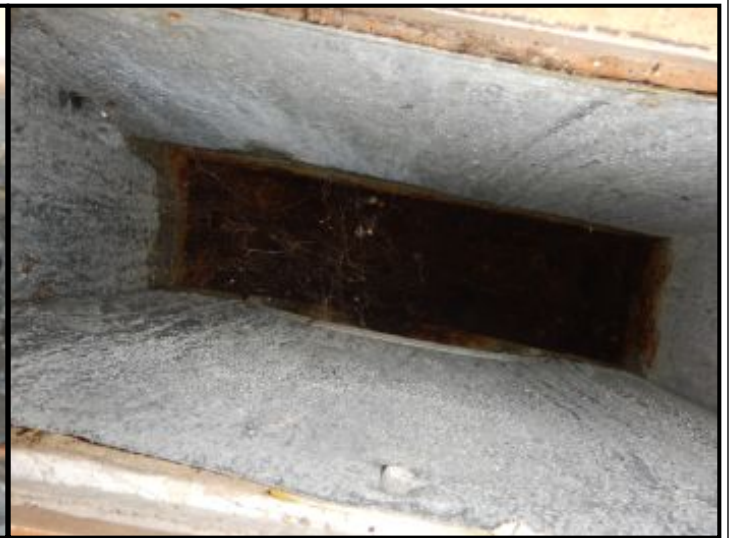
Rust/corrosion to heat register in dining room.

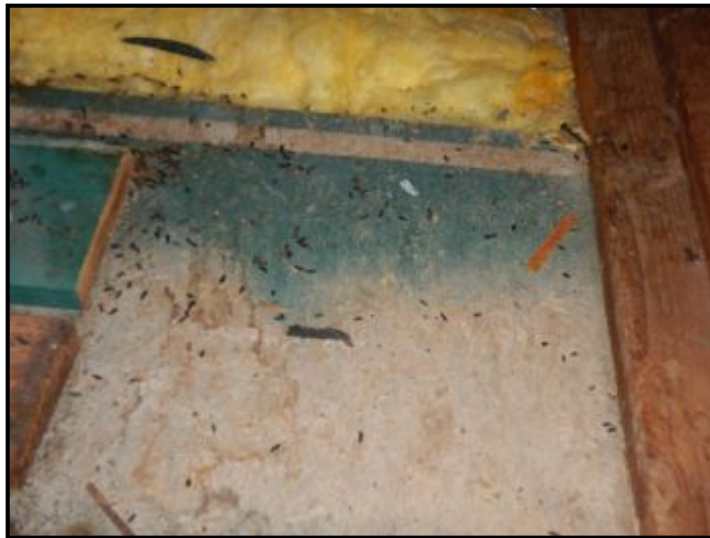
There is evidence of rodent activity in the attic and garage. It could not be determined if this is a current active issue or not. Recommend contacting the appropriate pest control company for evaluation/recommendations.

Rodent droppings in the attic.

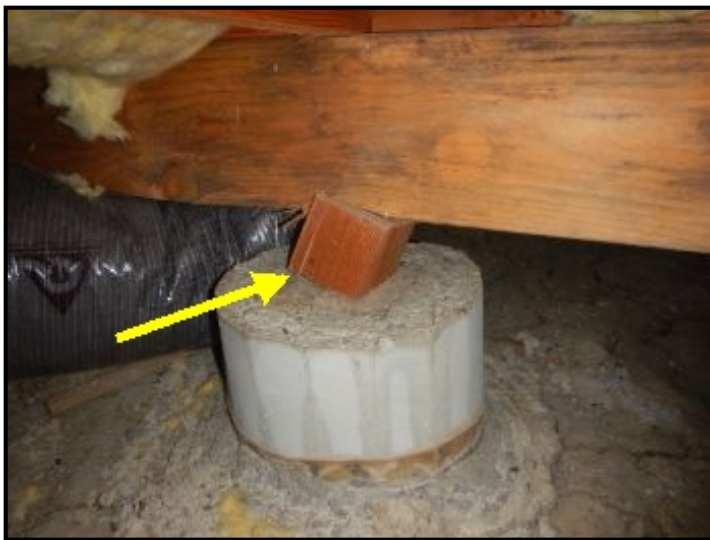
Leaning wood blocks in sub area.

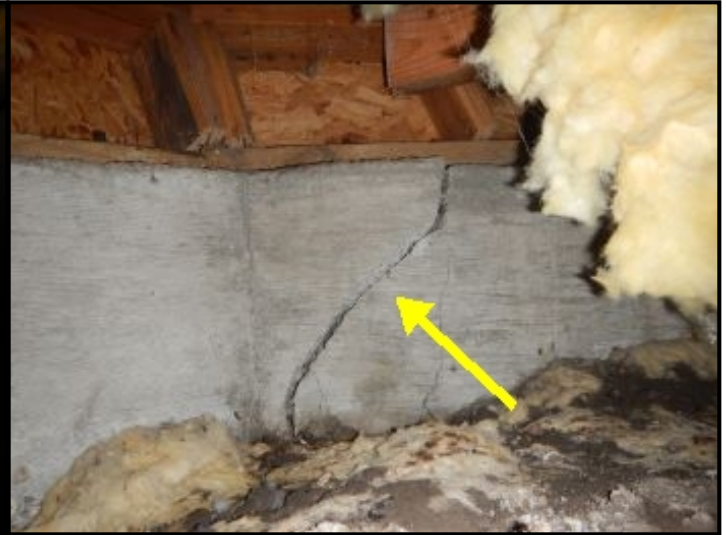
Page 69 Item: 12	Separation Over 1/4"	<b>Yes</b> There are cracks in the foundation that are in excess of 1/4 inch in separation or displacement. This indicates a condition in excess of normal expansion/movement. Contact a qualified foundation specialist for evaluation/recommendations.
------------------	----------------------	---

Excessive cracking at foundation wall.

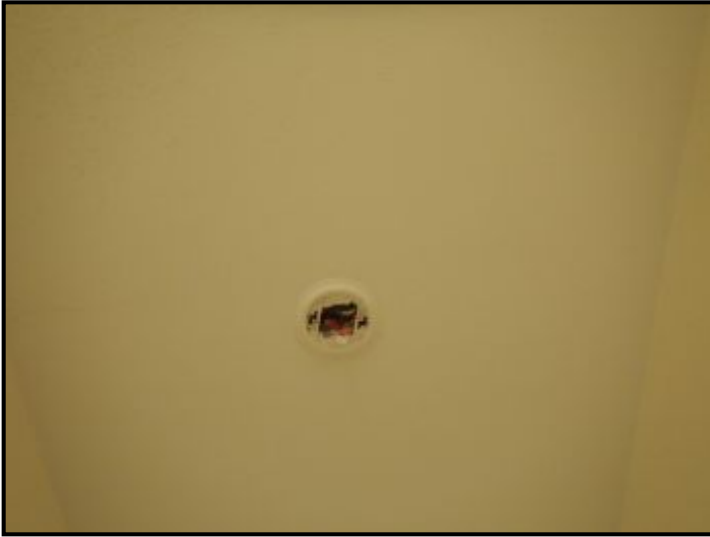
There is a missing smoke detector in the main hallway and a missing battery for a detector in the first bedroom. It is advised to install smoke detectors in the hallway outside of the sleeping areas as well as each bedroom.

Missing smoke detector at hallway.

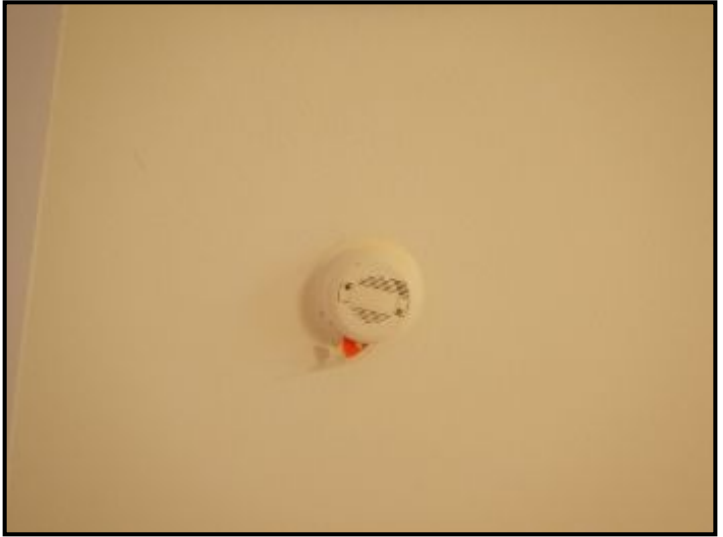
Missing battery at smoke detector.

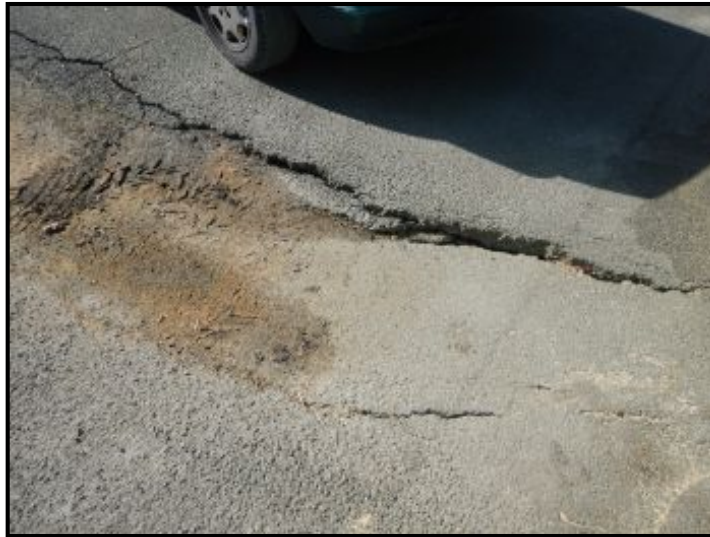
There is cracking/settling noted at the driveway. Repairs are advised to prevent any potential tripping hazards and maintain proper drainage away from the home.

The driveway slopes to the home and evidence of ponding water was noted. Inquire with owner disclosures for any past moisture intrusion or ponding water.

Cracking/settling to driveway.

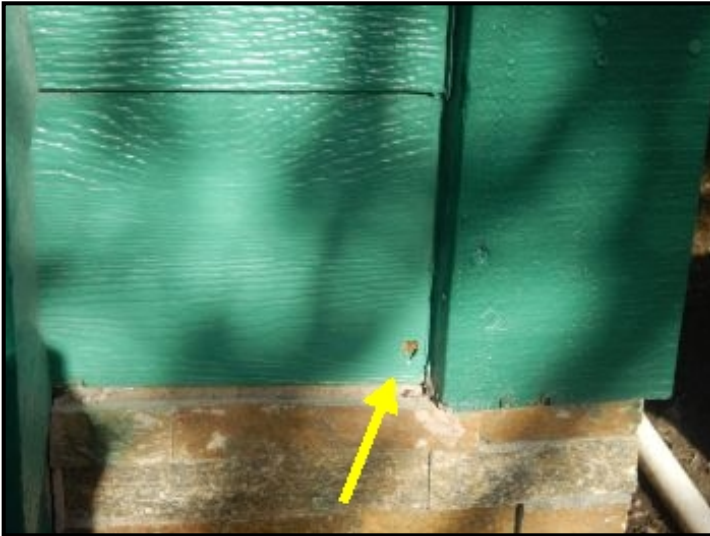
Siding damage was noted to areas at the exterior of the home. We recommend referring to the pictures and contacting a qualified contractor to review the current pest report and make needed repairs.

Siding damage to right of garage door.

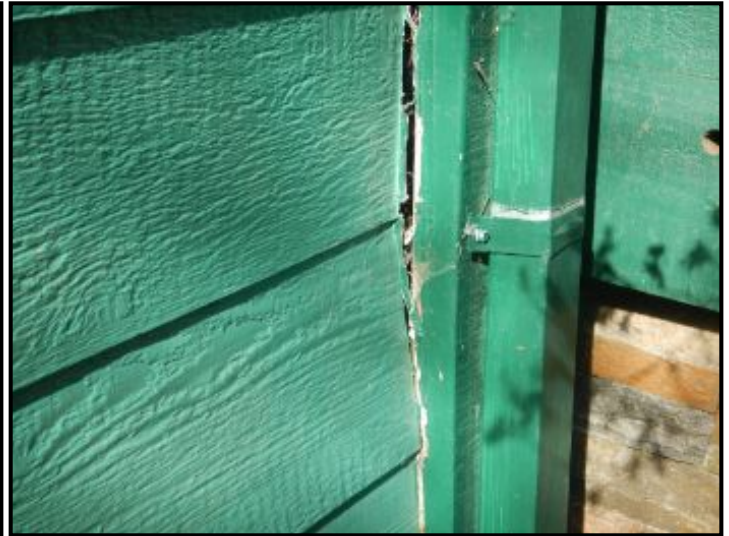
There is warped/bulging siding at the right side of the home. This appears to be caused by a structural issue. Recommend contacting a qualified contractor for evaluation/recommendations.

Bulging siding at right side of home.

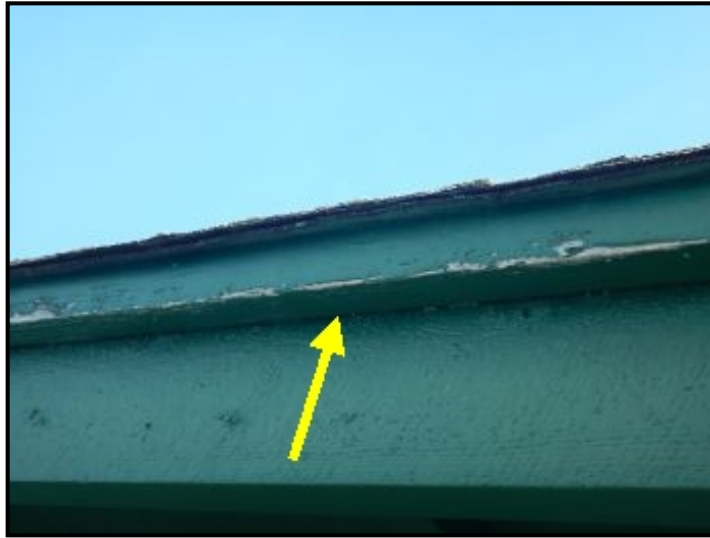
The paint on some of the exterior fascia boards are showing wear. Touch up painting is recommended to prevent potential damage and deterioration.

Repaint exterior fascia boards as needed.

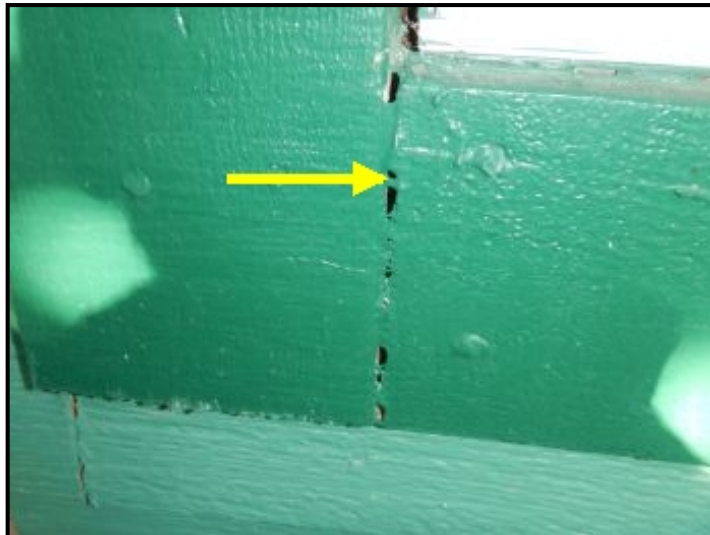
The exterior caulking is in need of touch ups to various areas at the exterior of the home. As part of preventative maintenance it is recommended to maintain the caulking around the windows, trim and siding material as needed.

Recaulk exterior trim as needed.

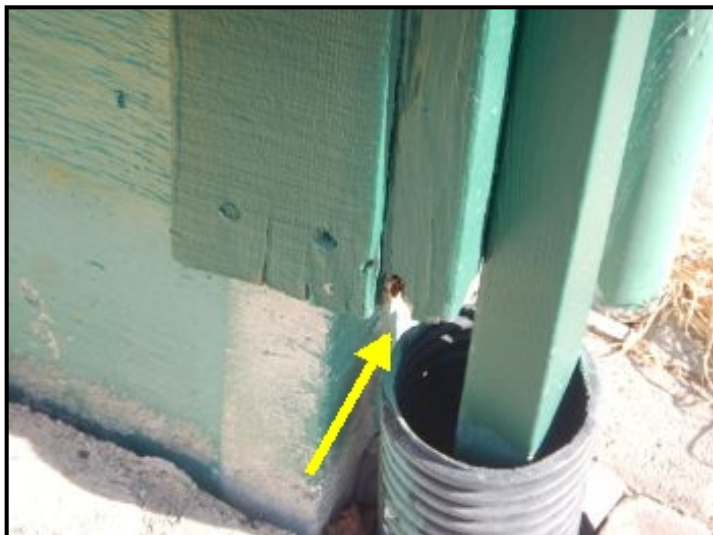
Trim damage has been noted at the exterior of the home. We recommend referring to the pictures and contacting a qualified contractor to review the current pest report and make needed repairs.

Trim damage at left of garage.
