# *Gage Inspection Services*

## Property Inspection Report

121 Mary Paige Ln, Santa Rosa, CA 95404  
Inspection prepared for: David Phillips  
Real Estate Agent: Mary Haufler - Sothebys

Date of Inspection: 3/27/2018 Time: 9:00 AM  
Order ID: 66

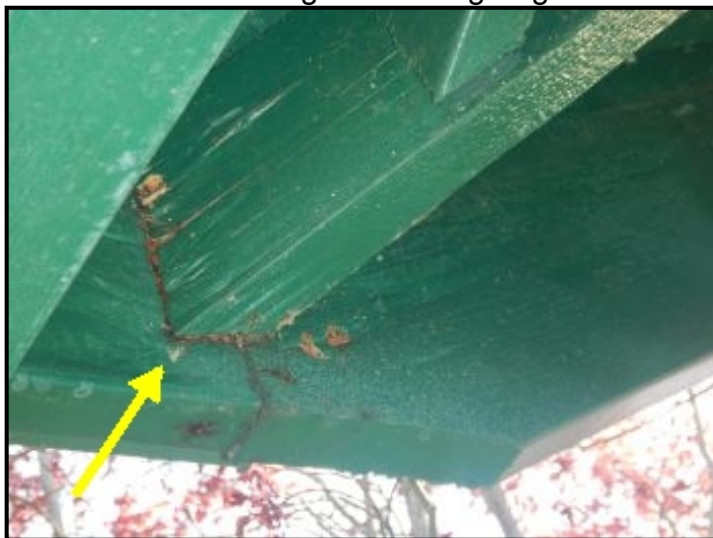
Fascia damage at right side of home.

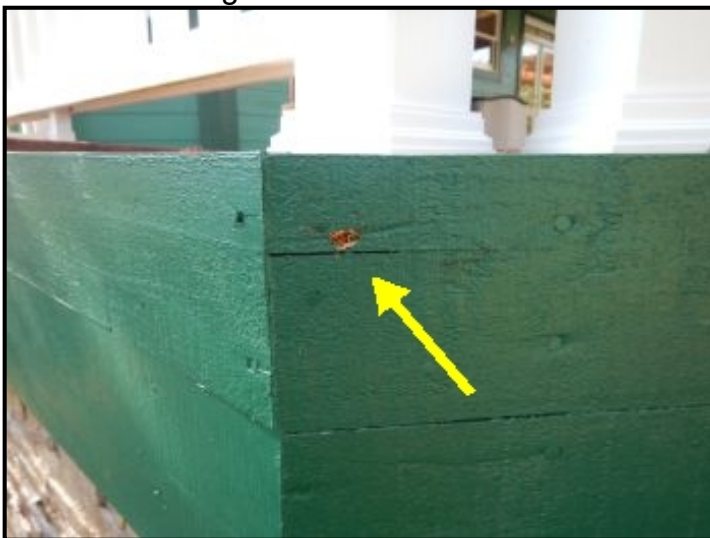
Fascia damage to areas at rear decks.

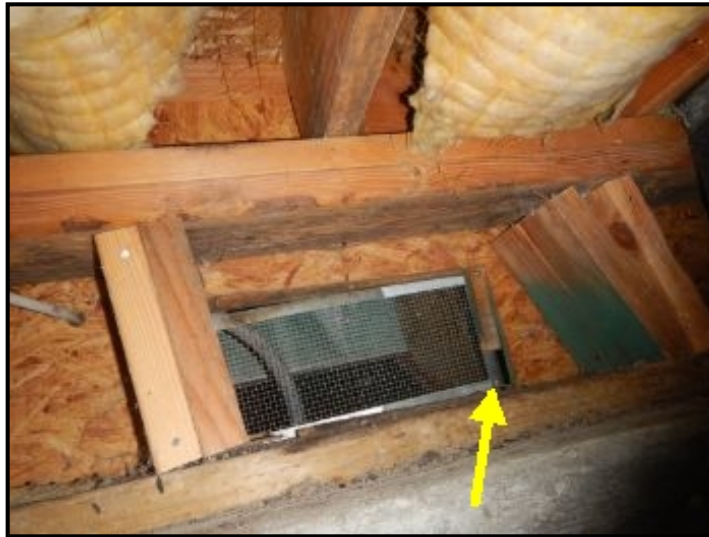
There are gaps noted to some of the under house vents under the rear deck noted from the sub area. Measures should be taken to keep the vent screens properly sealed to maintain intended drainage and prevent rodent access into the sub area.

Gaps around vent screens under rear decks.

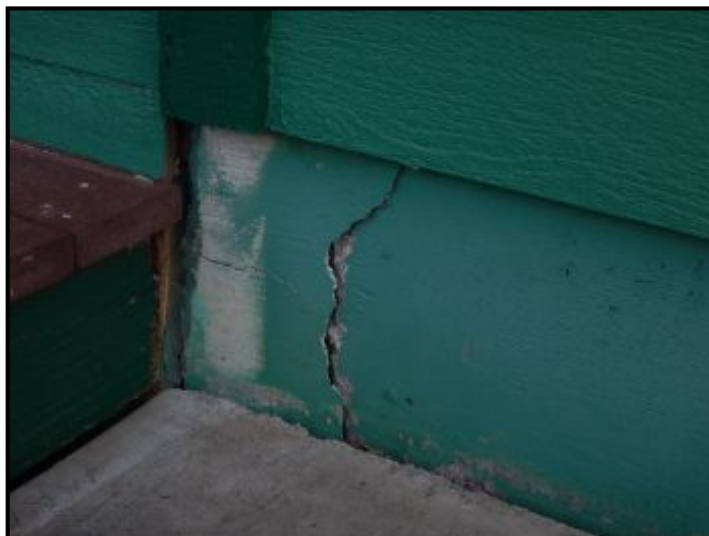
There is excessive cracking in the foundation system. Recommend contacting a qualified foundation specialist for evaluation/recommendations.

Cracking in foundation.

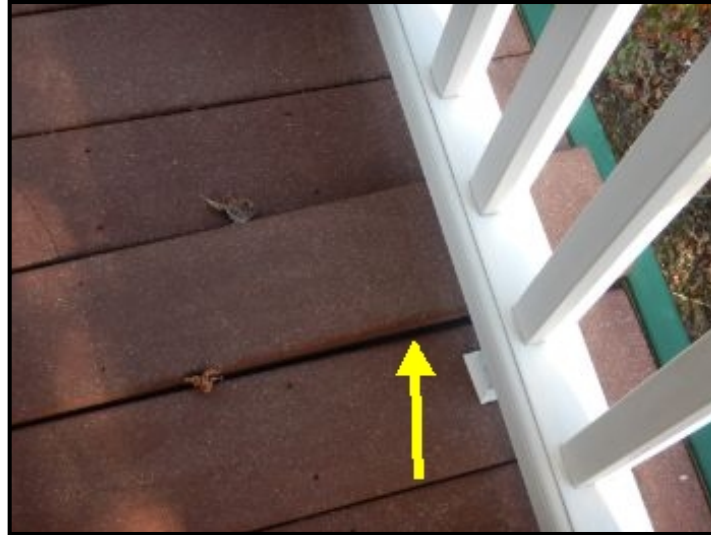
There are a couple of deck surface boards that are backing out. Recommend refastening to the deck framing to prevent potential tripping hazards.

Lifted deck surface board,

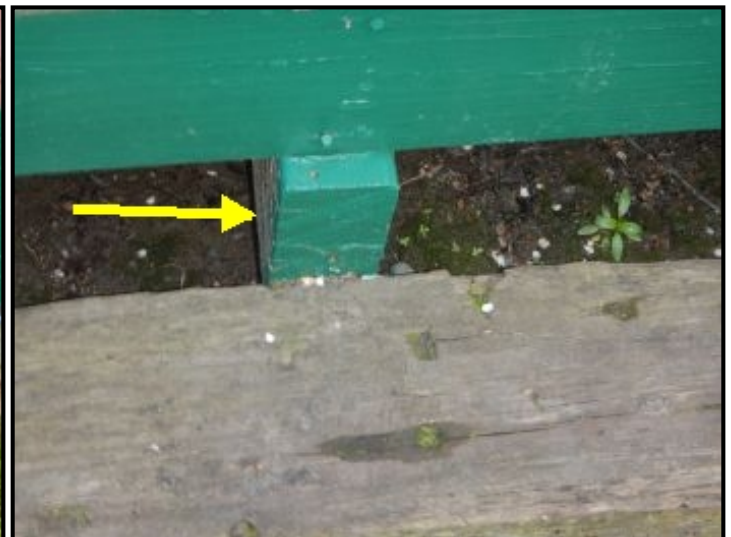
There was damage noted to the ends of girders at the rear deck. We recommend referring to the current pest report for further comment/recommendations.

Damage to ends of girders at rear deck.

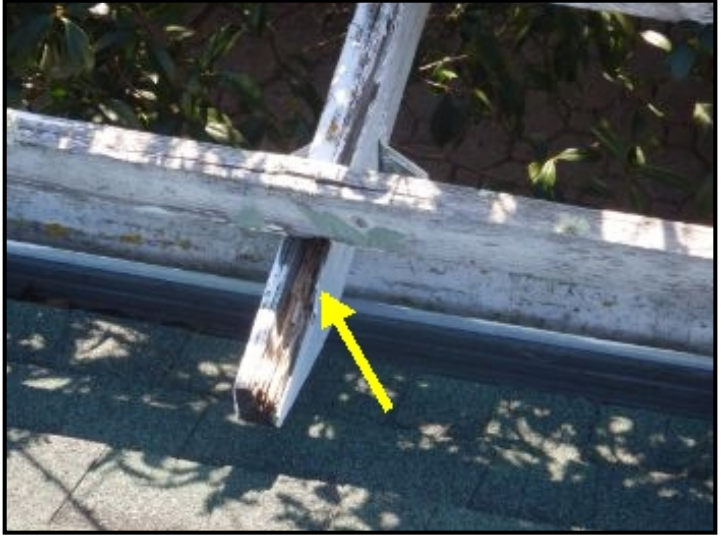
There was wood damage noted to multiple areas to the exterior trellis. Recommend referring to the current pest report for further comment/recommendations.

Deterioration of front trellis.

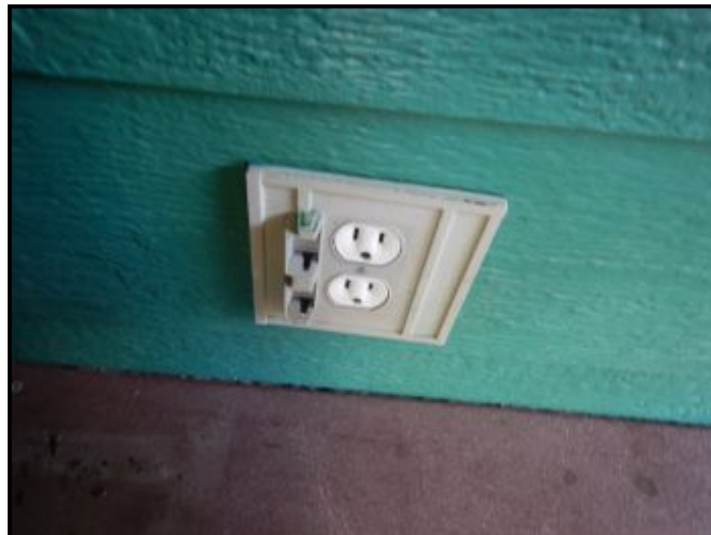
There is a damaged weather protective cover at the rear deck. Replacement of the cover is recommended as a health and safety consideration.

Replace weather protective cover at rear deck.

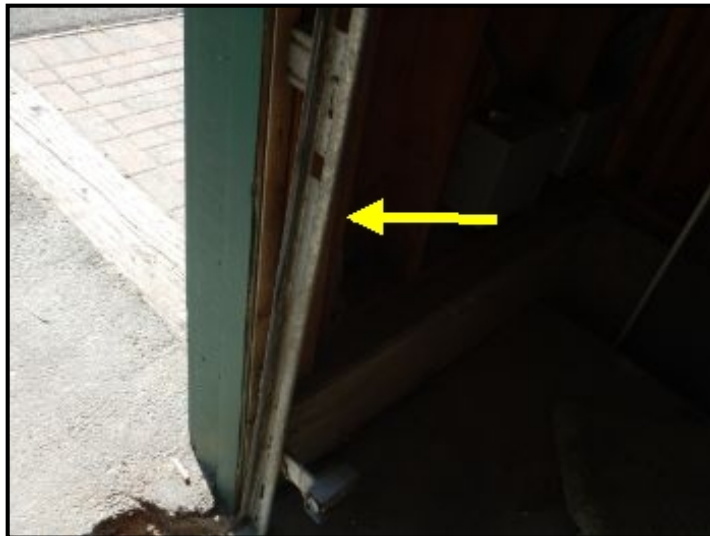
The automatic garage door opener for the single car garage would not close. It appears due to past settlement of the concrete floor and the track that is bent/warped the automatic reversing eyes are not lining up properly. Contact a qualified garage door specialist for evaluation/recommendations.

One of the tracks for the single car garage door is bent/warped causing the door to malfunction. Contact a qualified garage door specialist for evaluation/repairs. Installation specifications is not within the scope of this inspection.

Bent/warped track at garage door.

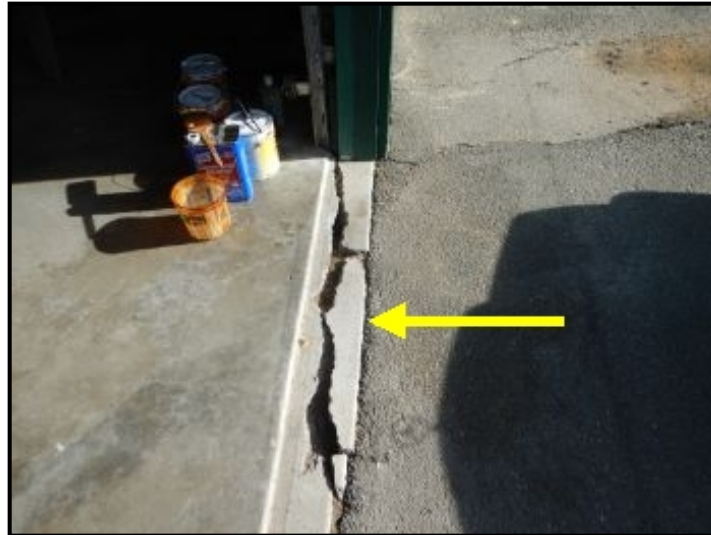
There is excessive cracking noted to the concrete garage slab. We recommend contacting the appropriate specialist for evaluation/recommendations for repairs.

Cracking at garage.

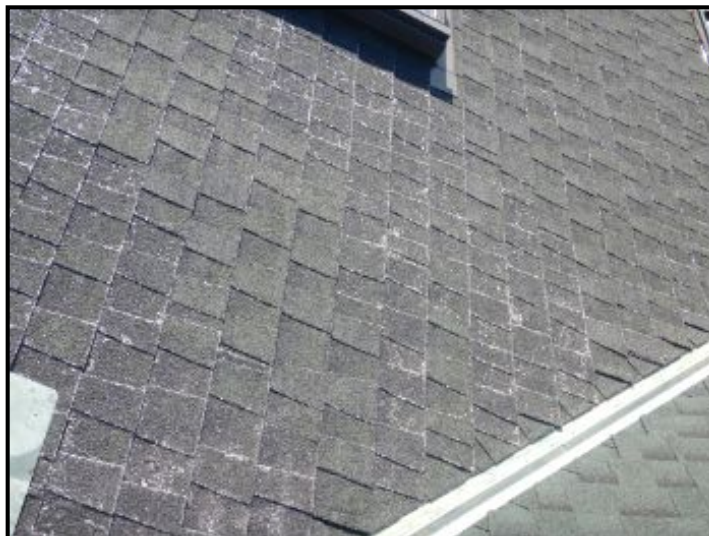
The roof cover for the main structure appears to be newer and in serviceable condition. The roof cover material over the sun room and garage is older showing wear indicating it is nearing the end of its useful life. Contact a qualified roofing contractor for evaluation/recommendations.

Older roof cover material over addition.

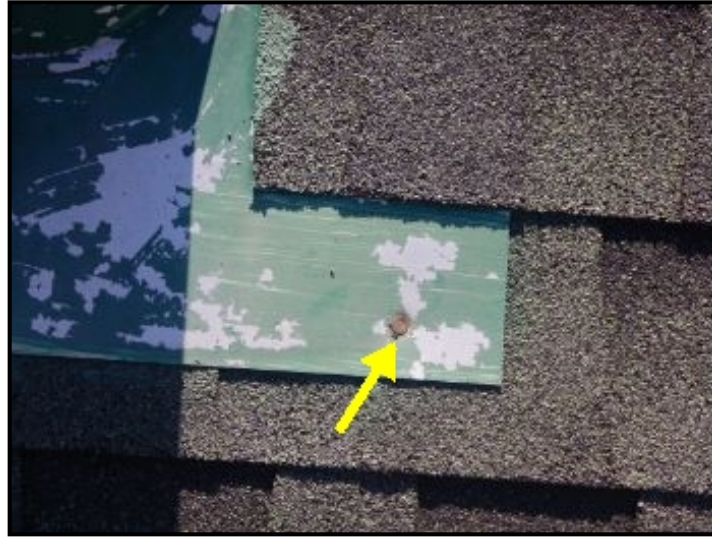
There are some exposed fasteners at the roof top flashings. It is recommended to keep these areas properly caulked and sealed to prevent potential leaking points. Contact a qualified roofing contractor for evaluation/repairs.

Seal exposed fasteners at roof top flashings.

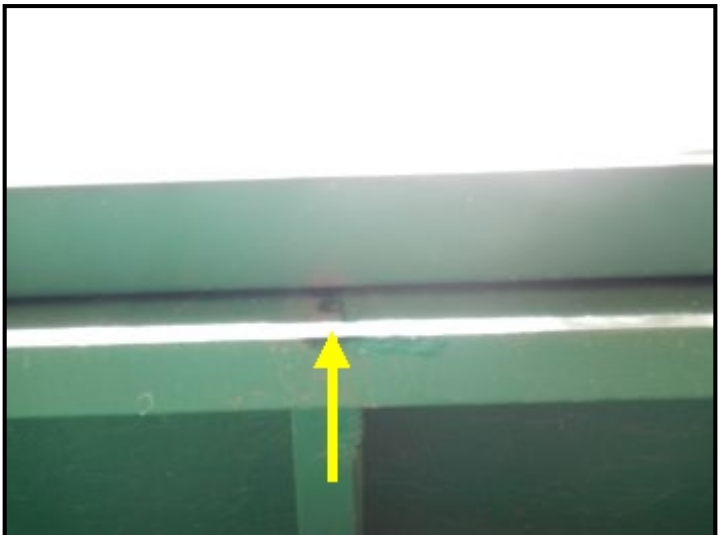
The gutters over the garage door are leaking. Contact the appropriate trades person for evaluation and recommendations for repairs.

Leaking gutter over garage.

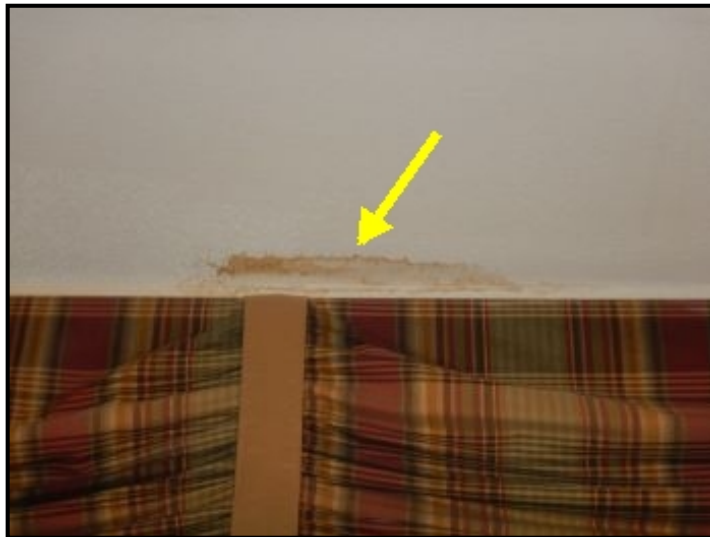
There is moisture staining at the ceiling over the family room window indicating past moisture intrusion. The area was dry at the time of the inspection and no major adverse conditions were noted. Recommend monitoring this area and taking corrective measures if needed.

Moisture stain at living room ceiling.

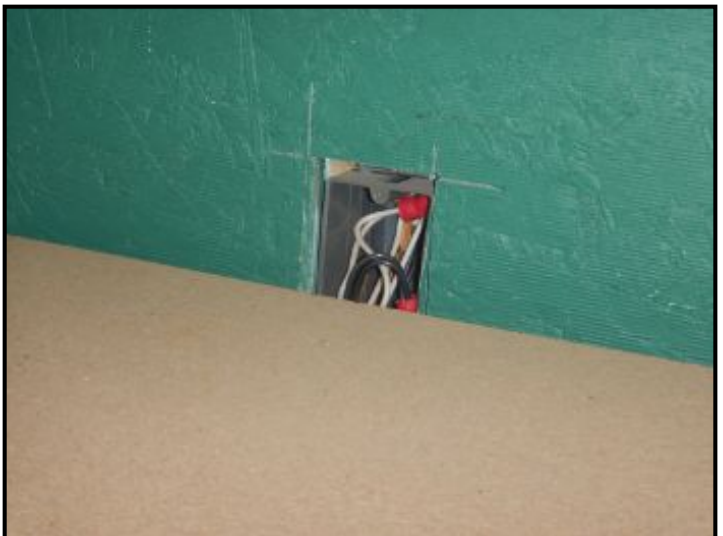
Missing junction box cover in garage cabinet.

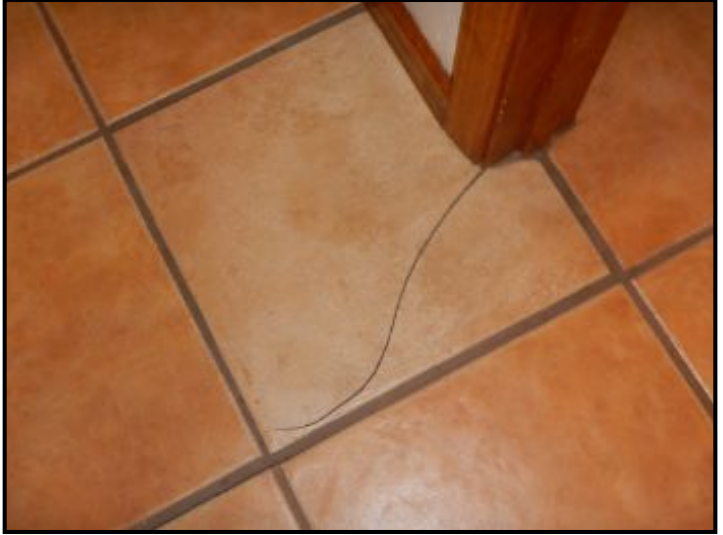
Cracked tile at hallway.

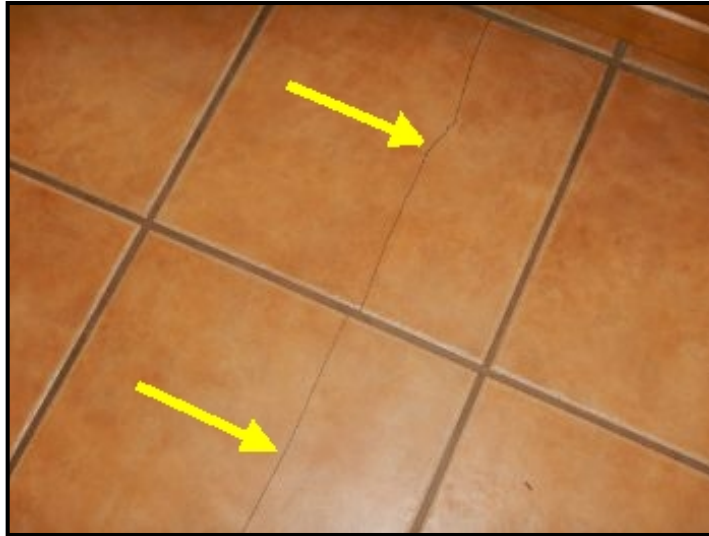
Cracking tiles at kitchen floor.

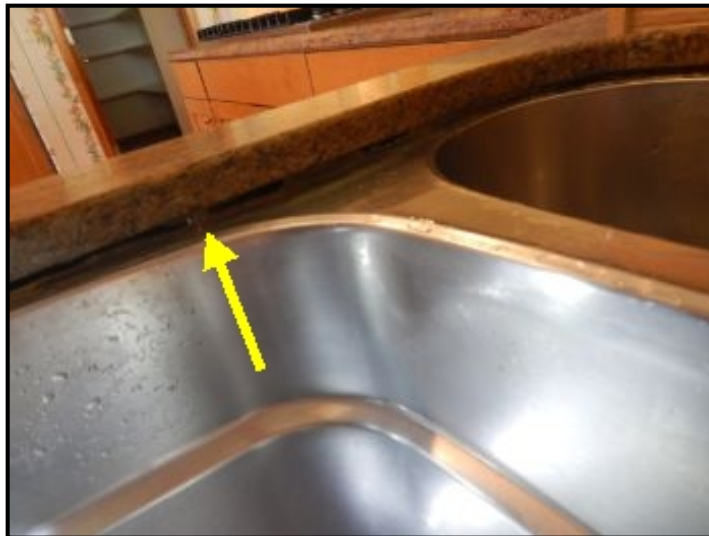
Recaulk and seal around kitchen sink.

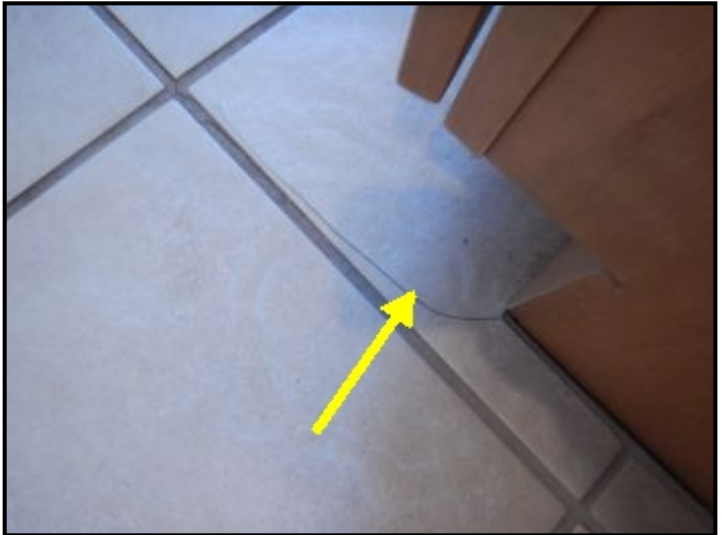
Cracked tiles at master bathroom.

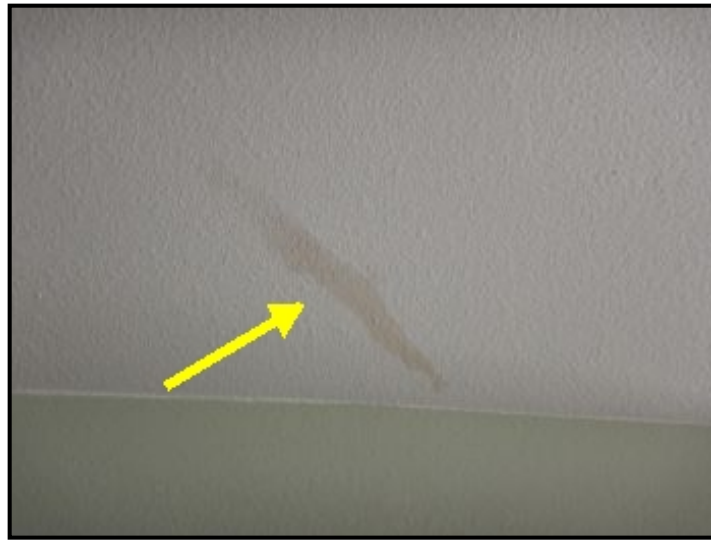
Stain at master bedroom ceiling.

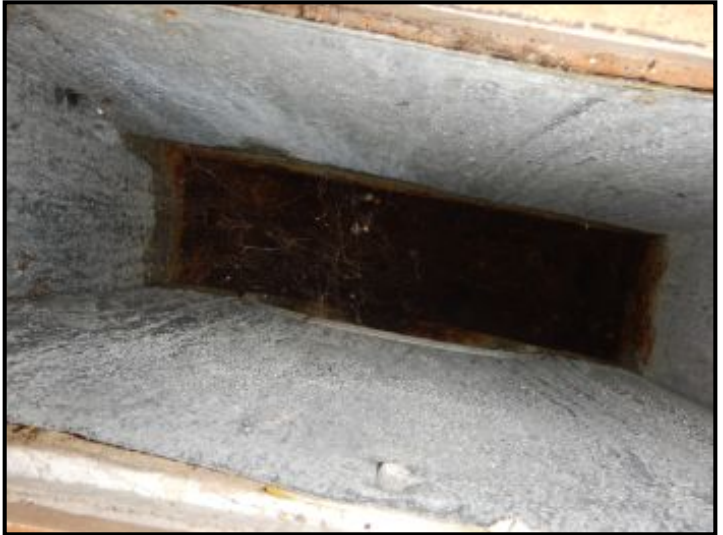
Rust/corrosion to heat register in dining room.

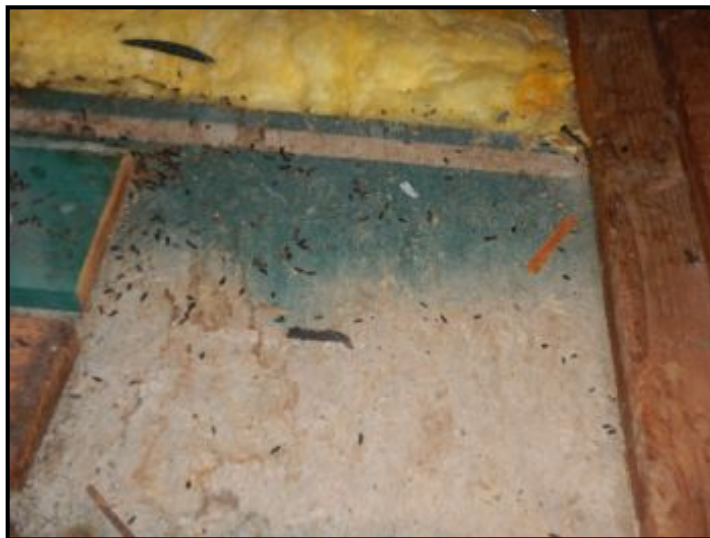
Rodent droppings in the attic.

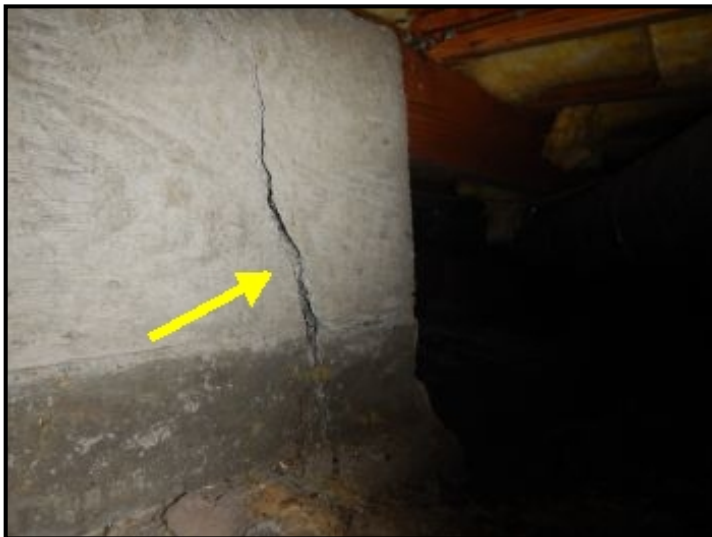
Excessive cracking at foundation wall.

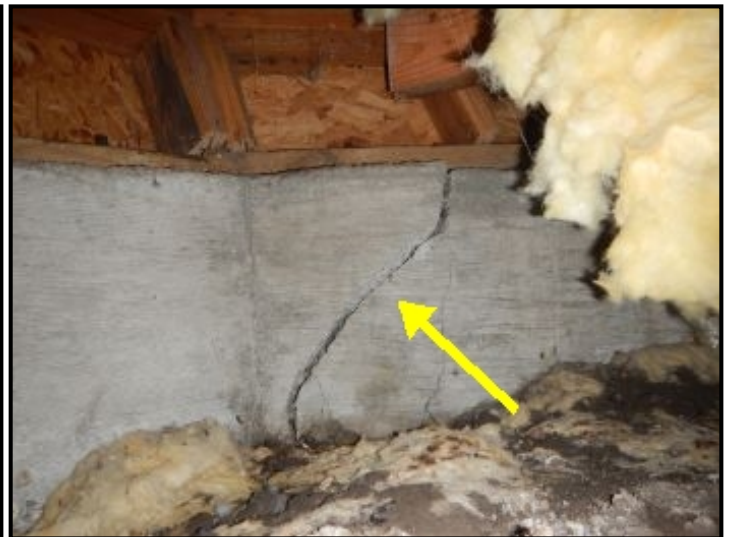
Excessive cracking at foundation wall.
