Property Inspection Report

1827 Pamela Dr, Santa Rosa, CA 95404
Inspection prepared for: Jan Volk
Real Estate Agent: Mary Haufler - Sothebys

Date of Inspection: 4/6/2018 Time: 9:00 AM
Order ID: 71

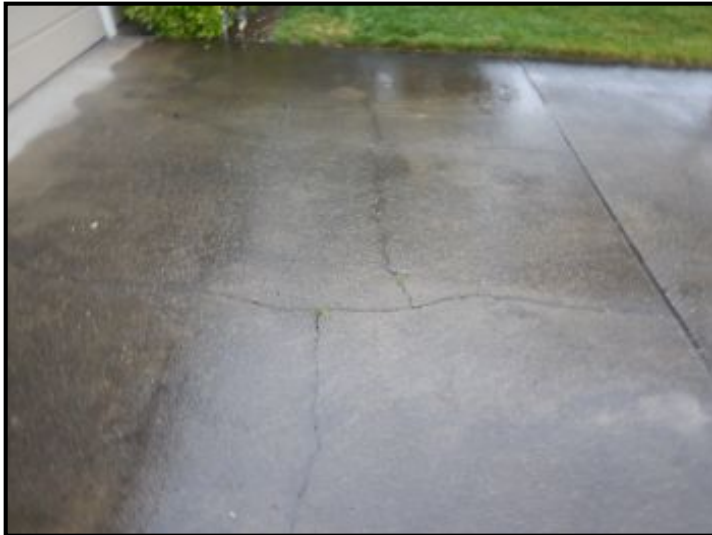
Page 19 Item: 1	Driveway/Parking	Attention There is cracking at the concrete driveway. Though still functional the concrete areas should be monitored for further distortion and repaired or replaces as necessary to eliminate tripping hazards

Cracking at driveway.		
Page 19 Item: 2	Walkways	Maintenance There is cracking/settling noted at the concrete walkways causing a potential tripping hazard. As a safety consideration patching/repairs are advised as needed. Contact a qualified concrete specialist for repairs.

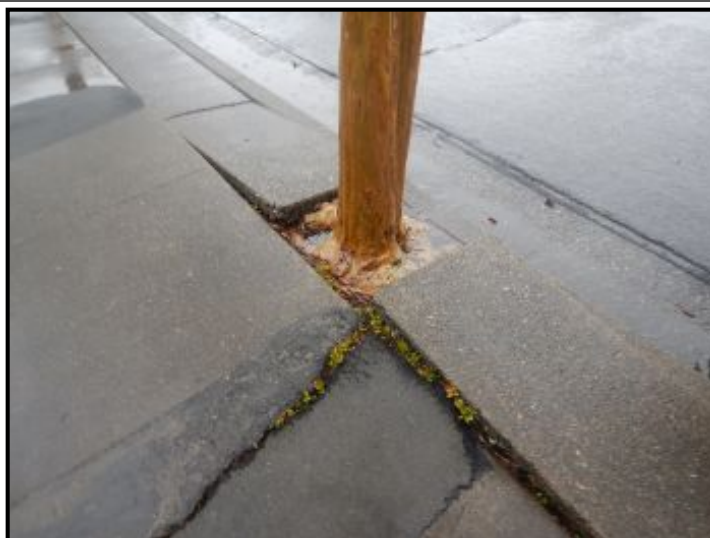
Lifted sidewalks around the home.

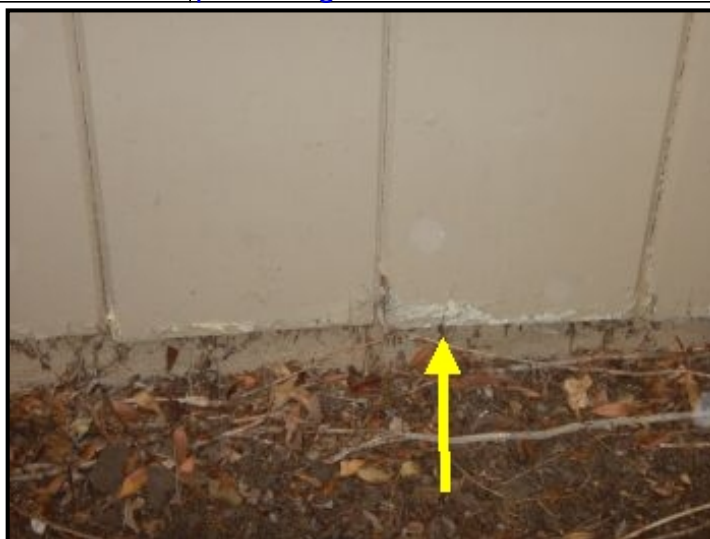
Some of the paint at the exterior of the home is showing wear. Touchup painting is recommended to provide long term protecting to the exterior of the home.

Repaint exterior wood members as needed.

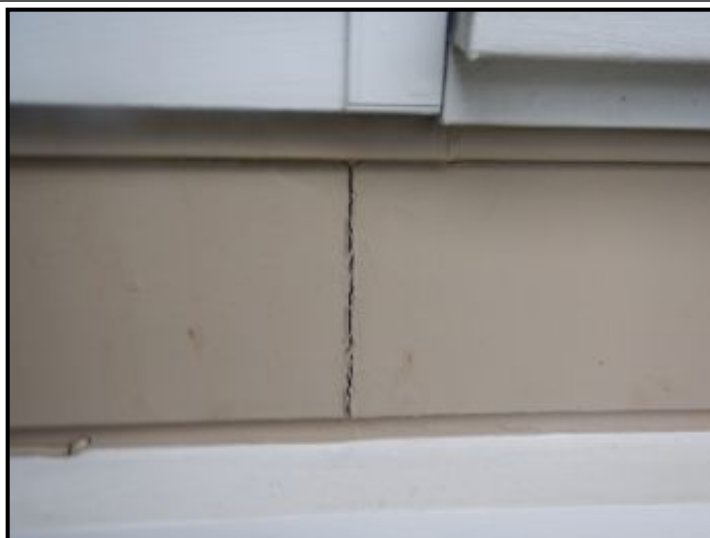
Touching up the structure caulking around the tops and sides of the windows, door trim and siding should be performed yearly as a part of routine maintenance. The caulking keeps rain water from penetrating behind the siding material and causing premature deterioration of the material.

Caulk/seal gaps at siding as needed

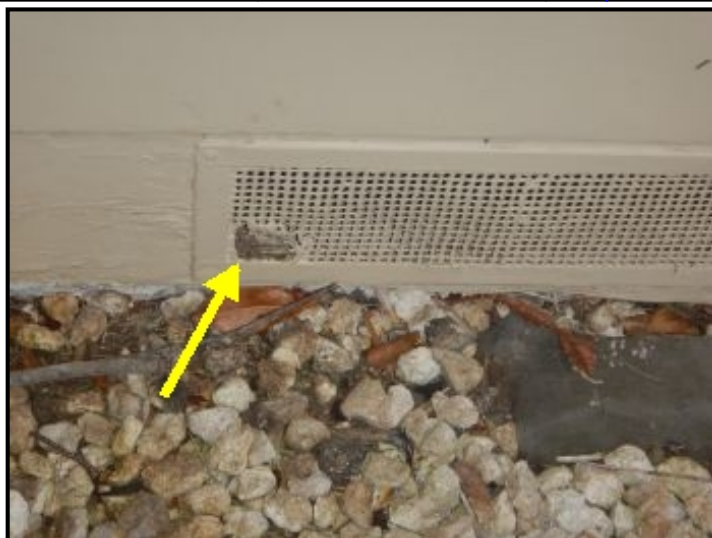
A side under-house vent screen is in need of repair/replacement at the rear of the garage. A tight screen should be maintained to allow for proper ventilation and to keep animals out of the sub area.

Seal vent screen at rear of garage.

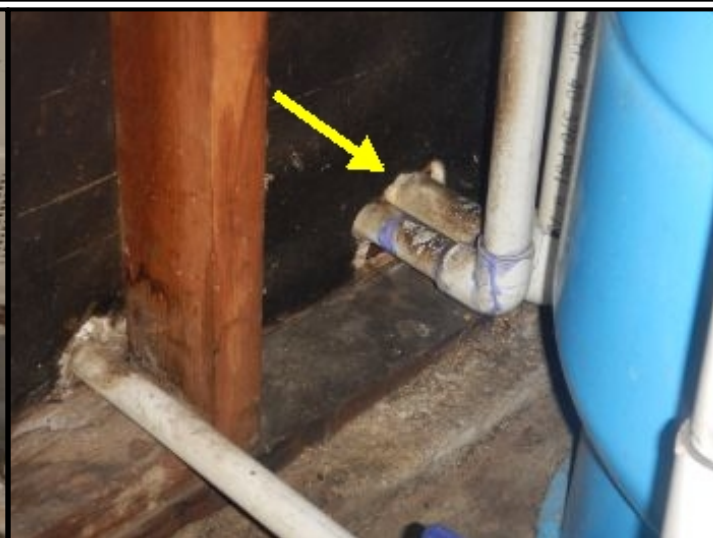
Seal around pipes at back of garage.

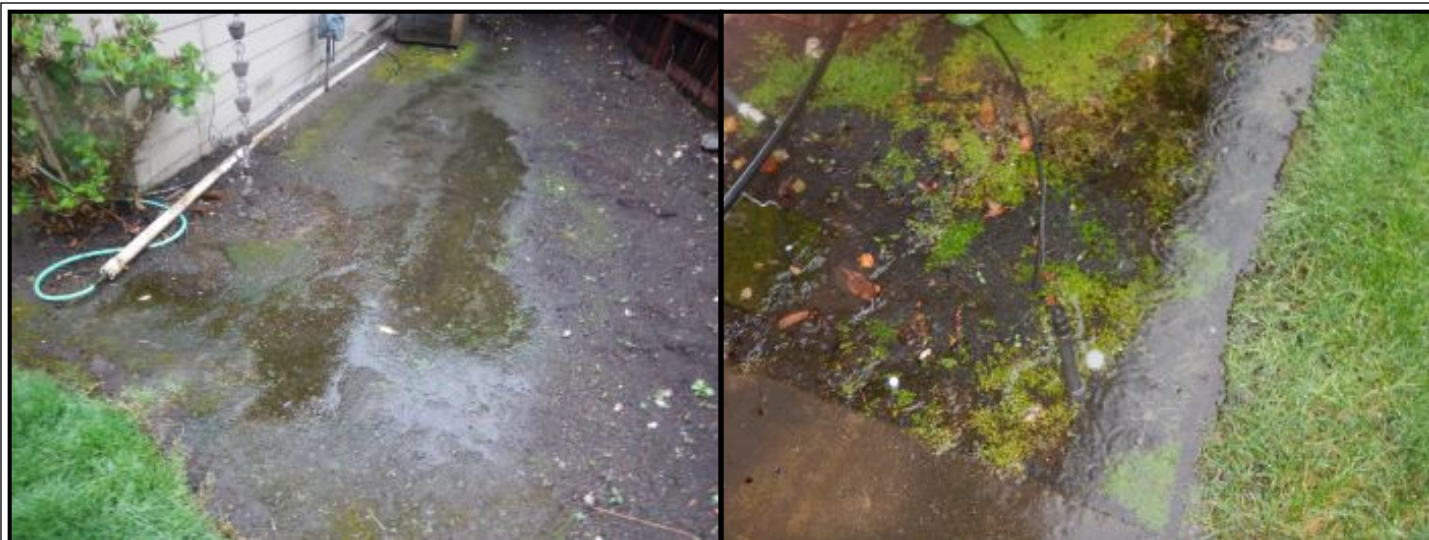
Areas of negative grade is noted around the structure which has caused ponding water at the rear of the home. This is a condition that can lead to moisture intrusion into the sub areas of the home. It is recommended to maintain proper drain slope away from the home.

Standing water at side of home.

Standing water at rear patio.

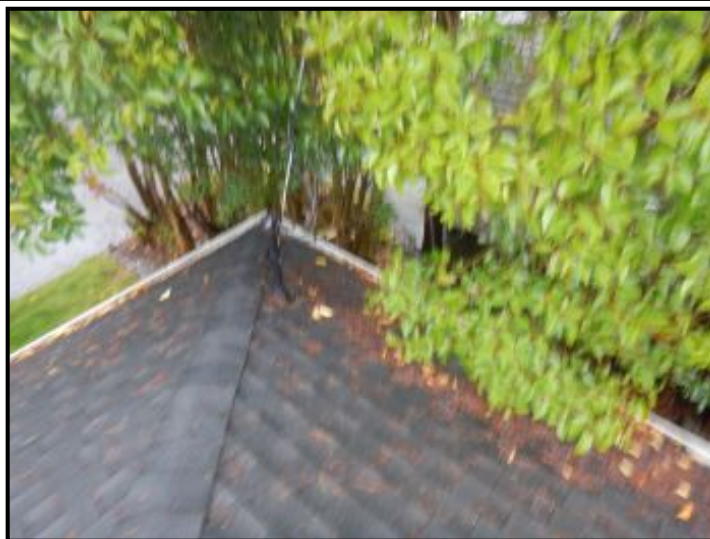
There is vegetation growing up against the exterior surface material. All vegetation should be trimmed at least 6-12 inches away from the structure to eliminate a common avenue for pest infestations or any damage to the exterior structure material.

Cut vegetation away from structure.

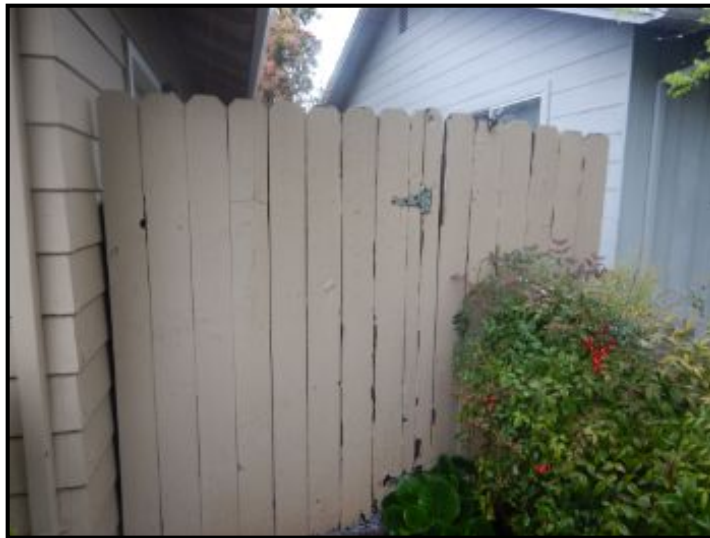
Though upright at the time of the inspection there are sections of the fence that are in a deteriorated condition. Future repair/replacement may will be needed. Contact the appropriate specialist for evaluation/repairs.

Deterioration to sections of fencing.

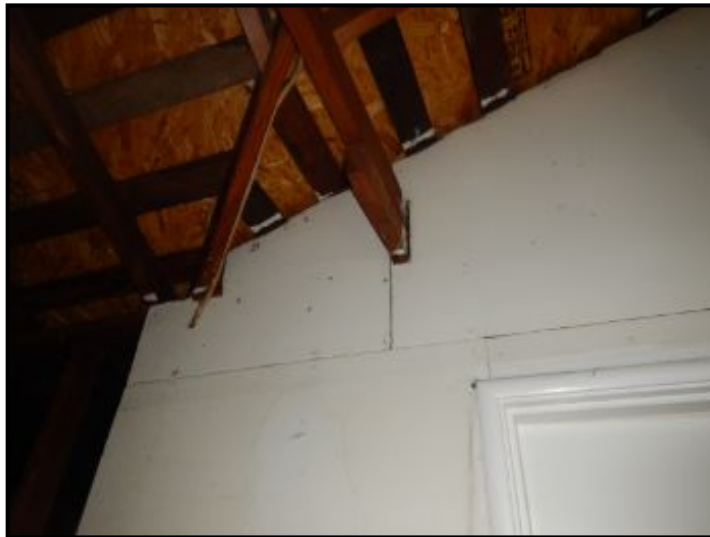
Page 26 Item: 9	Firewall	Maintenance There are gaps around pipes/cables/ducting/seams at the wall between the garage and living space. It is advised to use a fire rated caulking to seal around any gaps in the wall and properly tape and seal all the joints as a health and safety consideration. Contact a qualified contractor for repairs.
-----------------	----------	--

Seal firewall as needed.

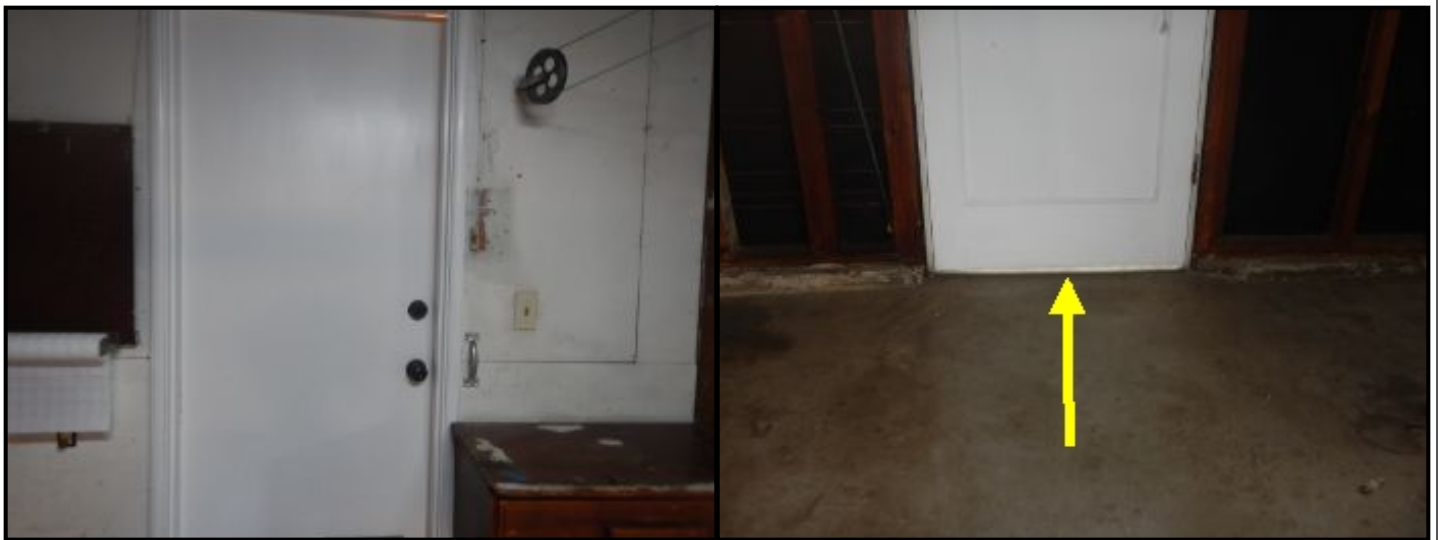
Page 27 Item: 10	Door(s) Garage-Building	Maintenance The door from the interior of the home to the garage is not a fire rated door. Recommend replacing with a 20 minute self closing fire rated door as a health and safety consideration. There are gaps under the side service garage door which may allow in moisture or an access point for rodents. It is recommended to install a door sweep to keep this area properly sealed. The glass at the door from the garage to the exterior yard is not labeled as tempered safety glass.
------------------	-------------------------	--

Garage door is not a fire rated door.

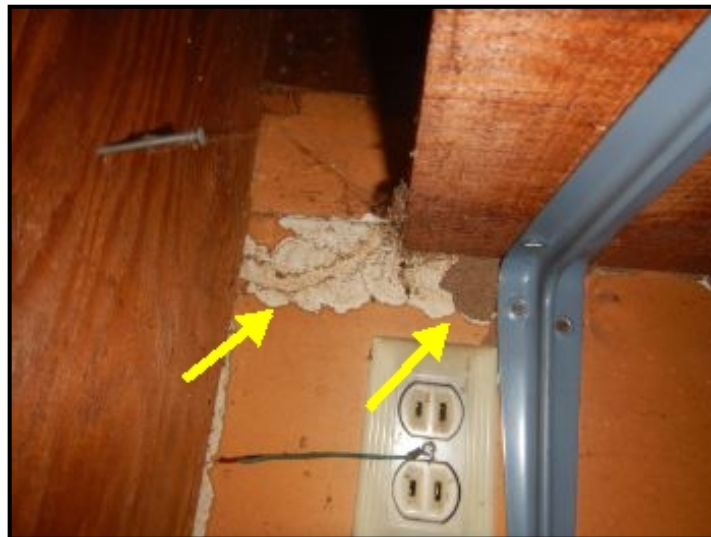
Page 27 Item: 12	Walls	Attention There is what appears to be termite activity at the wall in the garage. Gage Inspection Services is not a licensed pest inspector in the state of California. We recommend referring to the current pest report for further comment/recommendations.
------------------	-------	--

Apparent termite activity in the garage.

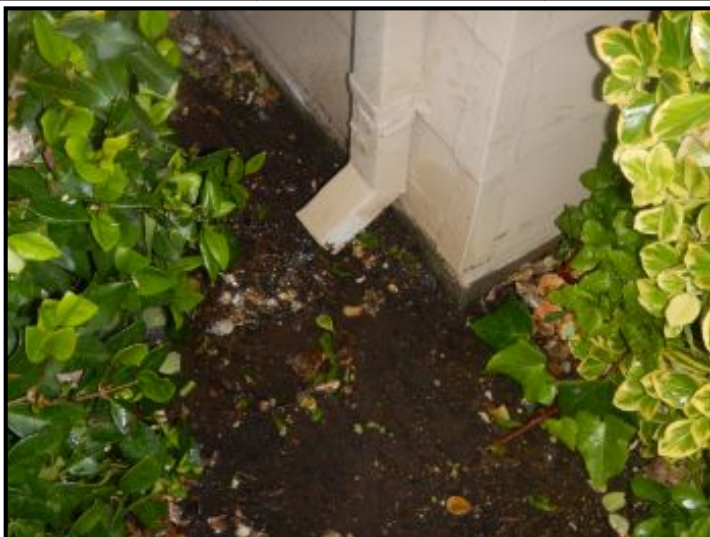
Direct downspouts away from home as needed.

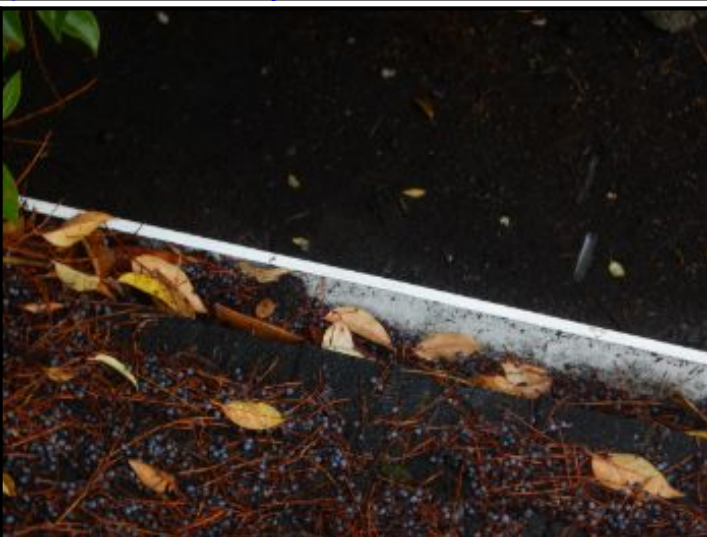
Page 30 Item: 11	Gutters/Downspouts	<p>Attention</p> <p>There is debris build up in the gutters that should be removed. Debris can clog the gutters, down spouts and drain system if not cleaned out. cleaning the gutters on an annual basis is recommended for proper care and maintenance of the gutter system.</p> <p>There are downspout that are draining at the foundation perimeter which can allow for water penetration into the crawl space. Recommend installing drain pipe extender or splash blocks to help divert water away from the structure.</p>
------------------	--------------------	--

Debris in gutters.

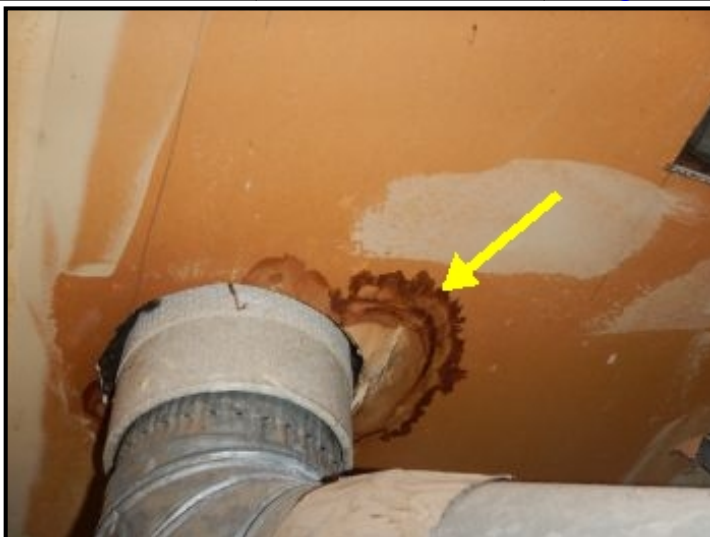
Page 30 Item: 12	Indications of leaking	<p>Yes</p> <p>There is moisture staining at the ceiling of the hallway furnace closet and to framing in the attic indicating past moisture intrusion. These areas were dry at the time of the inspection and no major adverse conditions were noted. These appear to be older roof issues. Recommend monitoring these areas and taking corrective measures if needed.</p>
------------------	------------------------	--

Moisture stains around furnace vent pipe.

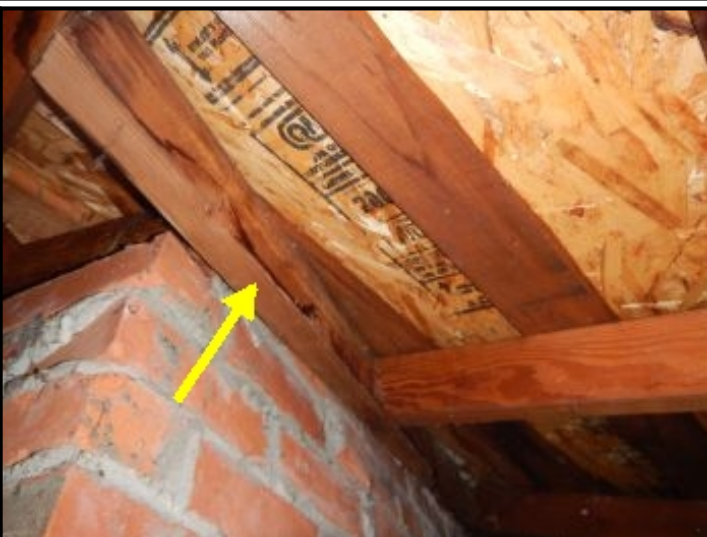
Moisture staining around chimney in attic.

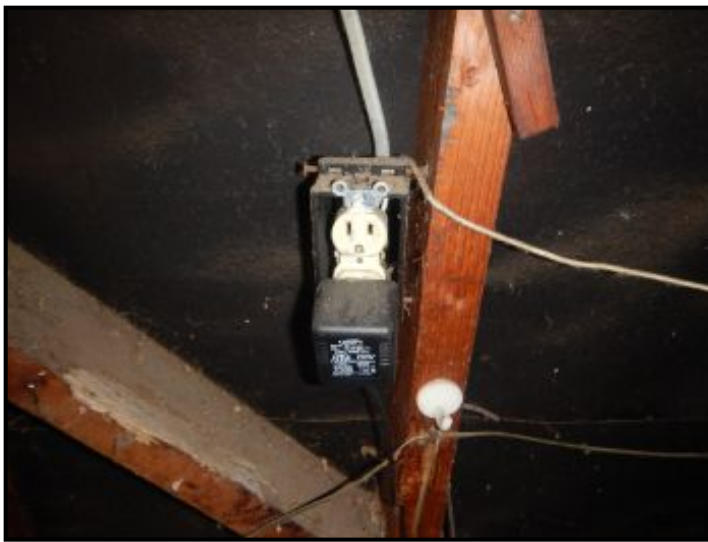
Missing cover plate in garage.

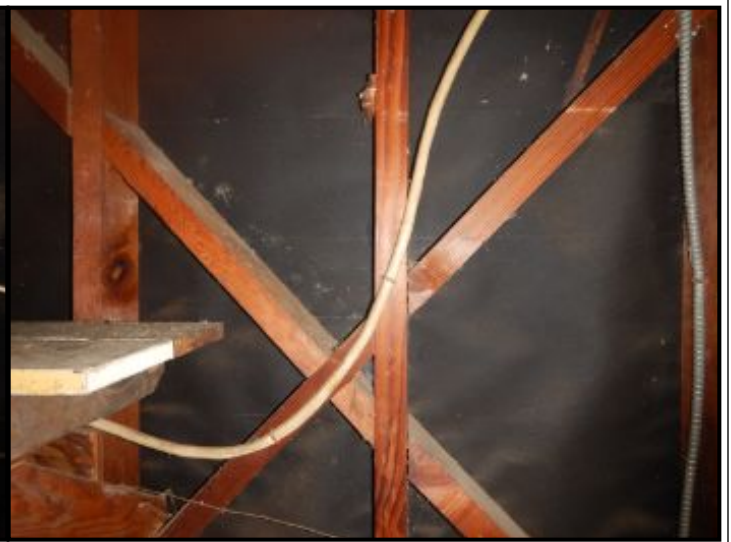
Exposed romex in the garage.

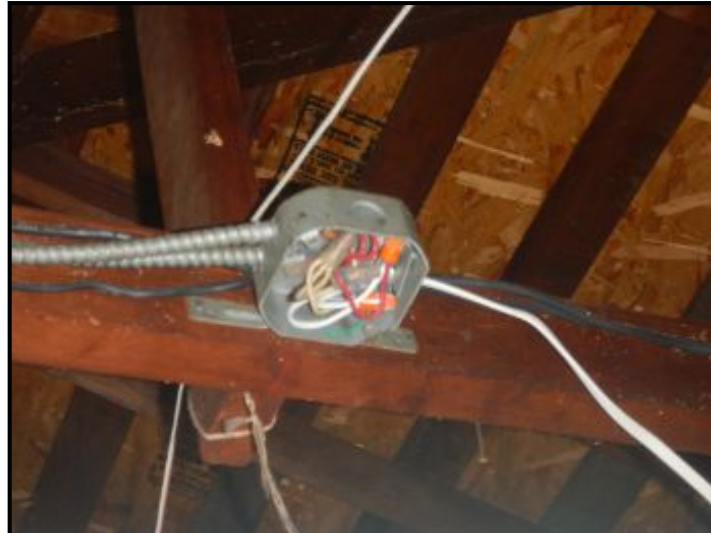
Page 32 Item: 9	Receptacle Ground Verify	Attention There are two prong receptacles in the home. Two prong receptacles are not grounded due to a two wire circuit: some three prong receptacles are not grounded as well. This is a common condition to homes of this age. For more information about grounding receptacles contact a qualified electrician for evaluation.
Page 33 Item: 10	GFCI Protection	No Current electrical standards require that ground fault interrupters (GFCI) be located in areas where there is a potential danger of electrical shock. Areas such as kitchens, bathrooms, garages and exterior outlets. The inspector recommend installing GFCI outlets at the kitchen, master bathroom and exterior as a preventative health and safety consideration.
Page 33 Item: 12	Outlets, Switches, Junction Boxes, Lighting	Maintenance All damaged or missing cover plates should be replaced with new cover plates to restore proper function and reduce the risk of electrical shorts and hazardous shocks. There is a missing cover plates in the garage. Unprotected non metallic sheathed cable was noted at the garage. Electrical cable is subject to physical damage and is typically installed in attics and inside walls. Repairs should be made to properly protect the wiring system inside conduit. Contact a qualified electrician for repairs. All spliced wires should do so inside of an appropriate covered junction box. There are spliced wires that do not meet this requirement in the attic. We suggest adding the appropriate sized junction boxes with covers as needed. There is a missing junction box cover in the garage.

Missing junction box cover in the garage.

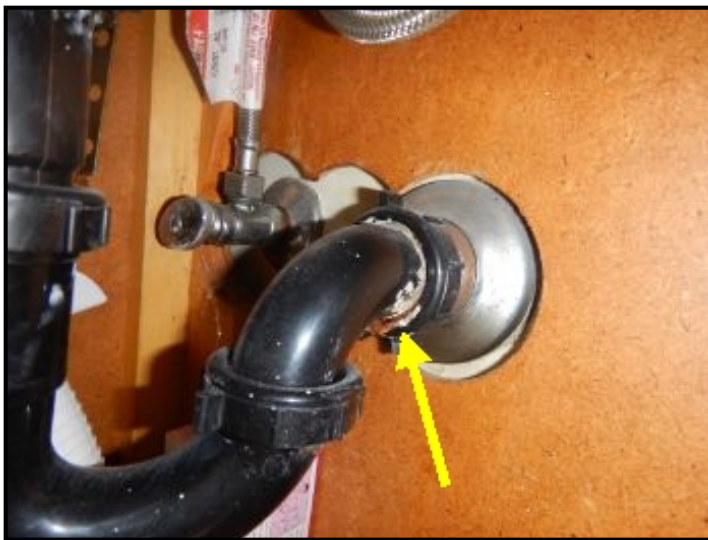
Page 35 Item: 8	Evidence Of Leaks	Yes The inspector has found evidence of plumbing leaks at the half bathroom sink drain line, half bathroom toilet and master bathroom shower pan as seen from the sub area. We advise the use of a qualified plumbing contractor to make final determination of the cause and to provide estimates for repairs.
-----------------	-------------------	---

Leaking at half bathorom sink.

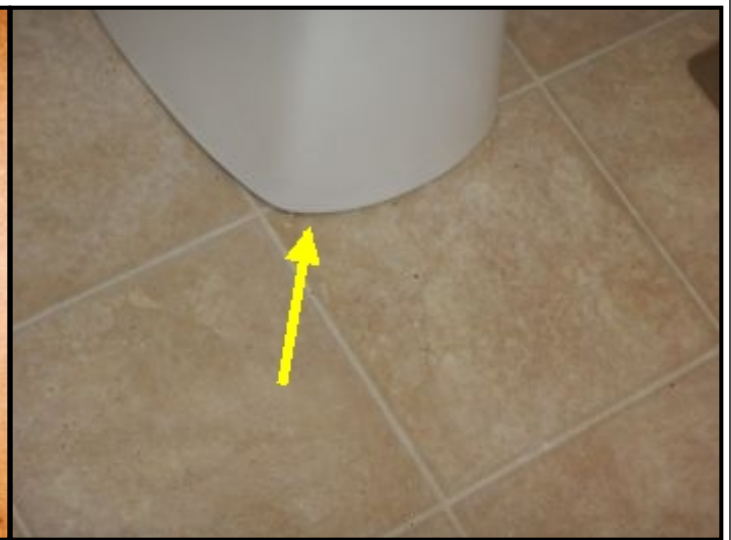
Leaking from toilet seal at half bathroom.

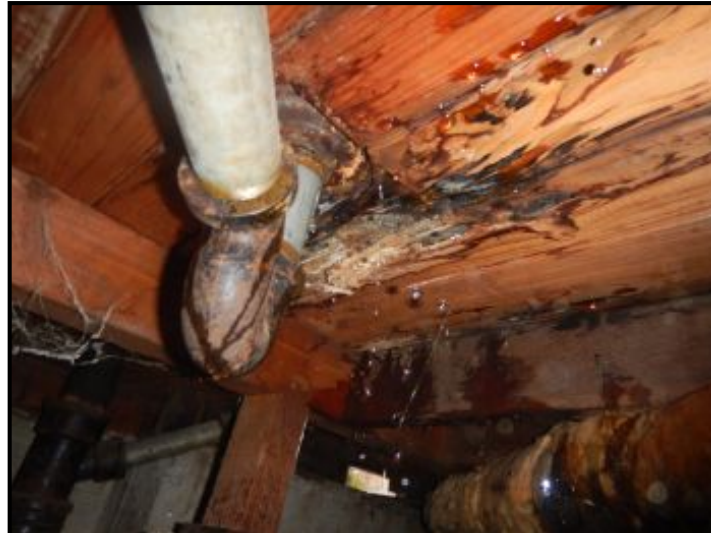
Leaking shower pan.

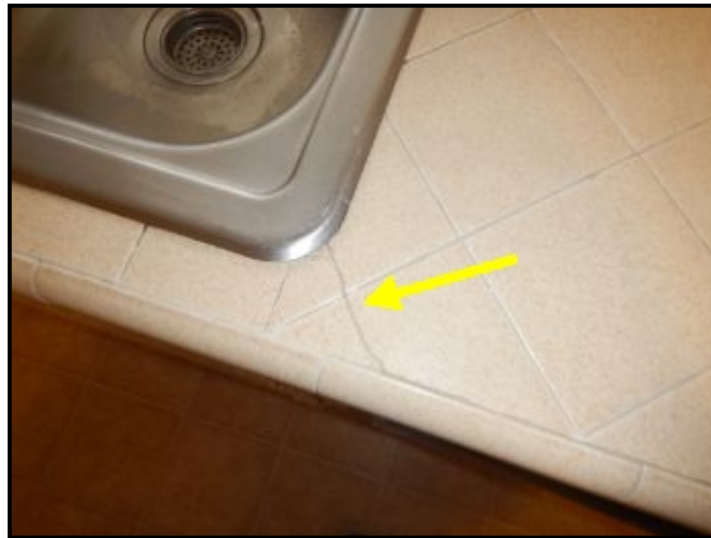
Page 42 Item: 17	Counter Tops	Attention There are some cracked tiles noted at kitchen counter top. Recommend keeping these areas properly sealed as part of preventative maintenance.
------------------	--------------	--

Cracked tiles noted at counter tops.

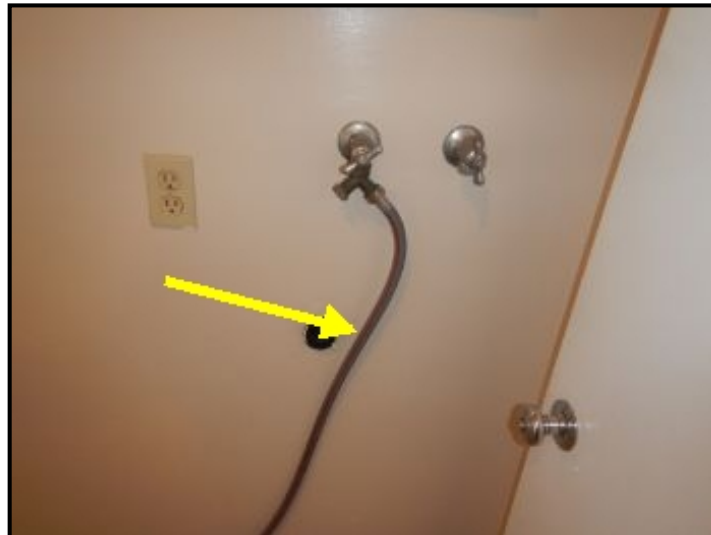
Page 43 Item: 7	Wash Basin	Maintenance There is a sub standard installation for the water supply lines from the laundry room to the sink in the garage. When the water at the garage sink was turned on the water supply in the garage was running onto the floor. Contact a qualified plumbing contractor.
-----------------	------------	--

Hose installed from water supply into garage for sink.

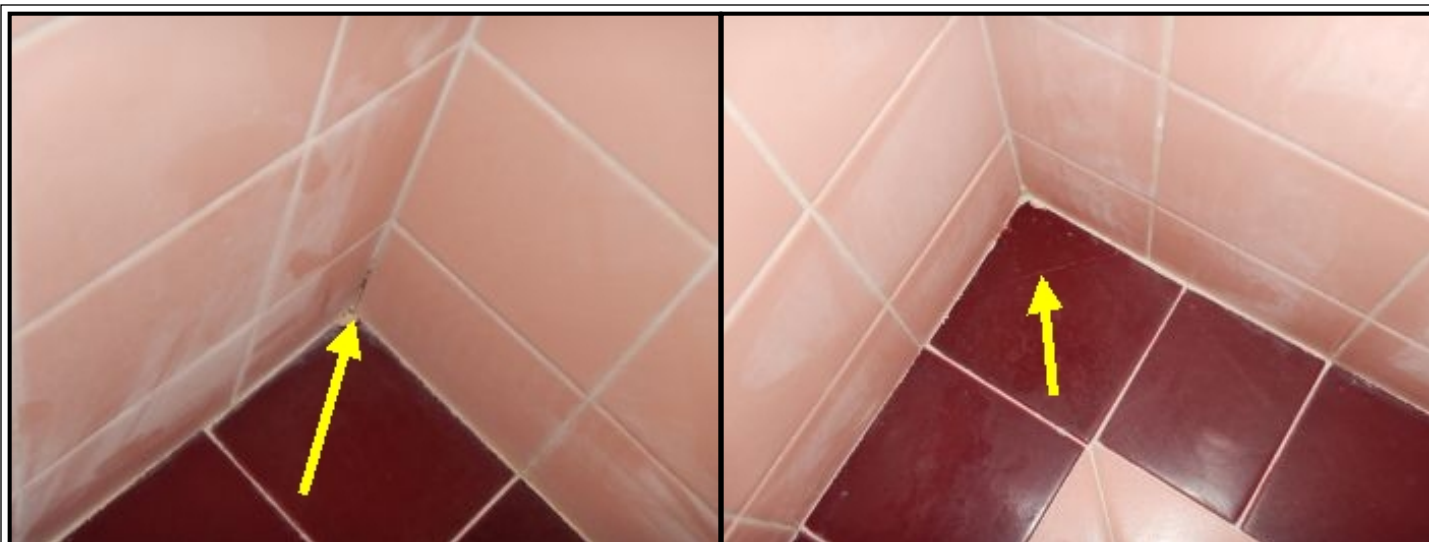
Page 46 Item: 9	Water Resistant Wall Cover	Attention Minor grout voids and a cracked tile were noted around the master bathroom shower surround tile wall. This is a condition that can lead to moisture intrusion and deterioration. Regrouting is recommended. These areas should be inspected and touched up on a regular basis as part of preventative home maintenance
-----------------	----------------------------	--

Grout voids at master shower.

Cracked tile at master bathroom shower.

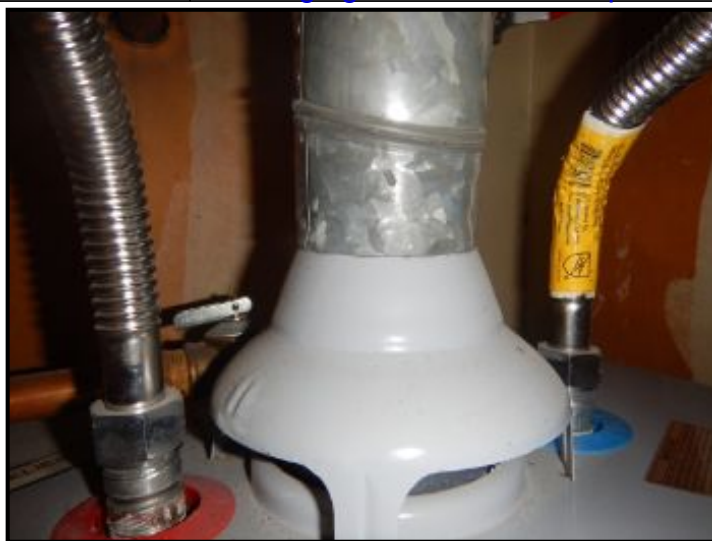
Install screws at flue/flue hood.

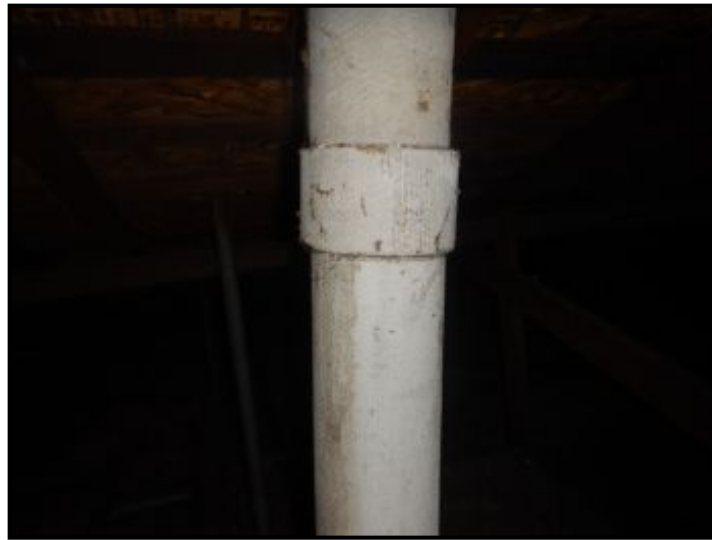
Older transite pipes in attic.

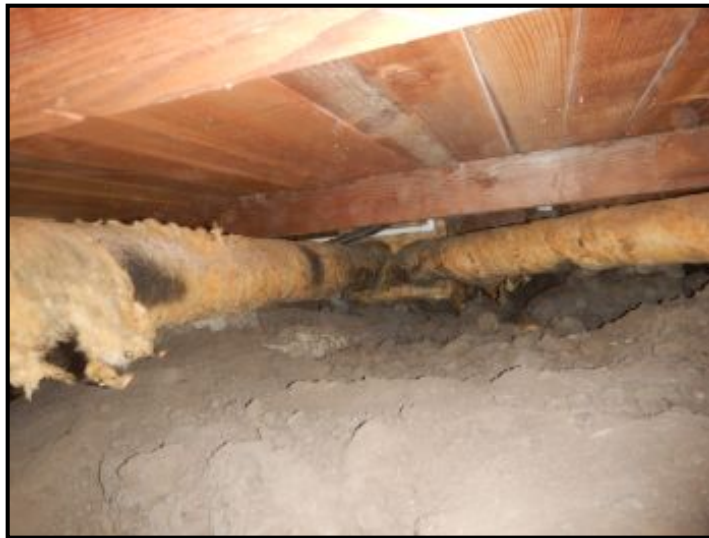
Page 52 Item: 10	Ducts/Returns	Maintenance There are areas of the ducting that the insulation wrap is in either a deteriorated condition or missing in the sub area. Keeping the ducting insulated is recommended to help with the heating/cooling efficiency of the home. Contact a qualified HVAC contractor for evaluation/repairs.
------------------	---------------	---

Deteriorated/missing insulation to ducting.

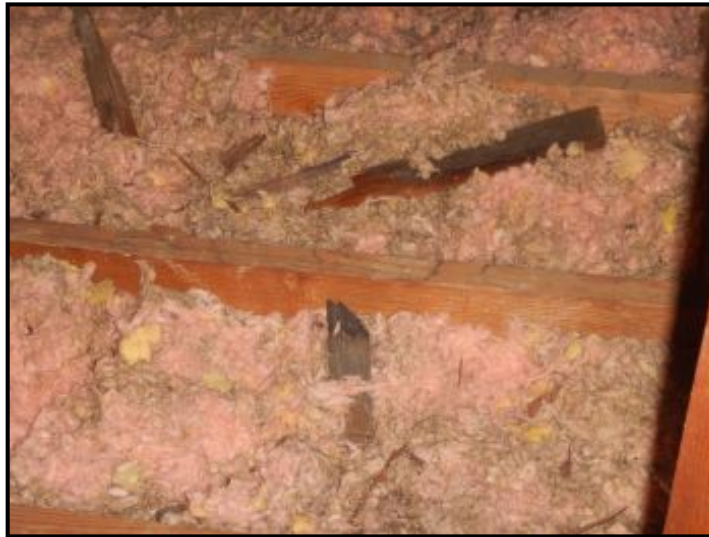
Page 54 Item: 10	Insulation	Blown in fiberglass There are low levels of insulation in the home. Adding additional insulation in the attic is recommended to help with the heating/cooling efficiency of the home. Contact the appropriate specialist for evaluation.
------------------	------------	--

Low insulation in the attic.

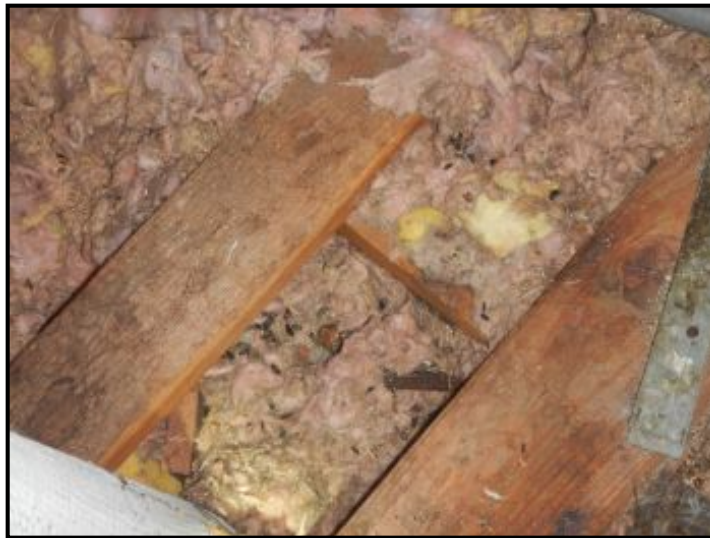
Page 55 Item: 12	Rodent Activity	Yes There is evidence of rodent activity in the attic. It could not be determined if this is a current active issue or not. Recommend contacting the appropriate pest control company for evaluation/recommendations.
------------------	-----------------	---

Rodent activity in the attic.

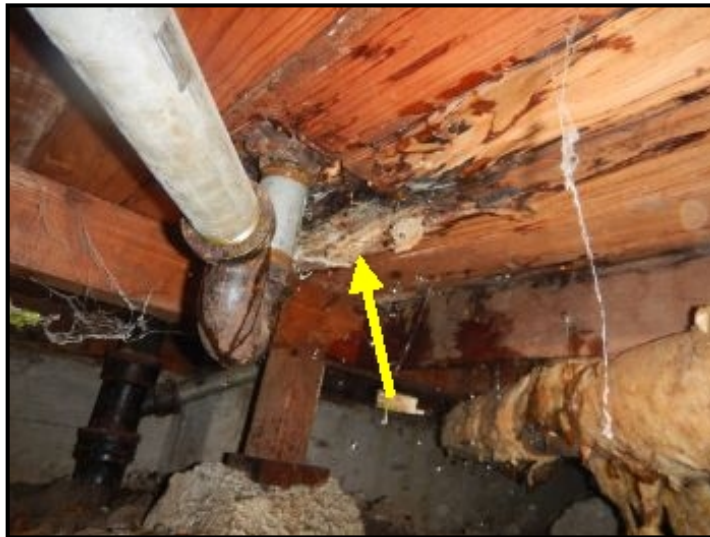
Damage was noted to the sub floor material at the master bathroom shower as observed from the sub area. Damaged wood should be removed and supported with new lumber and corrective measures to prevent this from recurring. We recommend referring to the current pest report for further comment/recommendations.

Wood damage to sub floor of master bathroom.

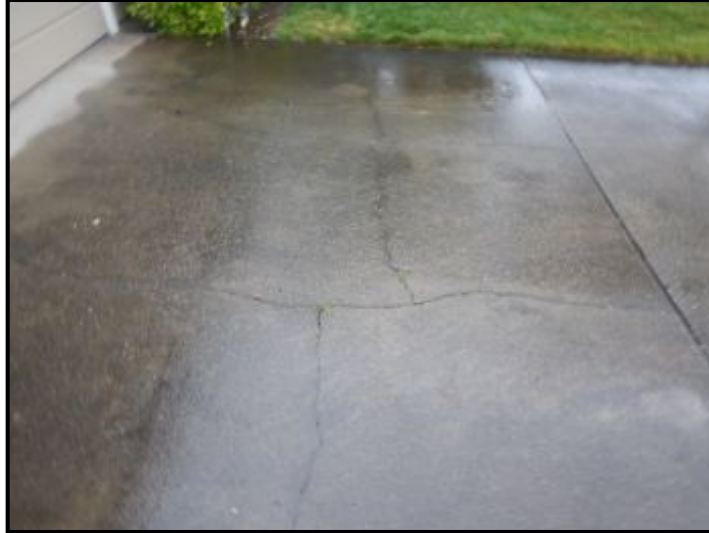
There is cracking at the concrete driveway. Though still functional the concrete areas should be monitored for further distortion and repaired or replaced as necessary to eliminate tripping hazards

Cracking at driveway.

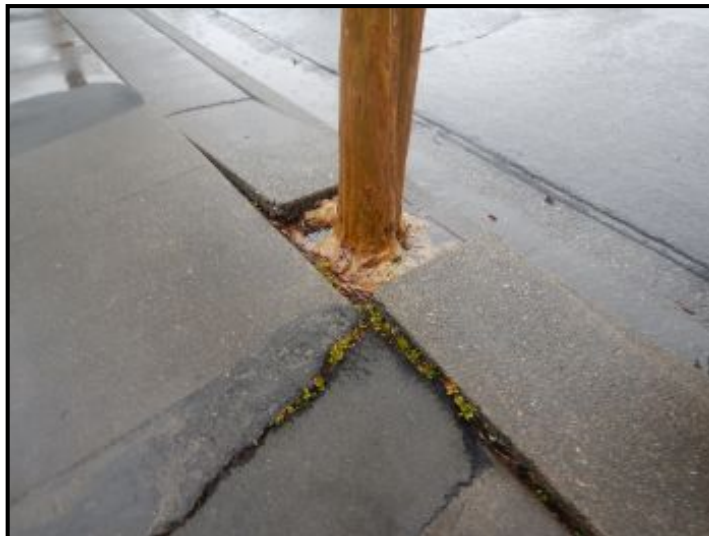
There is cracking/settling noted at the concrete walkways causing a potential tripping hazard. As a safety consideration patching/repairs are advised as needed. Contact a qualified concrete specialist for repairs.

Lifted sidewalks around the home.

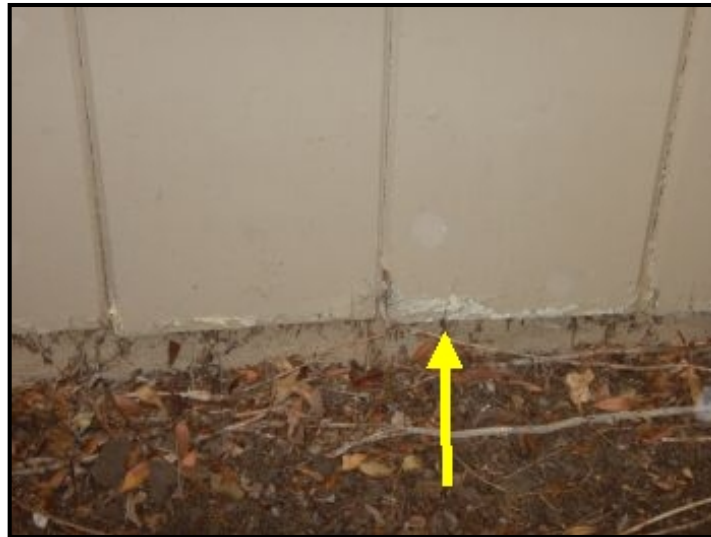
Some of the paint at the exterior of the home is showing wear. Touchup painting is recommended to provide long term protecting to the exterior of the home.

Repaint exterior wood members as needed.

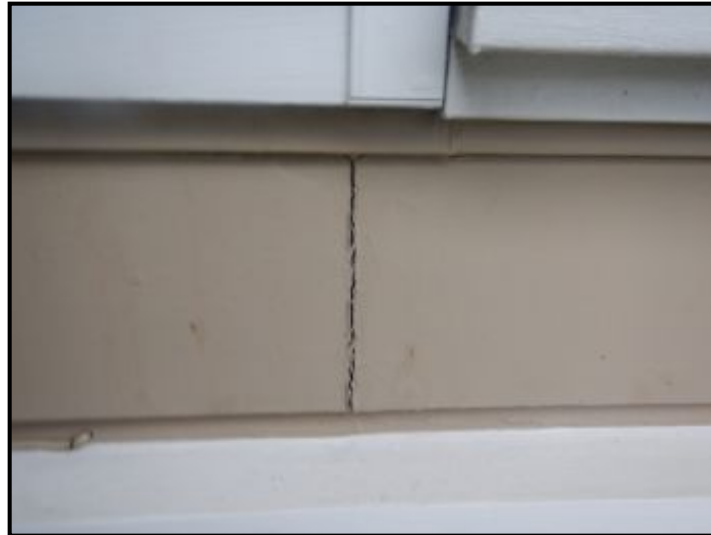
Touching up the structure caulking around the tops and sides of the windows, door trim and siding should be performed yearly as a part of routine maintenance. The caulking keeps rain water from penetrating behind the siding material and causing premature deterioration of the material.

Caulk/seal gaps at siding as needed

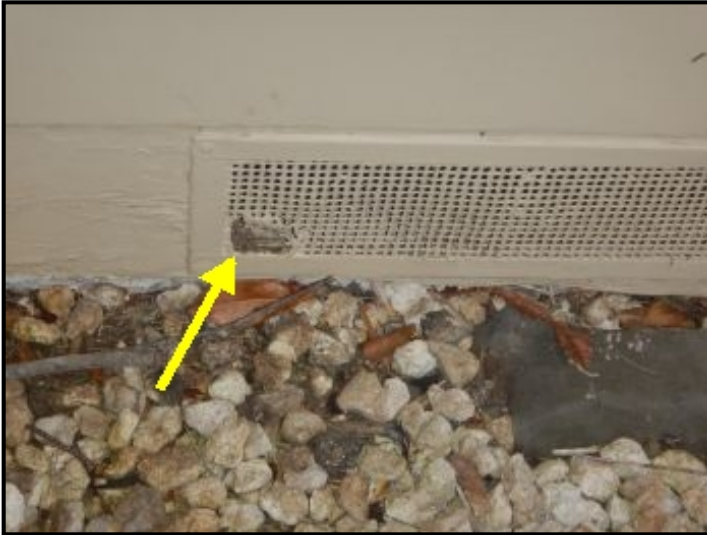
A side under-house vent screen is in need of repair/replacement at the rear of the garage. A tight screen should be maintained to allow for proper ventilation and to keep animals out of the sub area.

Seal vent screen at rear of garage.

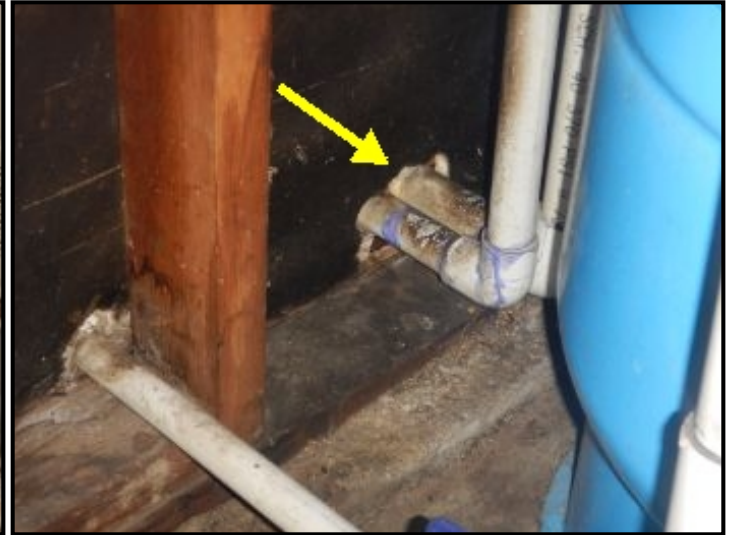
Seal around pipes at back of garage.

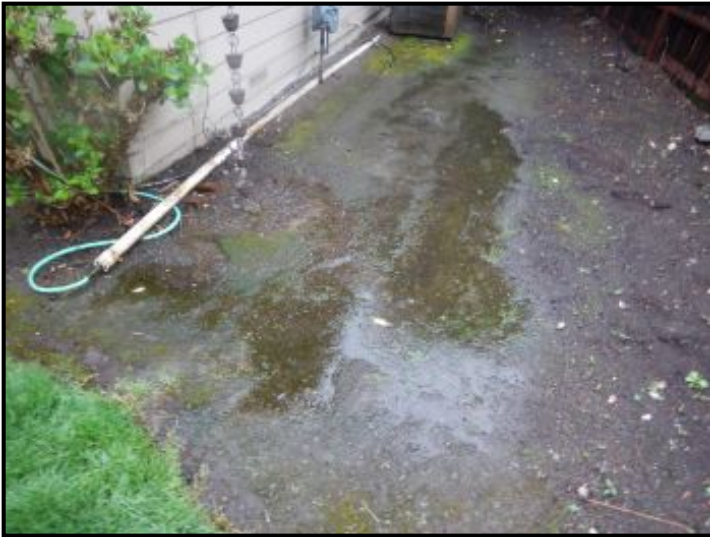
Areas of negative grade is noted around the structure which has caused ponding water at the rear of the home. This is a condition that can lead to moisture intrusion into the sub areas of the home. It is recommended to maintain proper drain slope away from the home.

Standing water at side of home.

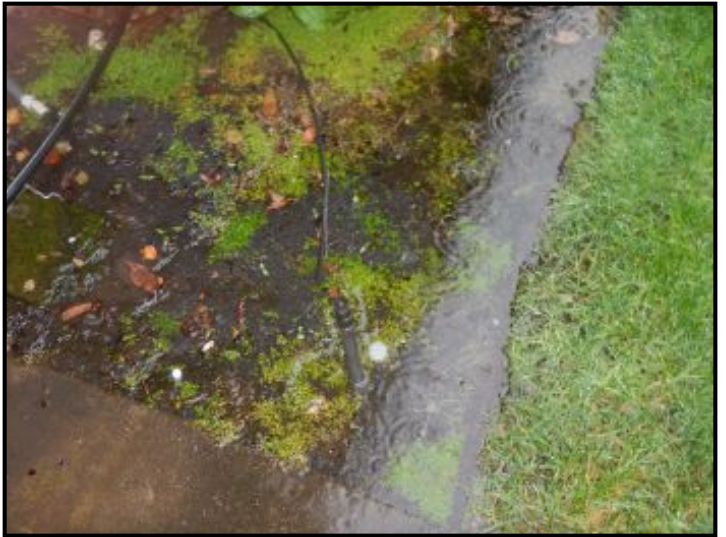
Standing water at rear patio.

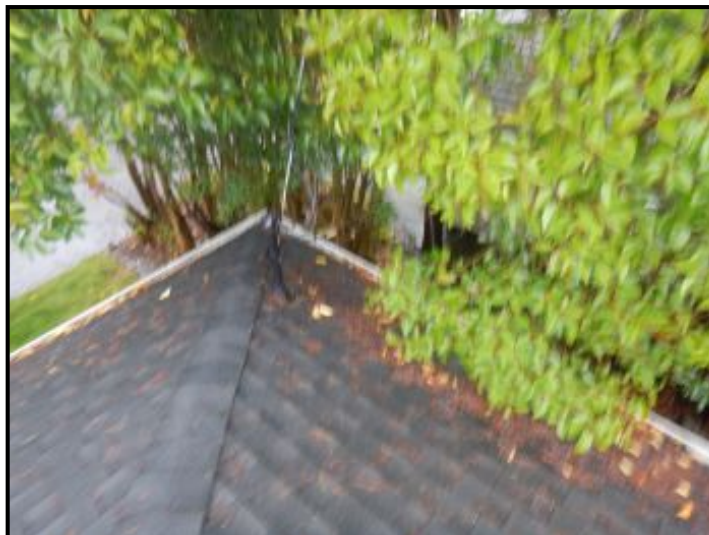
There is vegetation growing up against the exterior surface material. All vegetation should be trimmed at least 6-12 inches away from the structure to eliminate a common avenue for pest infestations or any damage to the exterior structure material.

Cut vegetation away from structure.

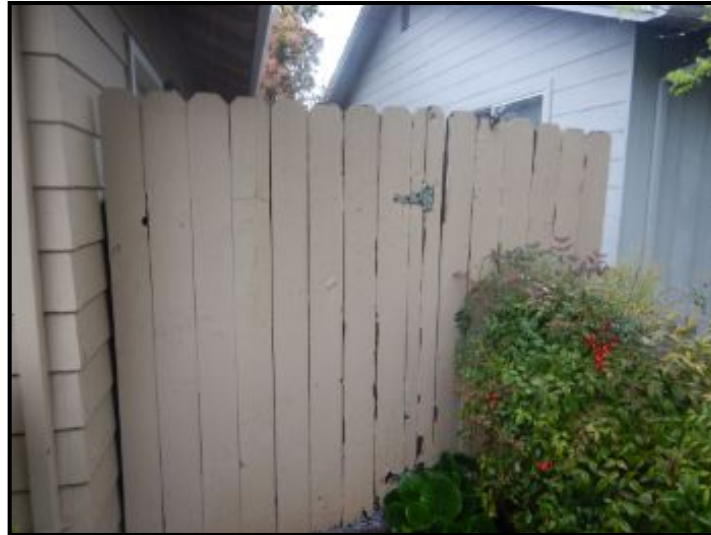
Though upright at the time of the inspection there are sections of the fence that are in a deteriorated condition. Future repair/replacement may will be needed. Contact the appropriate specialist for evaluation/repairs.

Deterioration to sections of fencing.

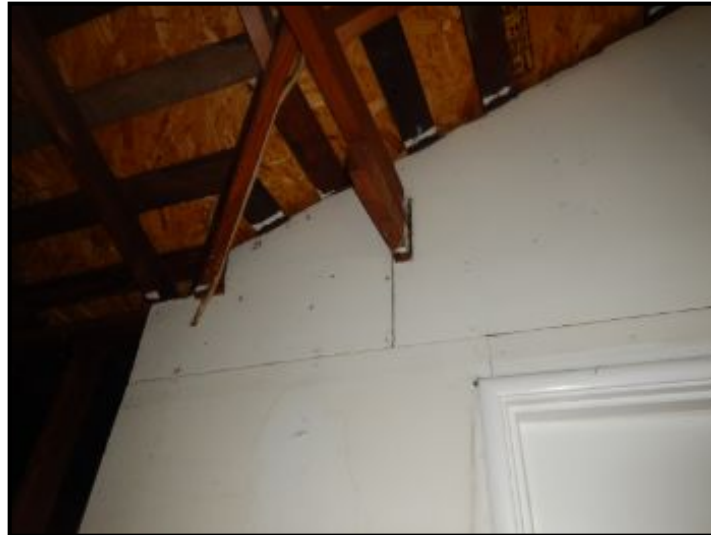
There are gaps around pipes/cables/ducting/seams at the wall between the garage and living space. It is advised to use a fire rated caulking to seal around any gaps in the wall and properly tape and seal all the joints as a health and safety consideration. Contact a qualified contractor for repairs.

Seal firewall as needed.

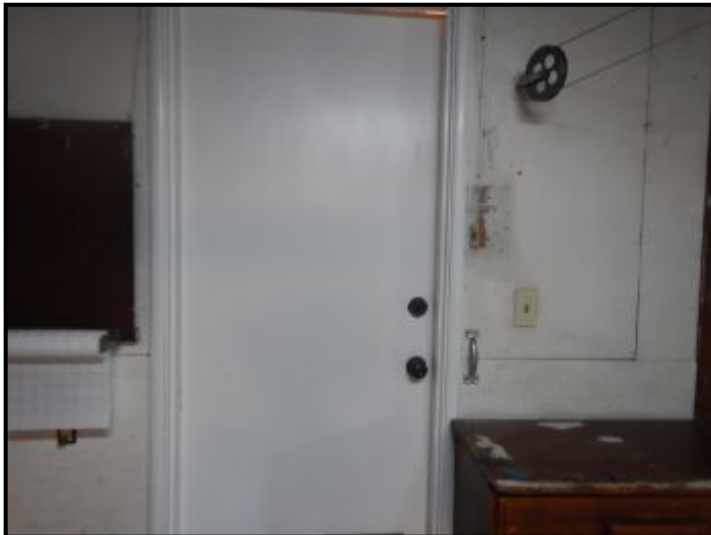
The door from the interior of the home to the garage is not a fire rated door. Recommend replacing with a 20 minute self closing fire rated door as a health and safety consideration.

Garage door is not a fire rated door.

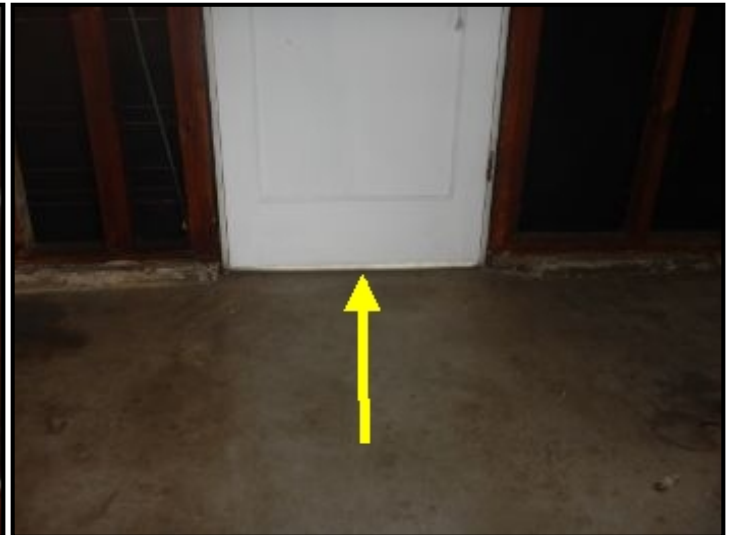
There are gaps under the side service garage door which may allow in moisture or an access point for rodents. It is recommended to install a door sweep to keep this area properly sealed.

Gaps below garage door.

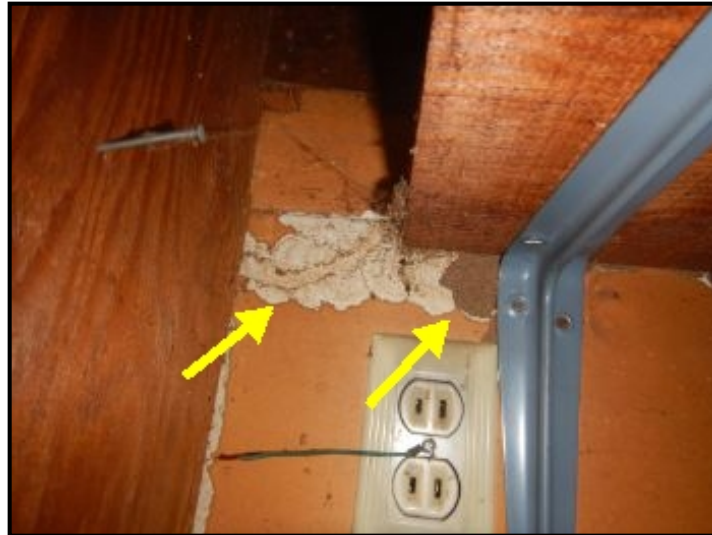
There is what appears to be termite activity at the wall in the garage. Gage Inspection Services is not a licensed pest inspector in the state of California. We recommend referring to the current pest report for further comment/recommendations.

Apparent termite activity in the garage.

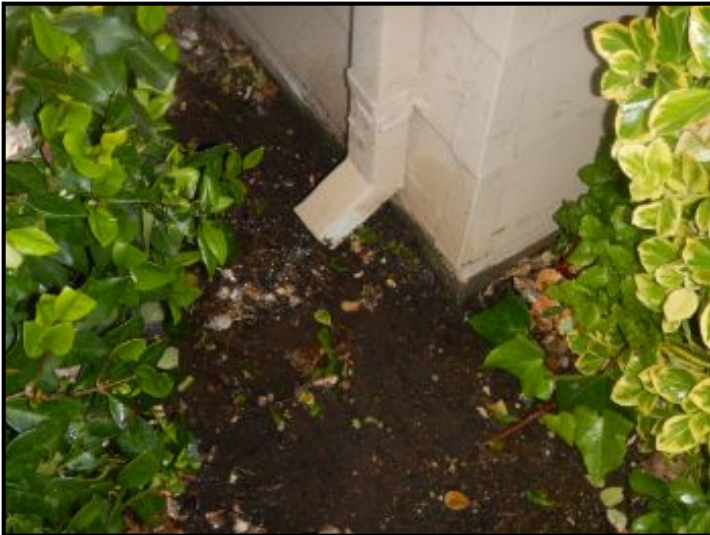
There are downspout that are draining at the foundation perimeter which can allow for water penetration into the crawl space. Recommend installing drain pipe extender or splash blocks to help divert water away from the structure.

Direct downspouts away from home as needed.

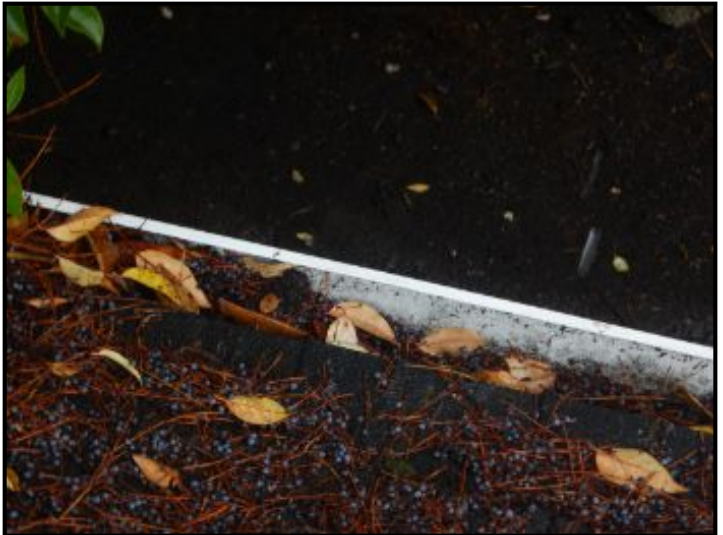
There is debris build up in the gutters that should be removed. Debris can clog the gutters, down spouts and drain system if not cleaned out. cleaning the gutters on an annual basis is recommended for proper care and maintenance of the gutter system.

Debris in gutters.
