Property Inspection Report

1827 Pamela Dr, Santa Rosa, CA 95404
Inspection prepared for: Jan Volk
Real Estate Agent: Mary Haufler - Sothebys

Date of Inspection: 4/6/2018 Time: 9:00 AM
Order ID: 71

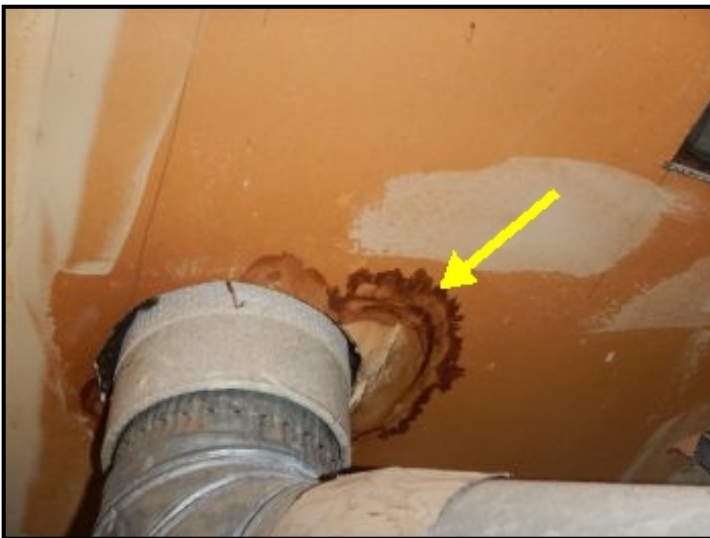
There is moisture staining at the ceiling of the hallway furnace closet and to framing in the attic indicating past moisture intrusion. These areas were dry at the time of the inspection and no major adverse conditions were noted. These appear to be older roof issues. Recommend monitoring these areas and taking corrective measures if needed.

Moisture stains around furnace vent pipe.

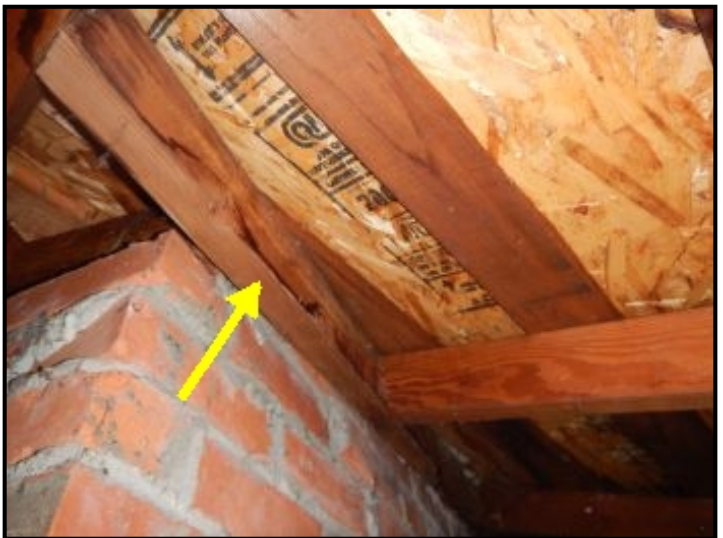
Moisture staining around chimney in attic.

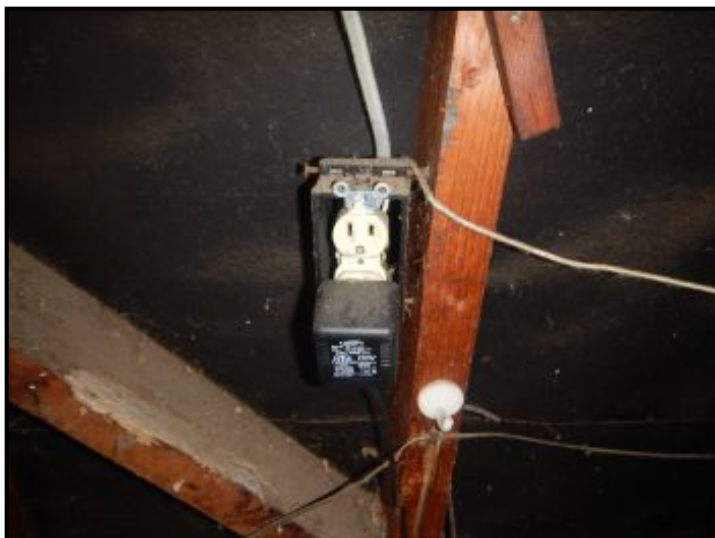
All damaged or missing cover plates should be replaced with new cover plates to restore proper function and reduce the risk of electrical shorts and hazardous shocks. There is a missing cover plates in the garage.

Missing cover plate in garage.

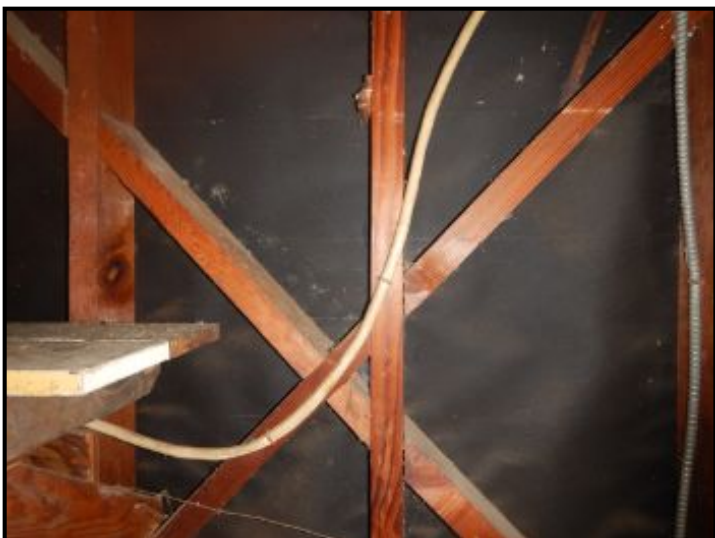
Unprotected non metallic sheathed cable was noted at the garage. Electrical cable is subject to physical damage and is typically installed in attics and inside walls. Repairs should be made to properly protect the wiring system inside conduit. Contact a qualified electrician for repairs.

Exposed romex in the garage.

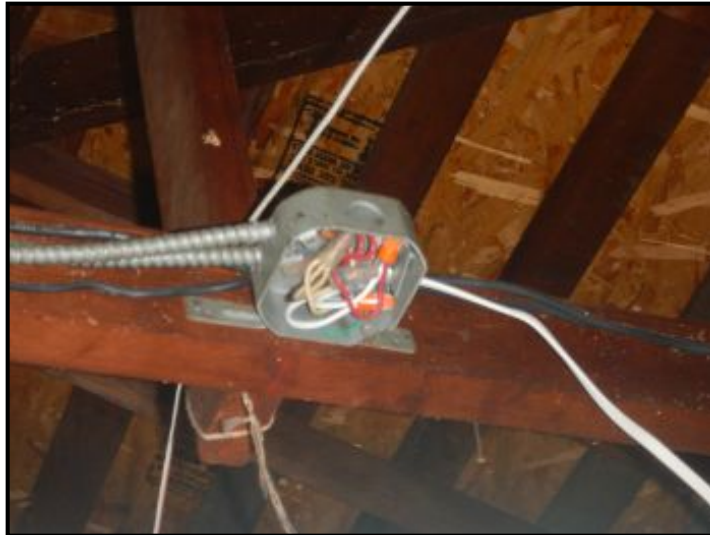
All spliced wires should do so inside of an appropriate covered junction box. There are spliced wires that do not meet this requirement in the attic. We suggest adding the appropriate sized junction boxes with covers as needed. There is a missing junction box cover in the garage.

Missing junction box cover in the garage.

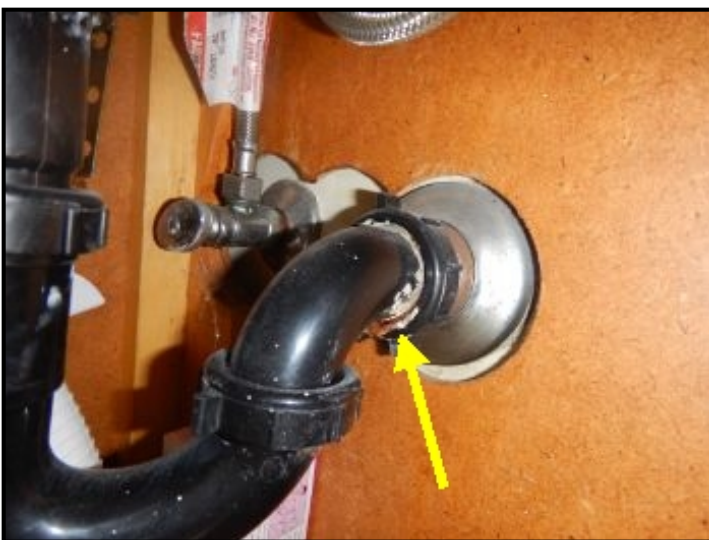
The inspector has found evidence of plumbing leaks at the half bathroom sink drain line, half bathroom toilet and master bathroom shower pan as seen from the sub area. We advise the use of a qualified plumbing contractor to make final determination of the cause and to provide estimates for repairs.

Leaking at half bathorom sink.

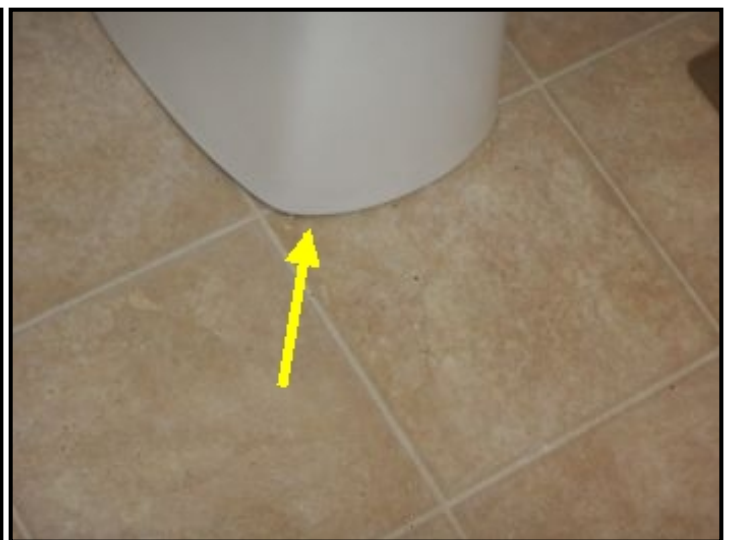
Leaking from toilet seal at half bathroom.

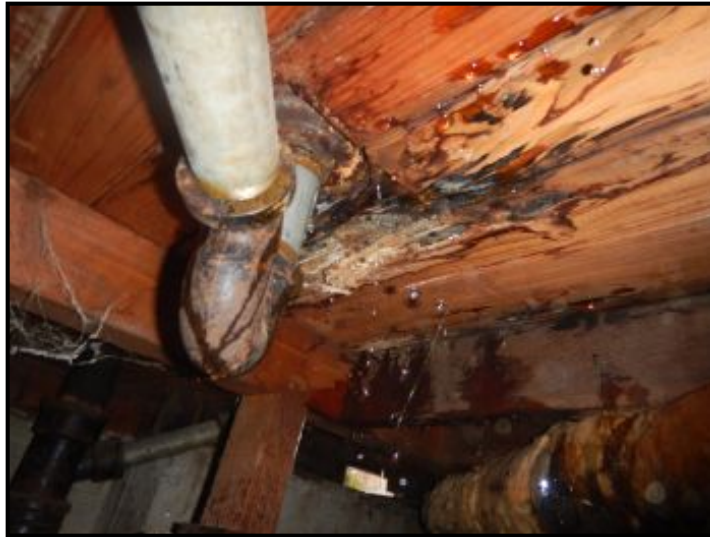
Leaking shower pan.

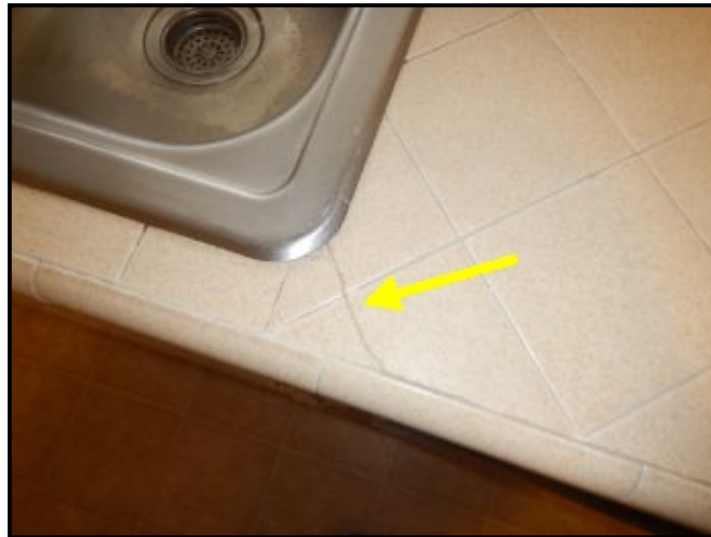
There are some cracked tiles noted at kitchen counter top. Recommend keeping these areas properly sealed as part of preventative maintenance.

Cracked tiles noted at counter tops.

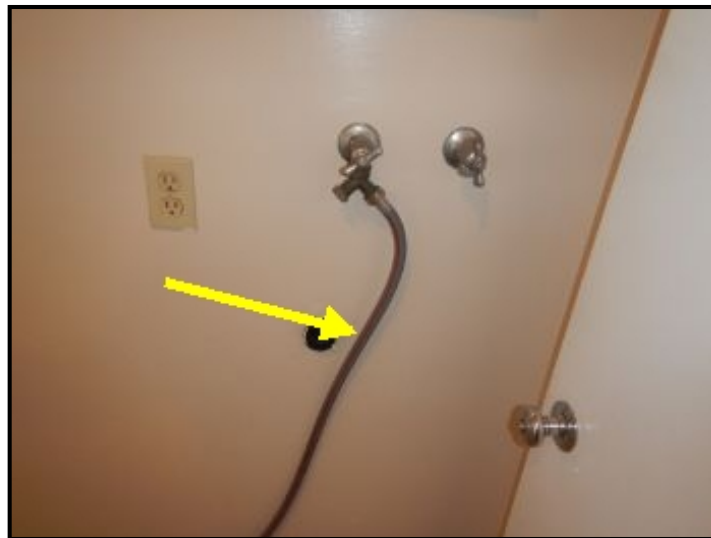
There is a sub standard installation for the water supply lines from the laundry room to the sink in the garage. When the water at the garage sink was turned on the water supply in the garage was running onto the floor. Contact a qualified plumbing contractor.

Hose isntalled from water supply into garage for sink.

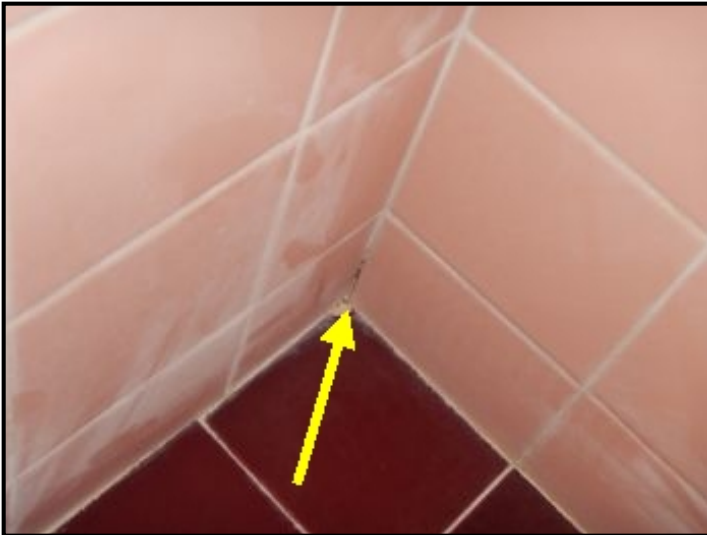
Minor grout voids and a cracked tile were noted around the master bathroom shower surround tile wall. This is a condition that can lead to moisture intrusion and deterioration. Regrouting is recommended. These areas should be inspected and touched up on a regular basis as part of preventative home maintenance

Grout voids at master shower.

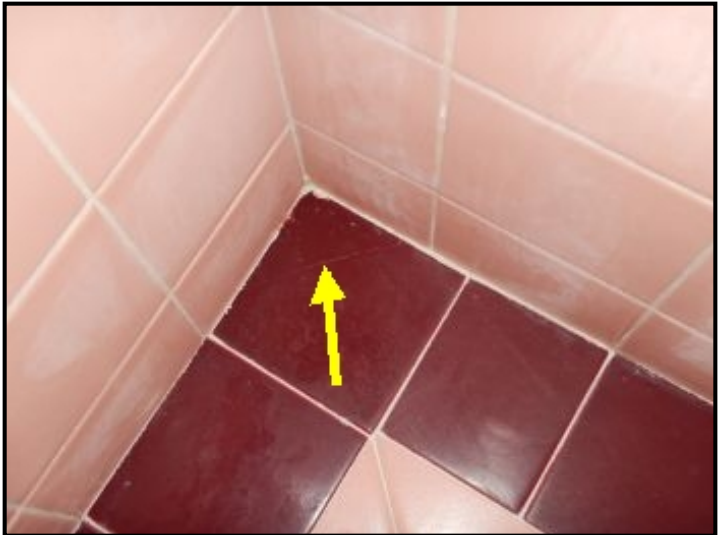
Cracked tile at master bathroom shower.

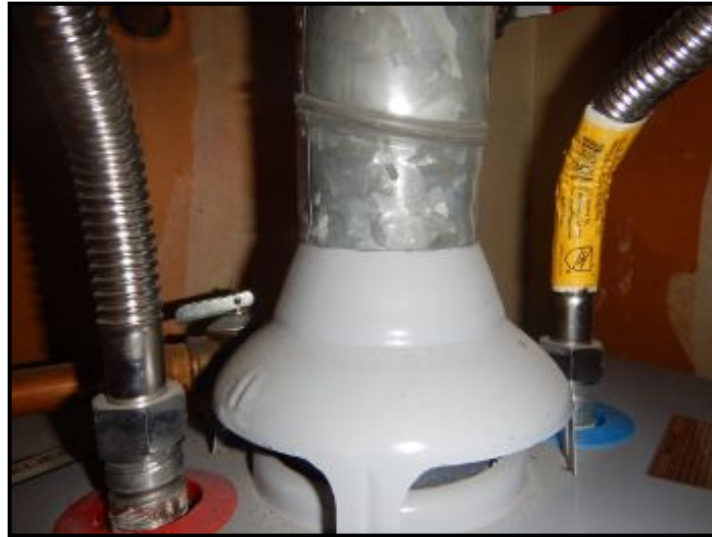
Install screws at flue/flue hood.

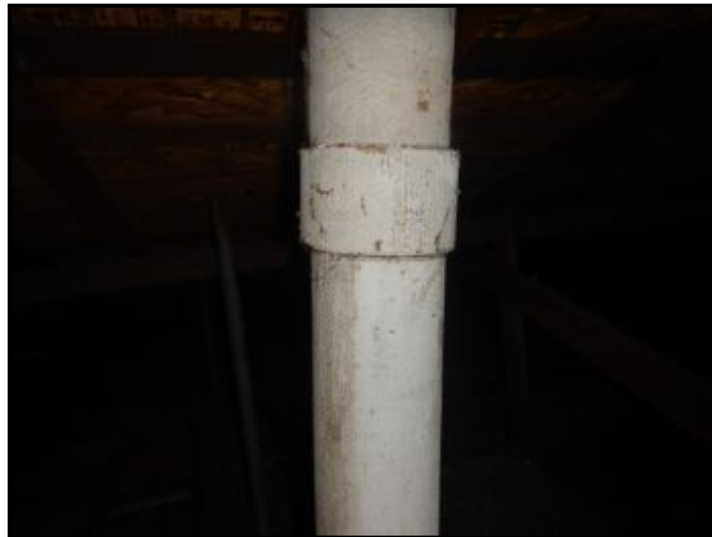
Older transite pipes in attic.

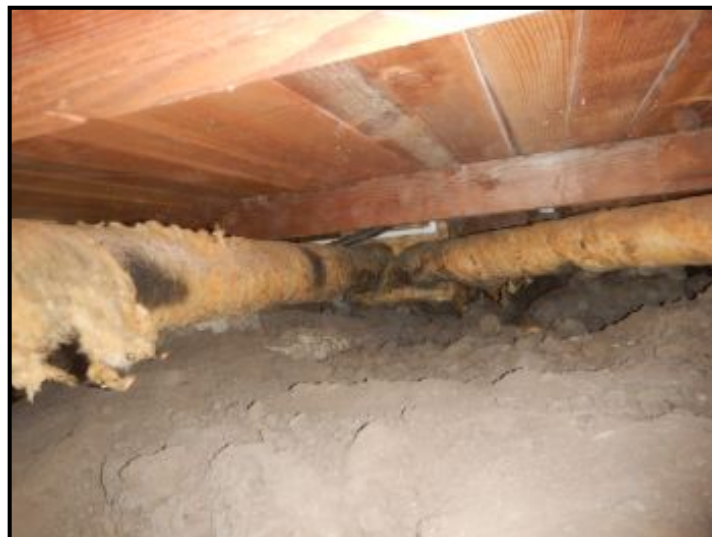
There are areas of the ducting that the insulation wrap is in either a deteriorated condition or missing in the sub area. Keeping the ducting insulated is recommended to help with the heating/cooling efficiency of the home. Contact a qualified HVAC contractor for evaluation/repairs.

Deteriorated/missing insulation to ducting.

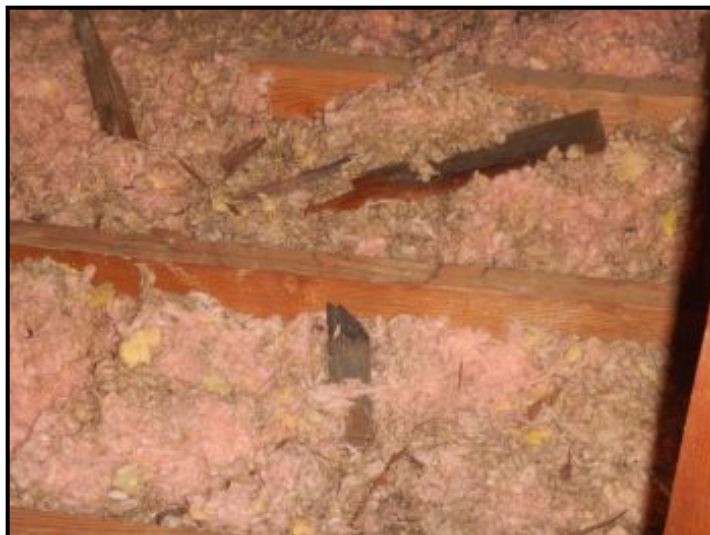
Low insulation in the attic.

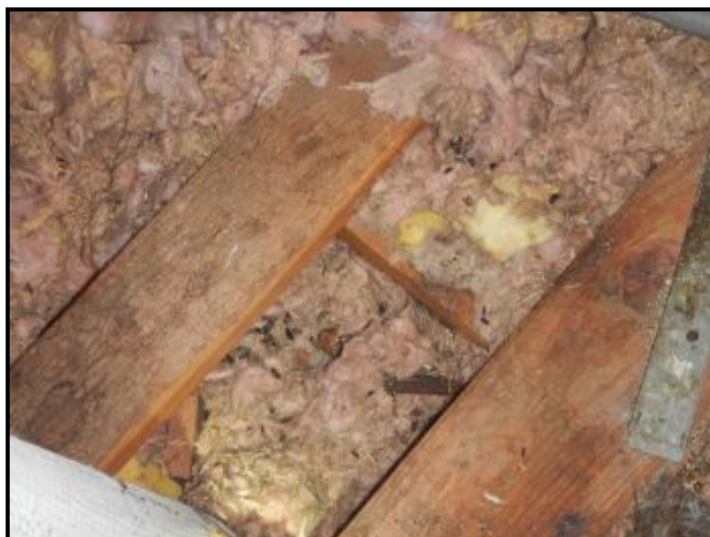
Rodent activity in the attic.

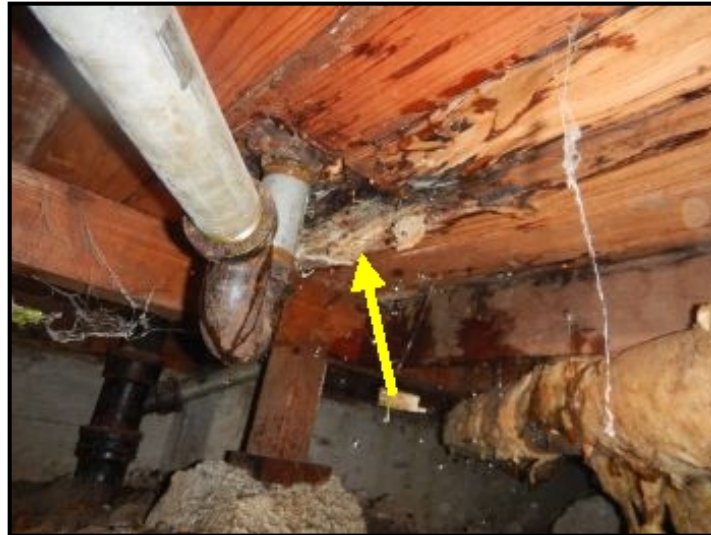
Wood damage to sub floor of master bathroom.
