Gage Inspection Services

Property Inspection Report

202 Adele Ave, Rohnert Park, CA 94928
Inspection prepared for: Faith Schon
Real Estate Agent: Mary Haufler - Sothebys

Date of Inspection: 6/26/2018 Time: 9:00 AM
Age of Home: 1958 Size: 1662
Order ID: 134

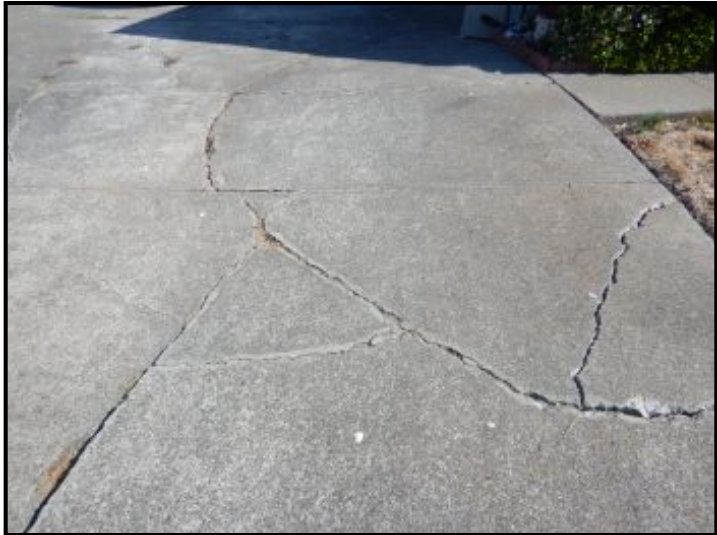
<p>Excessive cracking to driveway.</p>		
Page 16 Item: 2	Walkways	<p>Maintenance There is cracking/settling noted at the concrete walkways causing a potential tripping hazard. As a safety consideration patching/repairs are advised as needed. Contact a qualified concrete specialist for repairs.</p>

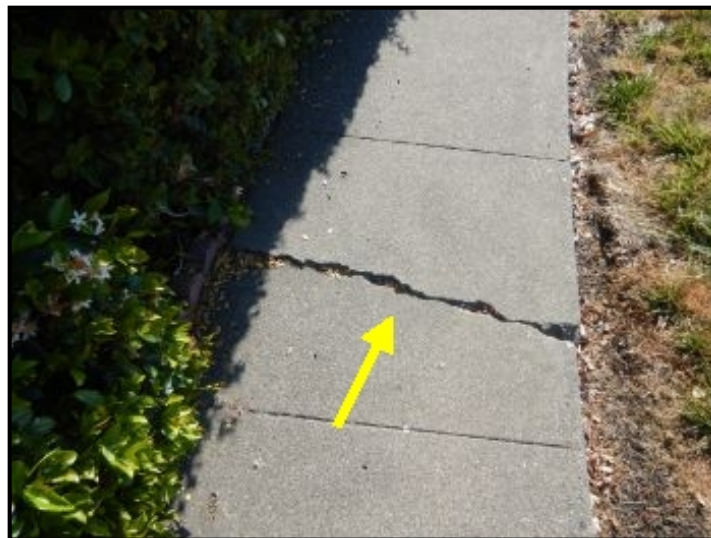
Cracking to walkways.

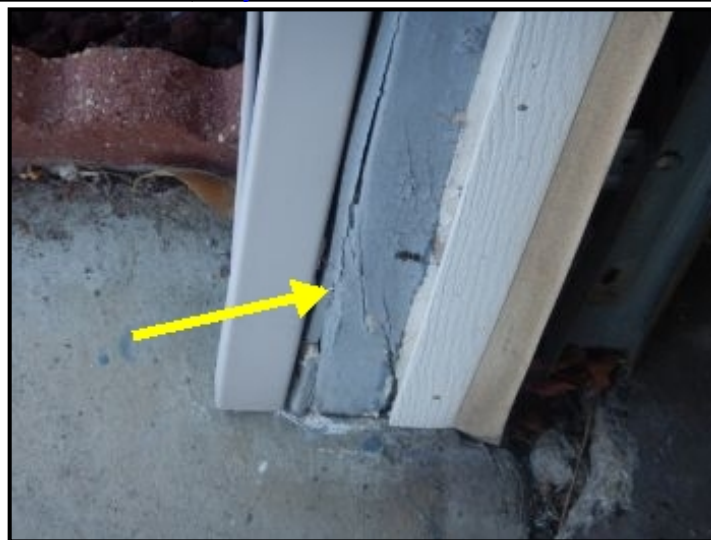
Page 17 Item: 7	Fascia Boards/Trim	<p>Attention There is cupped/warped/split trim at the exterior of the home. It is recommended to keep these areas properly painted and sealed as a preventative measure. Future repair/replacement may be needed.</p>
-----------------	--------------------	---

Split trim at garage door.

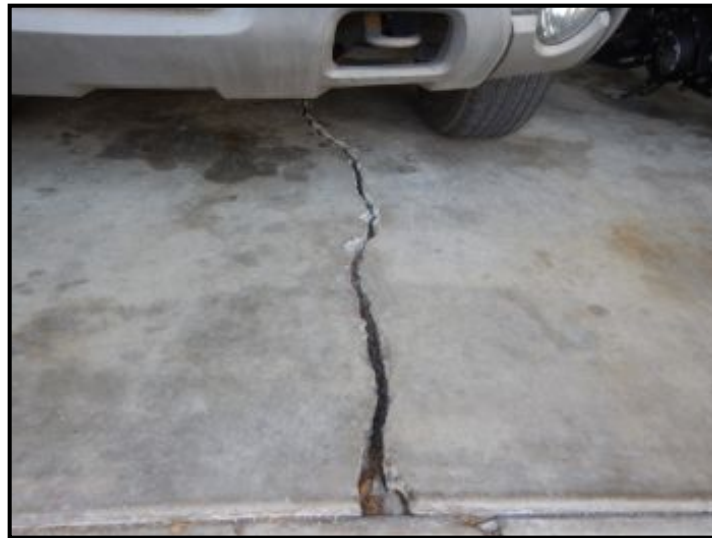
Page 22 Item: 7	Floor Foundation	<p>Maintenance Excessive cracking has been noted at the garage floor. Recommend contacting the appropriate specialist for evaluation/recommendations.</p>
-----------------	------------------	---

Cracking at garage floor.

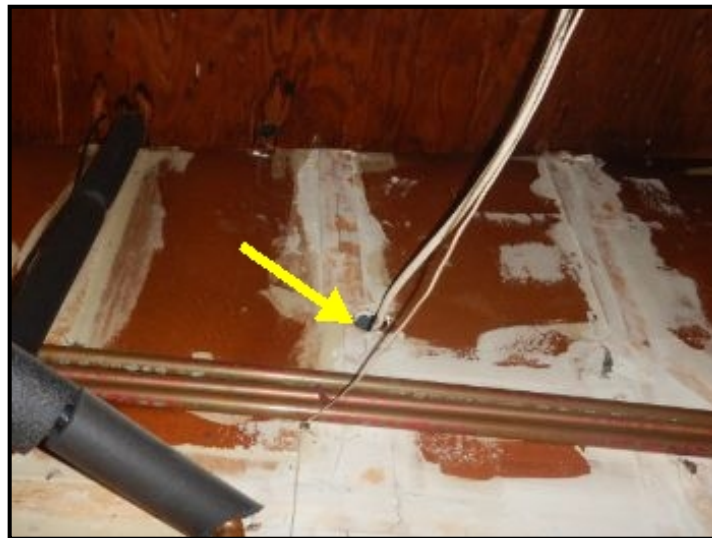
Page 23 Item: 9	Firewall	<p>Maintenance There are gaps around pipes/cables/ducting at the wall between the garage and living space. It is advised to use a fire rated caulking to seal around any gaps in the wall as a health and safety consideration.</p>
-----------------	----------	---

Seal all holes at firewall.

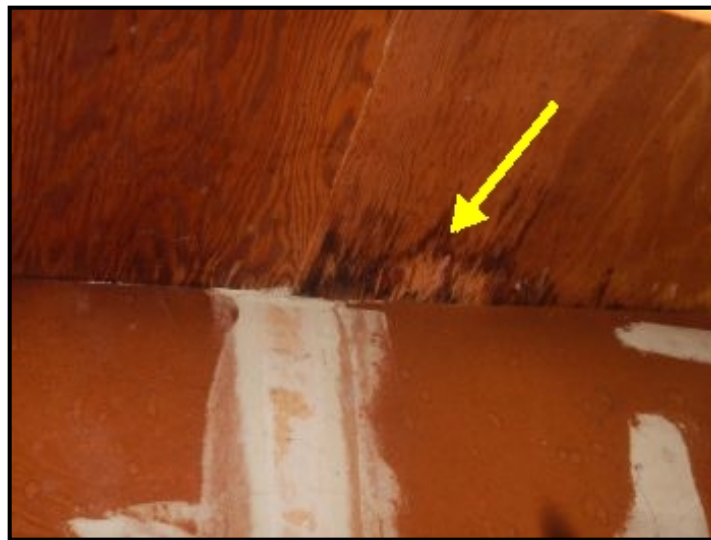
Page 23 Item: 11	Moisture Penetration	<p>Attention There is moisture staining at the ceiling of the garage indicating past moisture intrusion. The area was dry at the time of the inspection and no major adverse conditions were noted. We recommend monitoring this area during the rains to determine if repairs are needed.</p>
------------------	----------------------	--

Moisture staining at garage ceiling.

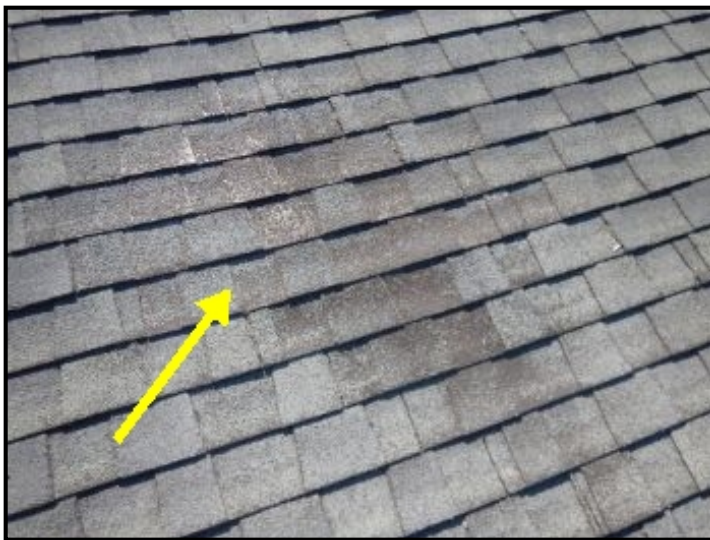
Worn section of roofing shingles.

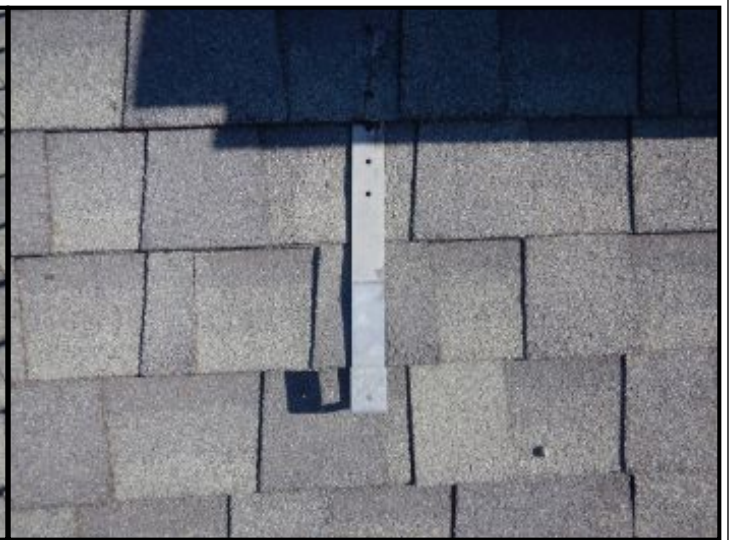
Exposed fasteners at brackets.

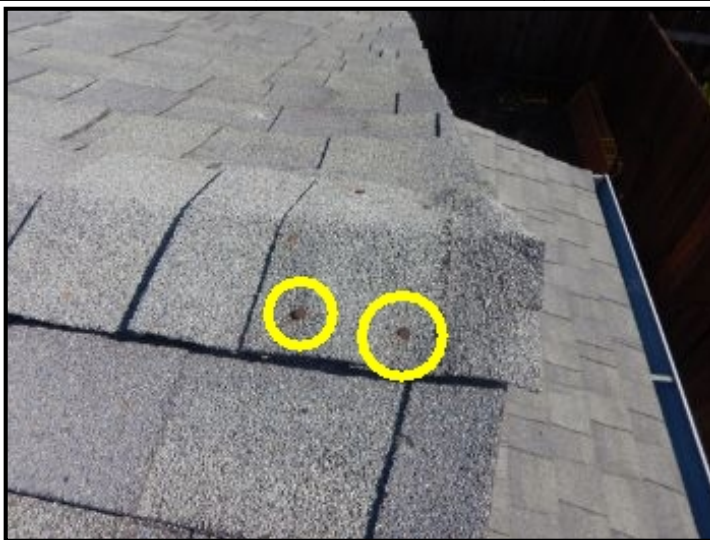
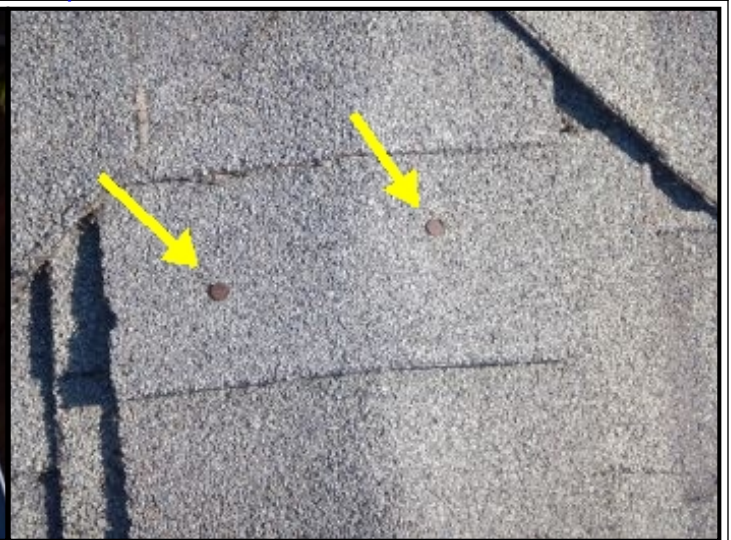
There are exposed fasteners at the ridge shingles. It is recommended to keep these areas properly caulked and sealed as a preventative measure. Contact a qualified roofing contractor for repairs.

Exposed fasteners at ridge shingles.

Exposed ridge fasteners.

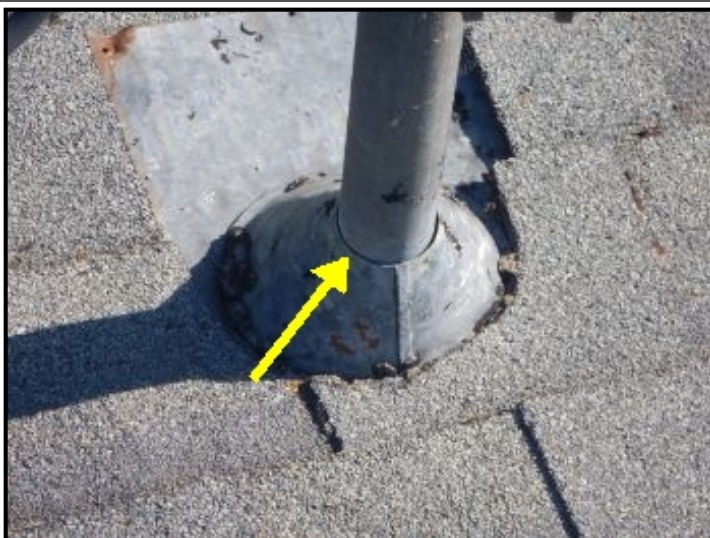
The main electrical service drop at the roof top does not have a storm collar installed and is not currently sealed. Recommend sealing this area with a roofing mastic material to prevent potential leaking.

Seal around main electrical drop.

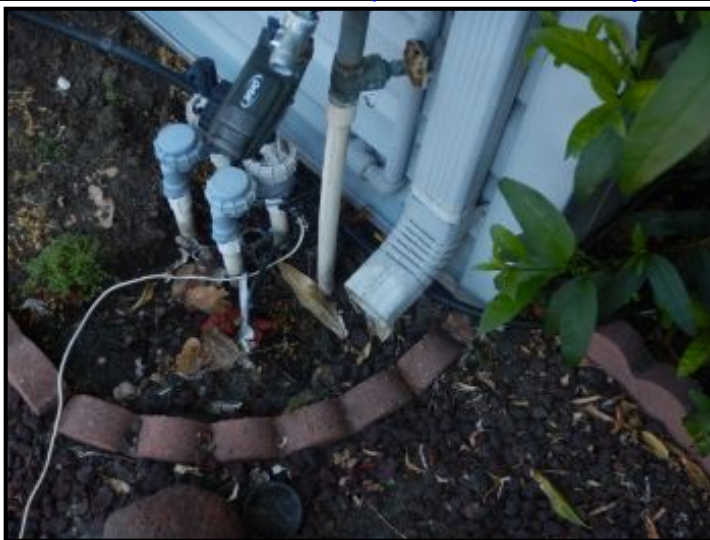
There are downspouts that are draining at the foundation perimeter which can allow for water penetration into the crawl space. Recommend installing drain pipe extender or splash blocks to help divert water away from the structure.

Gutters draining at foundation wall.

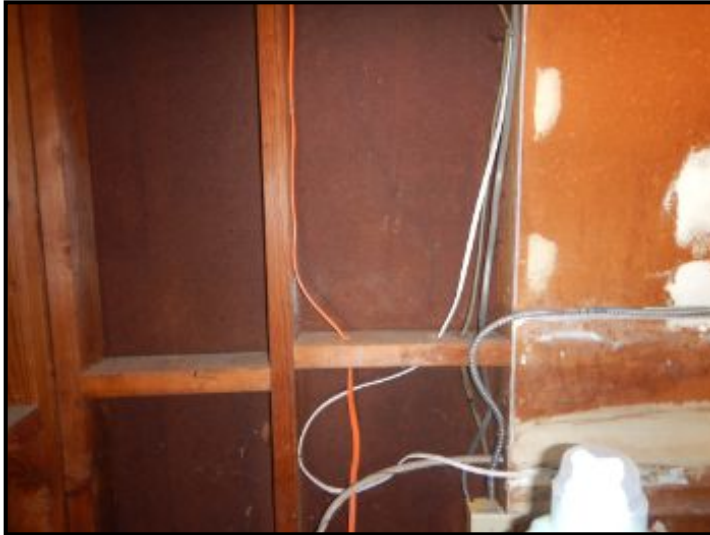
Unprotected romex in garage.

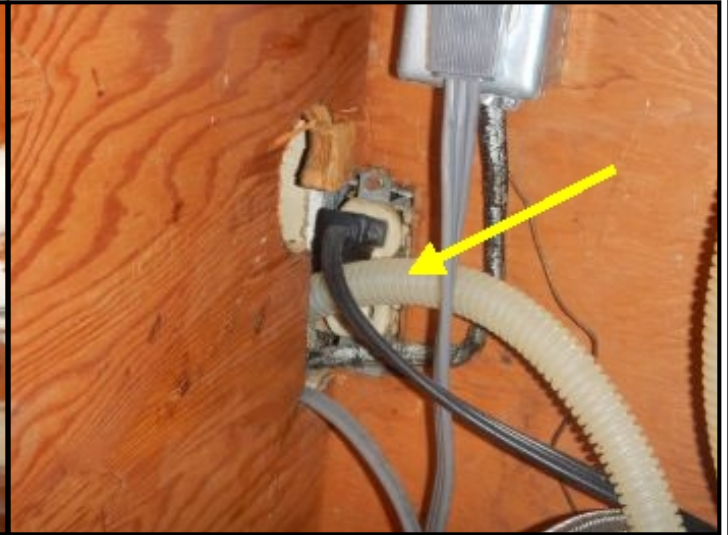
Missing cover plate under the kitchen sink.

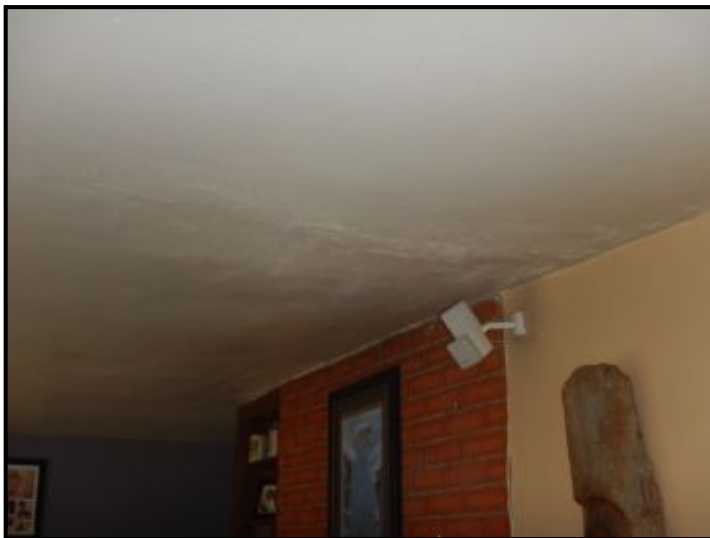
Sagging ceiling in living room.

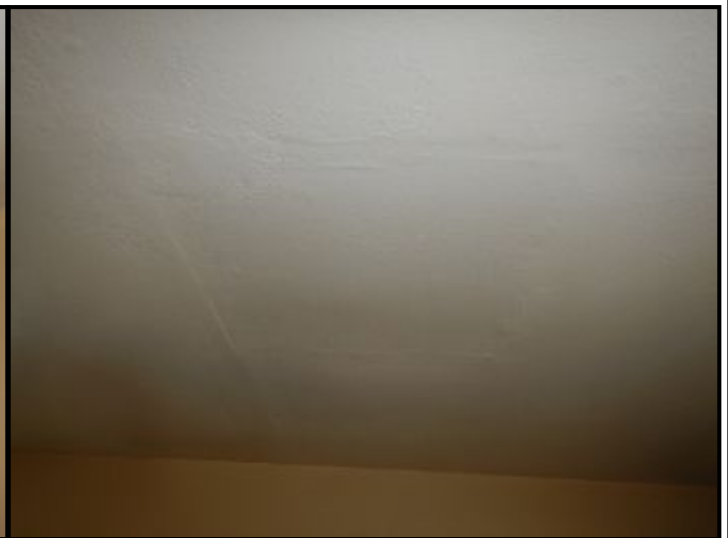
Patch marks at living room ceiling.

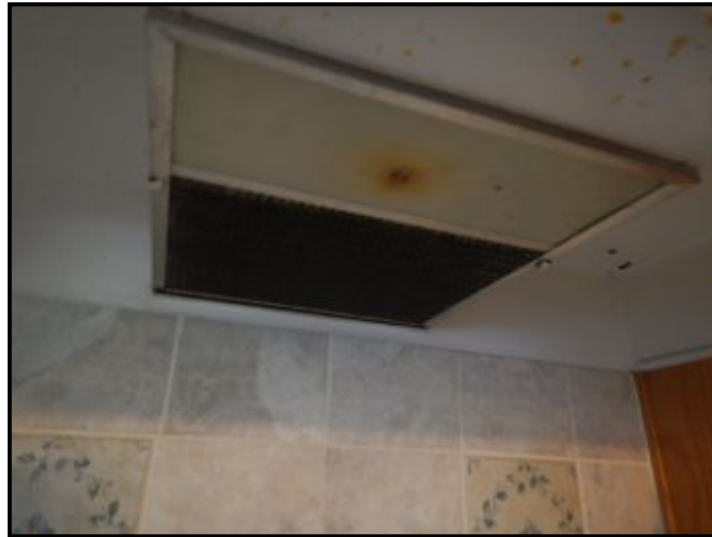
Page 35 Item: 10	Stove Exhaust Filter	<p>Attention The grease filter(s) on the exhaust fan needs to be replaced or cleaned. This should be done on a regular basis as part of preventative home maintenance.</p>
------------------	----------------------	--

Clean stove top filters.

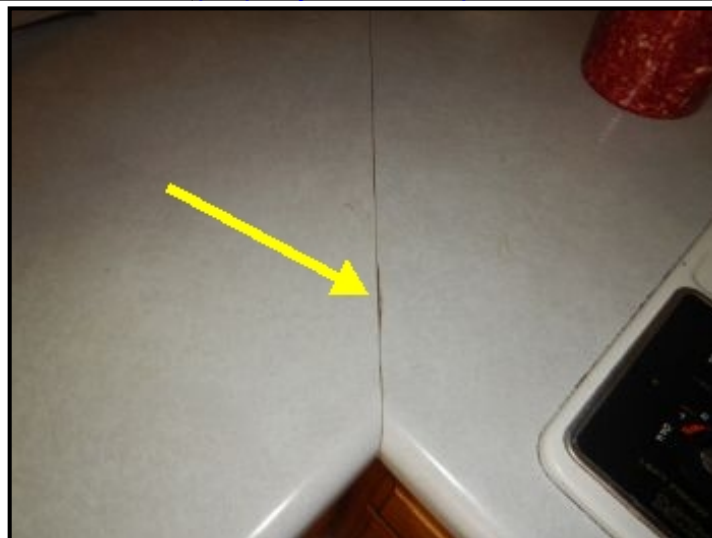
Page 36 Item: 17	Counter Tops	<p>Attention There are swollen counter tops at the seam from past moisture intrusion. It is recommended to keep these areas properly sealed to prevent deterioration.</p>
------------------	--------------	---

swollen kitchen counter top.

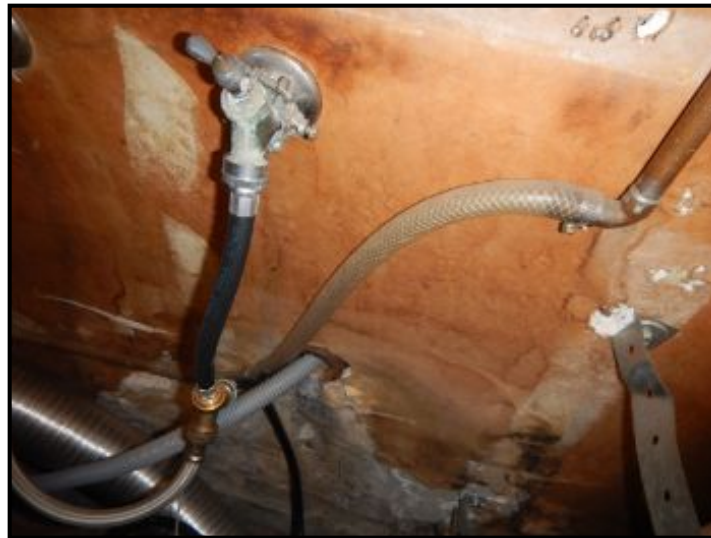
Page 38 Item: 6	Drains	<p>Attention There was no test performed of the washing machine drain line. There are indications of past leaking from the drain line and sheet rock damage noted. The inspector recommends testing the drain function prior to occupying the home to prevent any potential water damage and desired drainage.</p>
-----------------	--------	--

Indications of past leaking washing machine drain line.

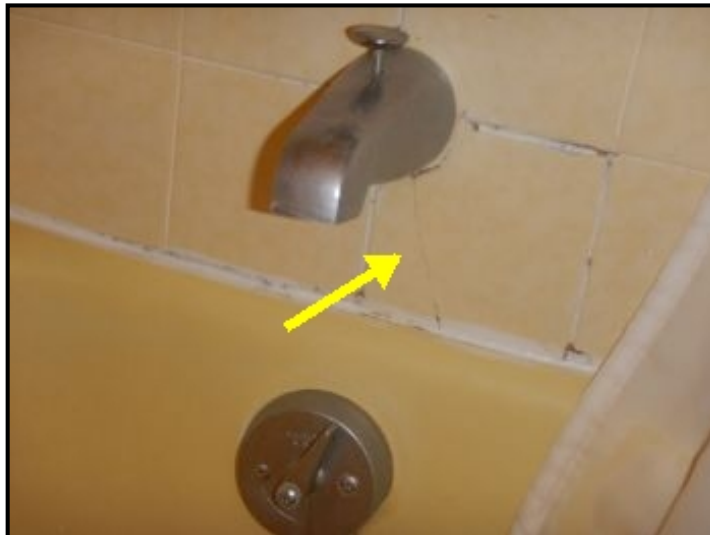
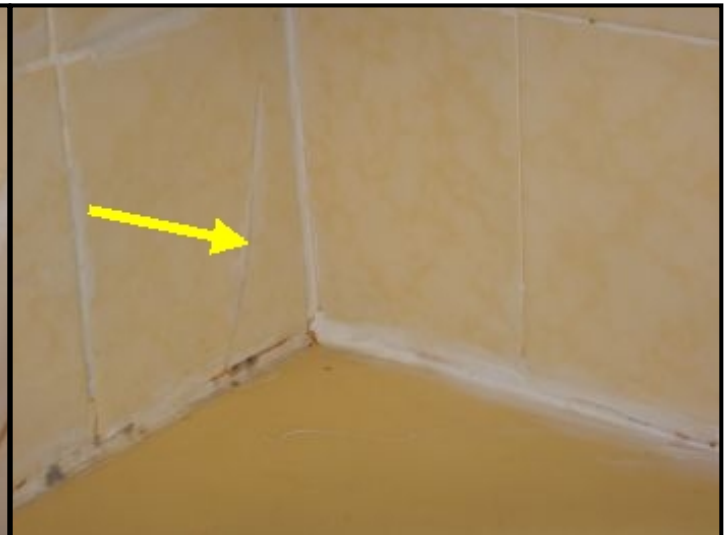
Page 41 Item: 9	Water Resistant Wall Cover	<p>Maintenance There are cracked tiles and grout voids were noted around the hall bathroom shower tile wall. This is a condition that can lead to moisture intrusion and deterioration. Regrouting and replacing damaged tiles is recommended to prevent potential moisture intrusion.</p>
-----------------	----------------------------	--

Cracked tiles at bathroom shower.

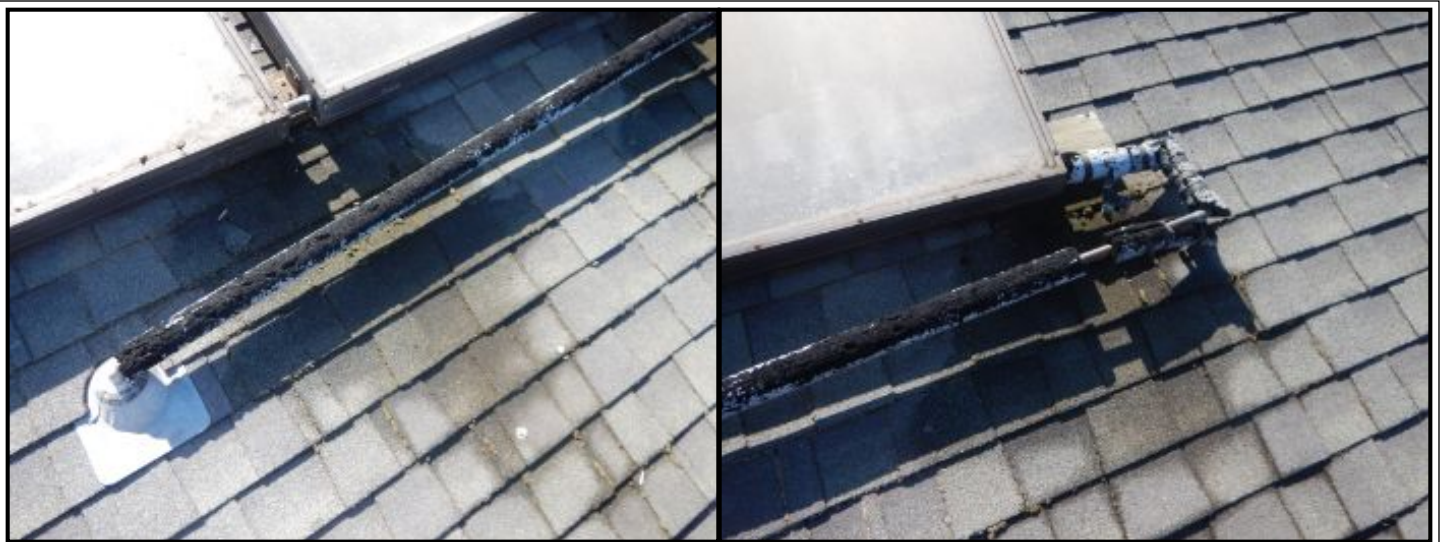
Page 44 Item: 5	Evidence of leaks	<p>Yes The roof top water heater solar panels are leaking. This system is outside the scope of the inspection. We recommend referring to the appropriate specialist for evaluation/recommendations.</p>
-----------------	-------------------	---

Leaking from roof top water heater solar panels. Leaking from roof top water heater solar panels.

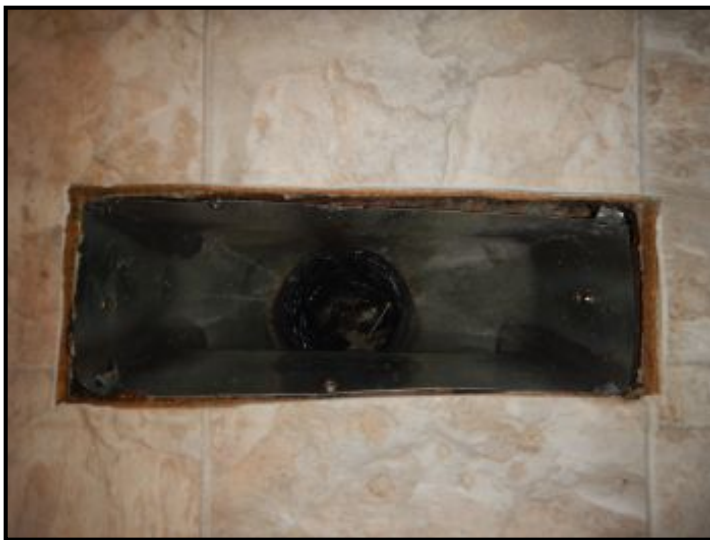
Seal gaps around the floor heat registers.

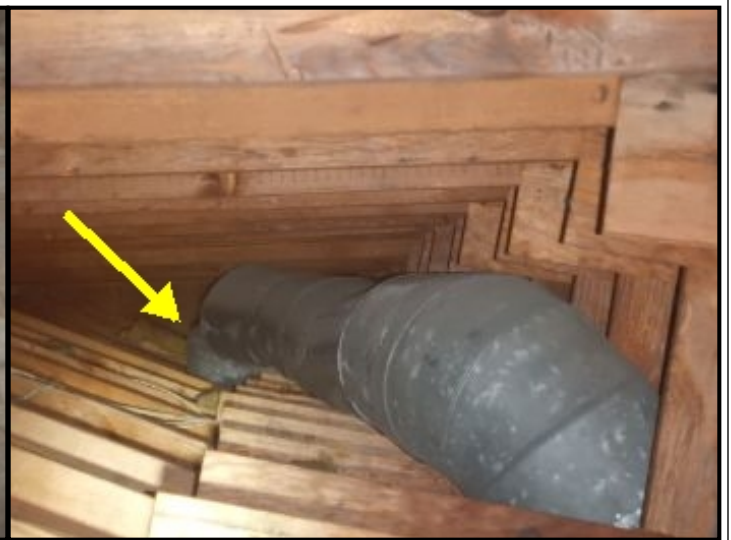
Disconnected air return in attic.

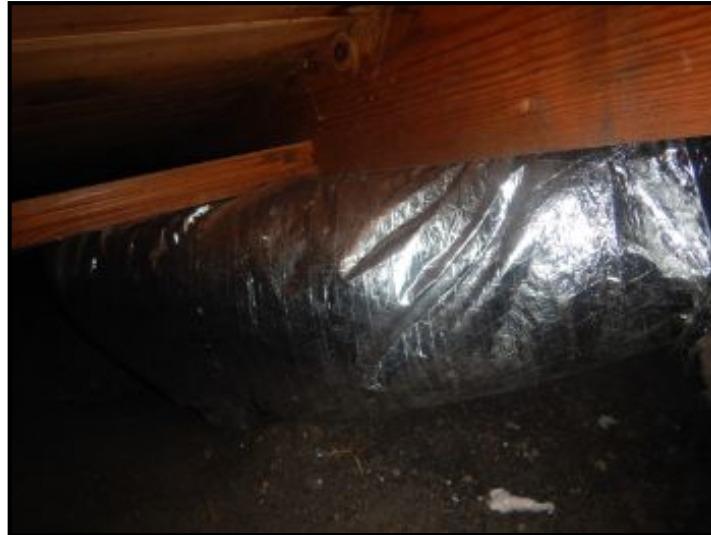
Heating ducts sitting on ground in sub area.

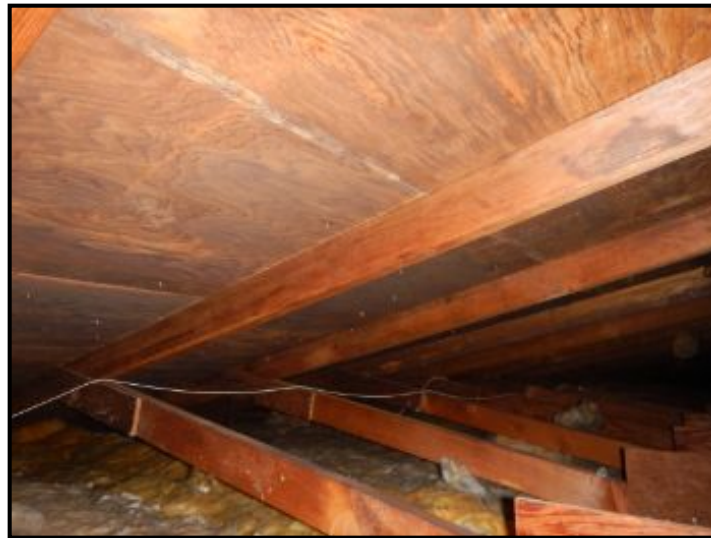
Discoloration was noted to wood members in the attic indicating a lack of ventilation. Recommend adding additional ventilation to the attic. Contact a qualified roofing contractor for evaluation/recommendations.

Discoloration to framing in attic.

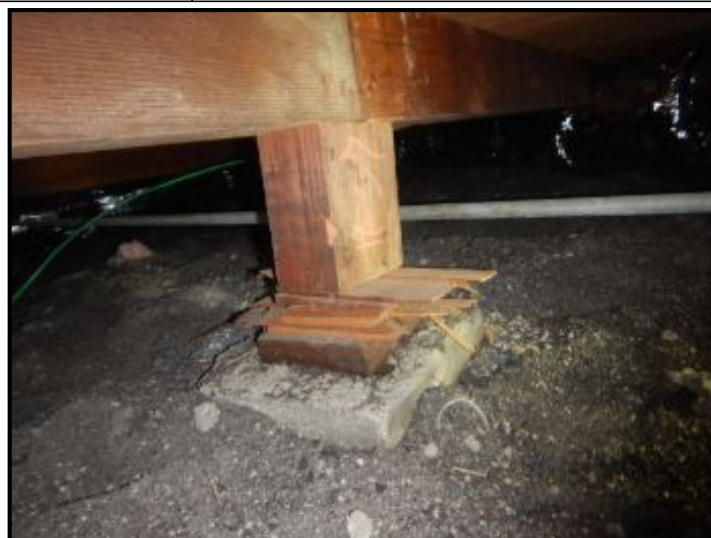
Shims used at concrete piers.

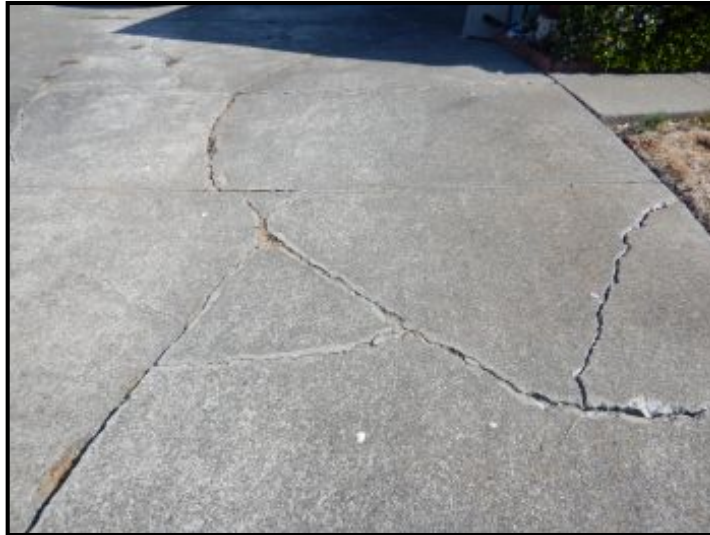
Due to past cracking/settling the concrete driveway is in a deteriorated condition. Repairs/replacement is recommended to prevent potential tripping hazards. Contact a qualified concrete specialist for evaluation/recommendations.

Excessive cracking to driveway.

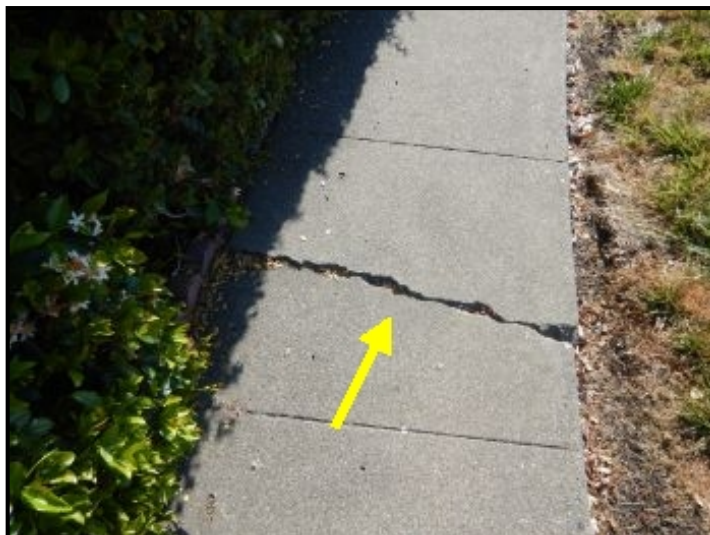
There is cracking/settling noted at the concrete walkways causing a potential tripping hazard. As a safety consideration patching/repairs are advised as needed. Contact a qualified concrete specialist for repairs.

Cracking to walkways.

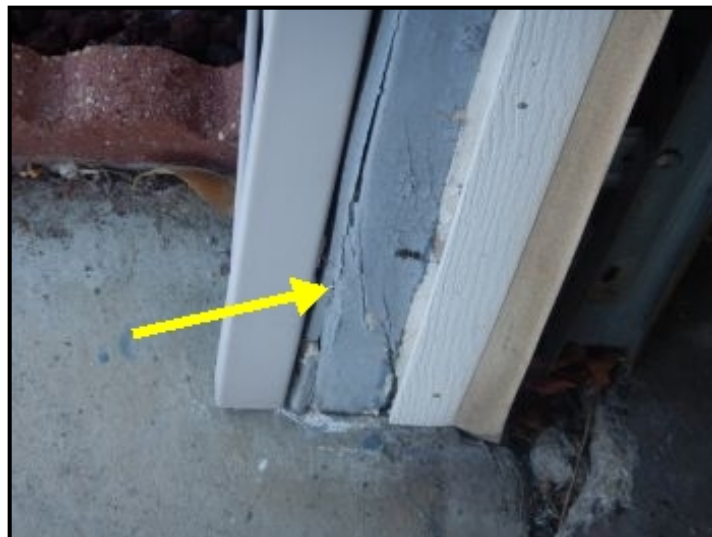
There is cupped/warped/split trim at the exterior of the home. It is recommended to keep these areas properly painted and sealed as a preventative measure. Future repair/replacement may be needed.

Split trim at garage door.

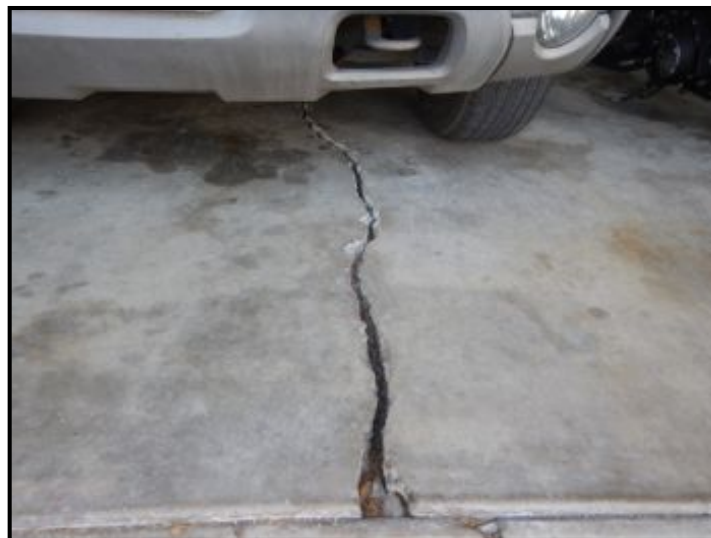
Excessive cracking has been noted at the garage floor. Recommend contacting the appropriate specialist for evaluation/recommendations.

Cracking at garage floor.

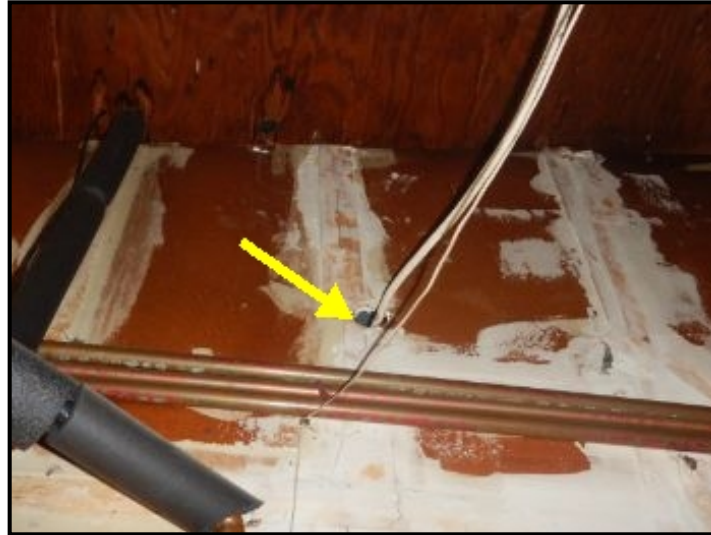
There are gaps around pipes/cables/ducting at the wall between the garage and living space. It is advised to use a fire rated caulking to seal around any gaps in the wall as a health and safety consideration.

Seal all holes at firewall.

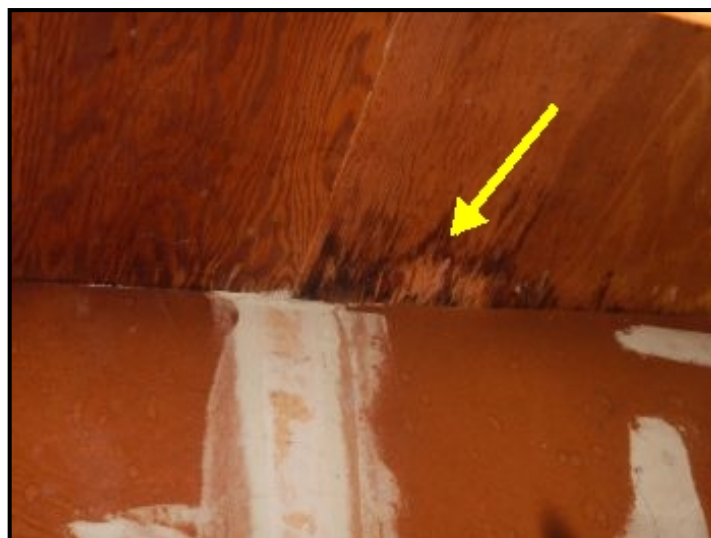
There is moisture staining at the ceiling of the garage indicating past moisture intrusion. The area was dry at the time of the inspection and no major adverse conditions were noted. We recommend monitoring this area during the rains to determine if repairs are needed.

Moisture staining at garage ceiling.

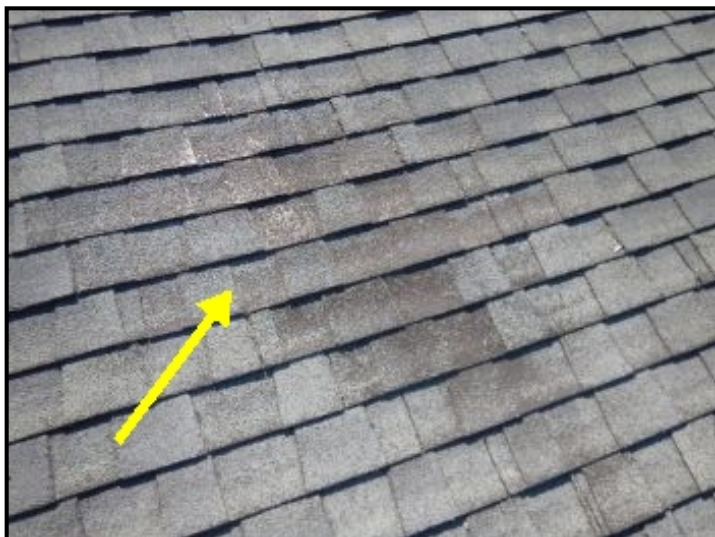
There is a portion of the roof at the front side of the home that is showing excessive wear. We recommend contacting a qualified roofing contractor for evaluation/recommendations.

Worn section of roofing shingles.

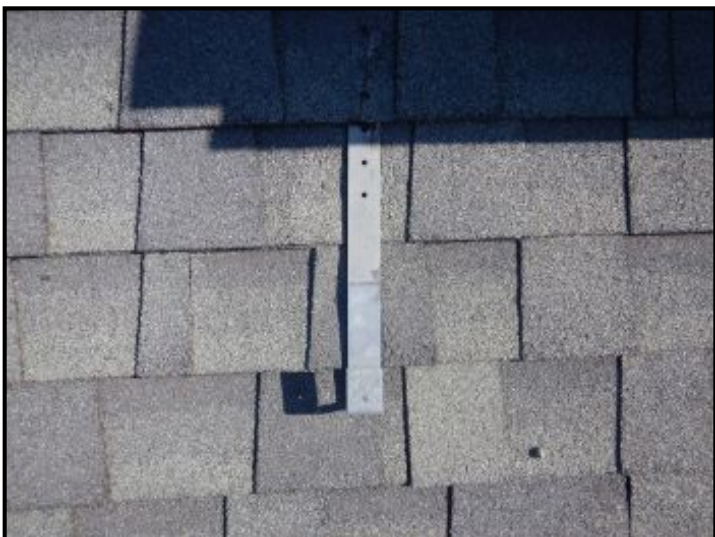
There are brackets installed at the roof top with exposed fasteners. The purpose of the brackets is unknown. It is recommended to remove the brackets and sealed any penetrations at the roof top. Contact a qualified roofing contractor for evaluation.

Exposed fasteners at brackets.

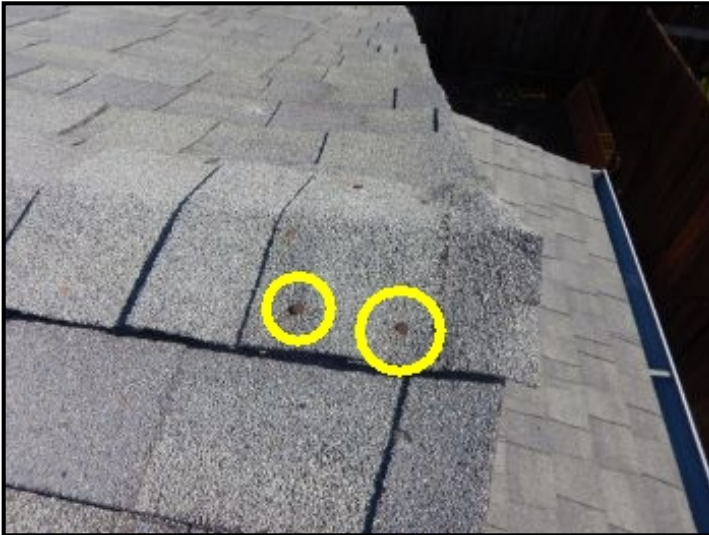
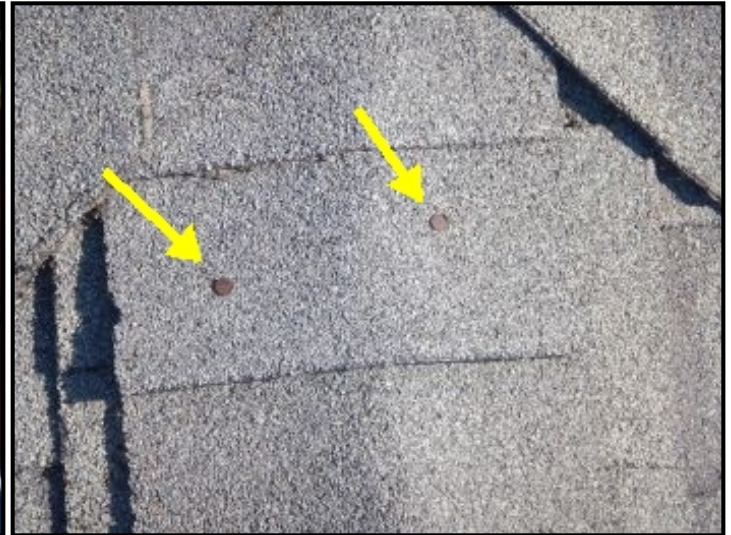
There are exposed fasteners at the ridge shingles. It is recommended to keep these areas properly caulked and sealed as a preventative measure. Contact a qualified roofing contractor for repairs.

Exposed fasteners at ridge shingles.

Exposed ridge fasteners.

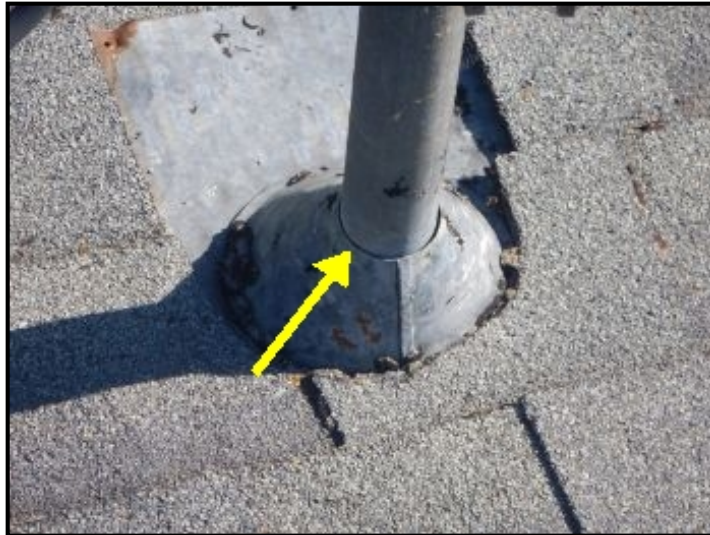
The main electrical service drop at the roof top does not have a storm collar installed and is not currently sealed. Recommend sealing this area with a roofing mastic material to prevent potential leaking.

Seal around main electrical drop.

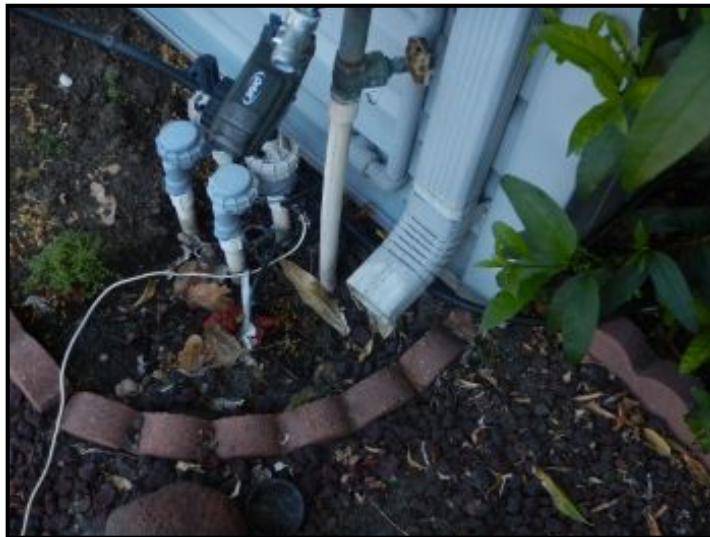
There are downspout that are draining at the foundation perimeter which can allow for water penetration into the crawl space. Recommend installing drain pipe extender or splash blocks to help divert water away from the structure.

Gutters draining at foundation wall.

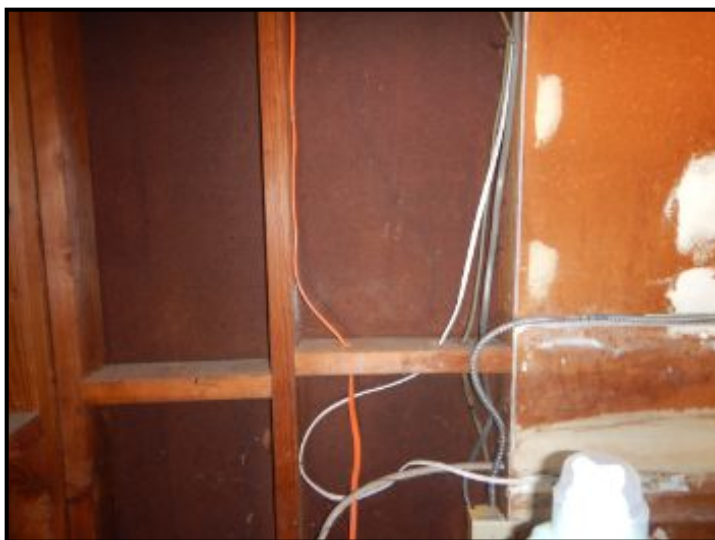
Unprotected non metallic sheathed cable was noted at the garage. Electrical cable is subject to physical damage and is typically installed in attics and inside walls. Repairs should be made to properly protect the wiring system inside conduit. Contact a qualified electrician for repairs.

Unprotected romex in garage.

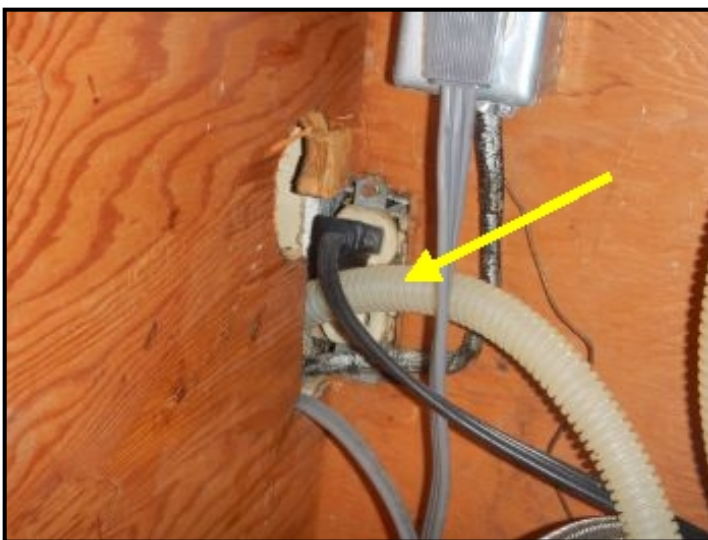
All damaged or missing cover plates should be replaced with new cover plates to restore proper function and reduce the risk of electrical shorts and hazardous shocks. There is a missing cover plate under the kitchen sink.

Missing cover plate under the kitchen sink.

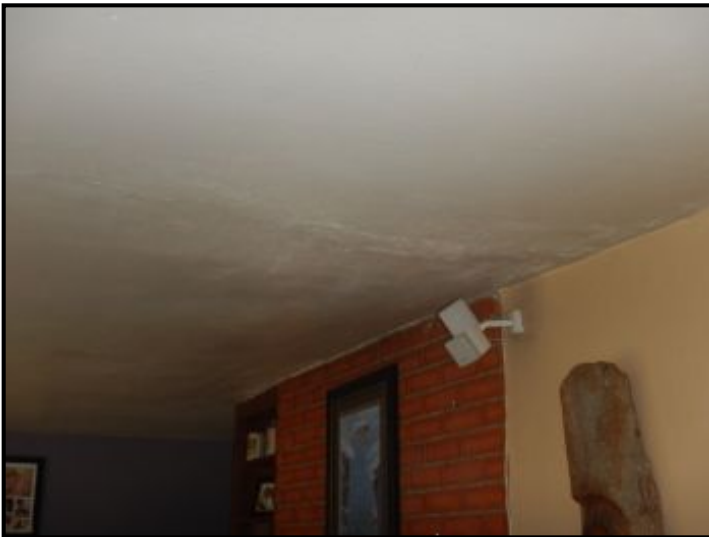
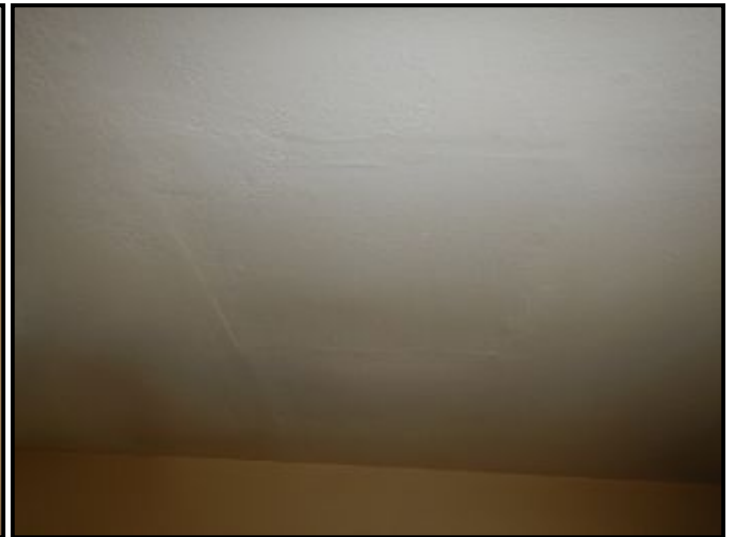
There is patching and sagging ceilings at the living room. Due to the lack of attic space this area was not accessible for inspection. We recommend contacting a qualified contractor for evaluation.

Sagging ceiling in living room.

Patch marks at living room ceiling.

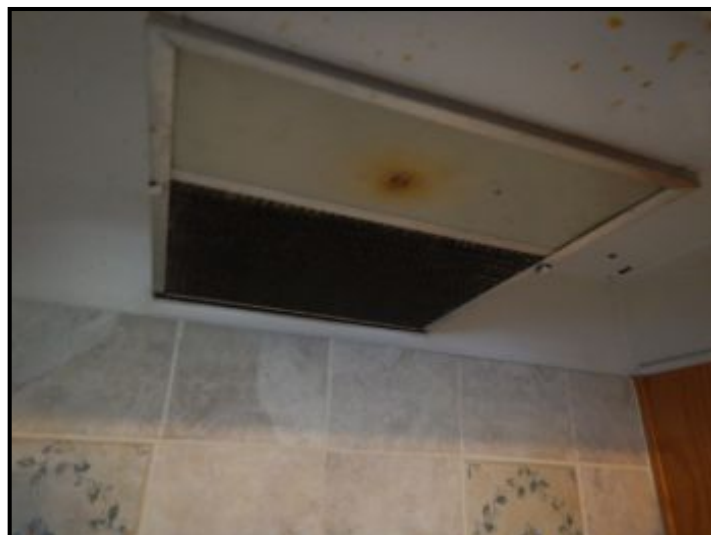
The grease filter(s) on the exhaust fan needs to be replaced or cleaned. This should be done on a regular basis as part of preventative home maintenance.

Clean stove top filters.

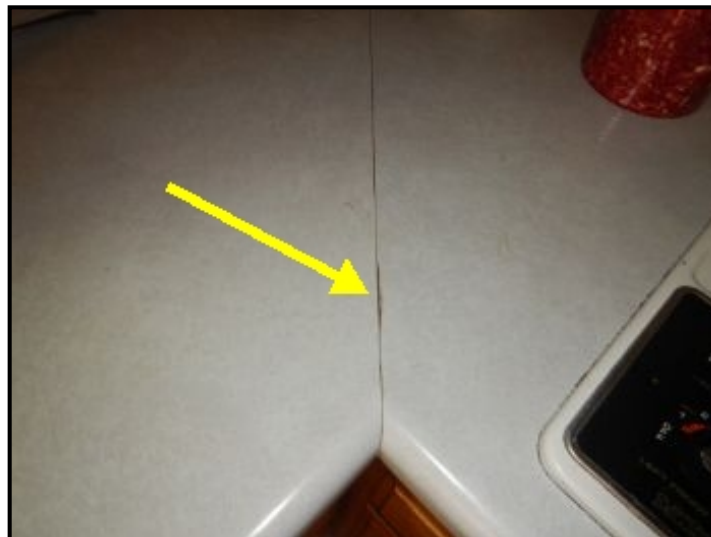
There are swollen counter tops at the seam from past moisture intrusion. It is recommended to keep these areas properly sealed to prevent deterioration.

swollen kitchen counter top.

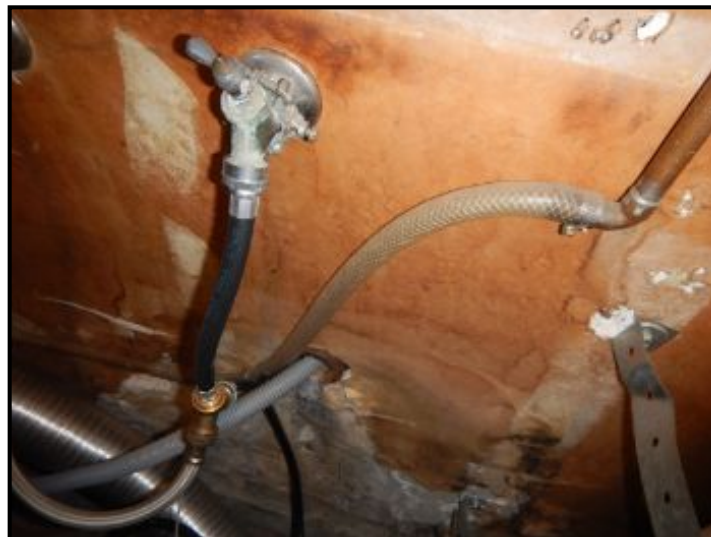
There was no test performed of the washing machine drain line. There are indications of past leaking from the drain line and sheet rock damage noted. The inspector recommends testing the drain function prior to occupying the home to prevent any potential water damage and desired drainage.

Indications of past leaking washing machine drain line.

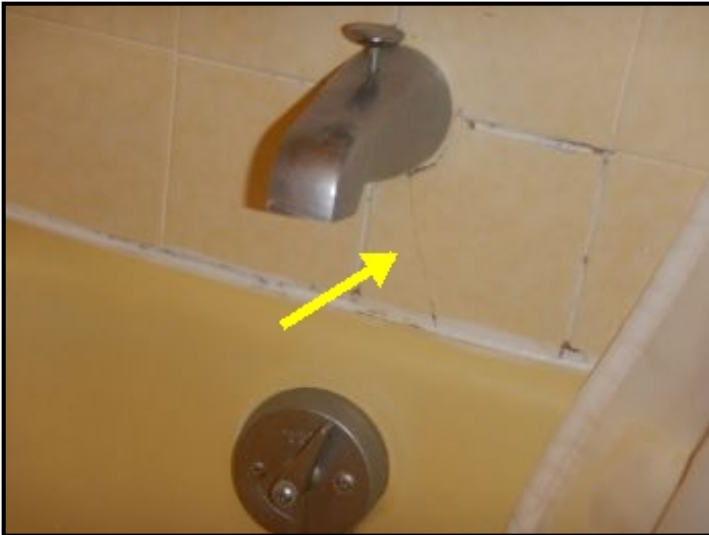
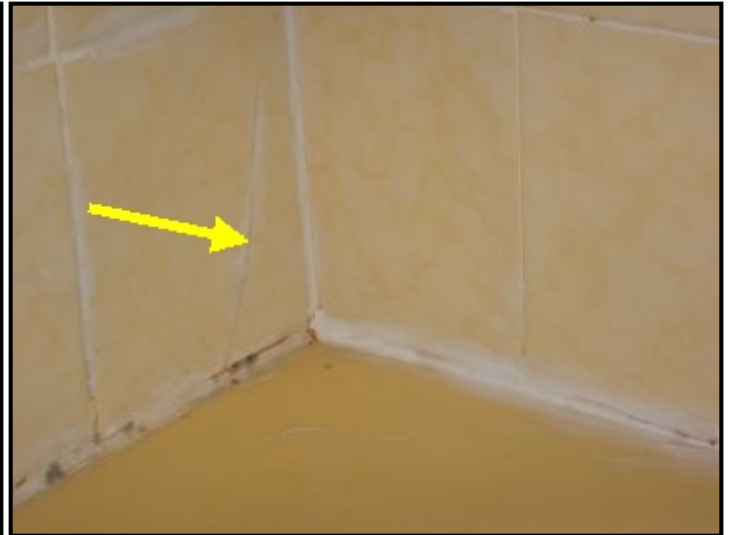
There are cracked tiles and grout voids were noted around the hall bathroom shower tile wall. This is a condition that can lead to moisture intrusion and deterioration. Regrouting and replacing damaged tiles is recommended to prevent potential moisture intrusion.

Cracked tiles at bathroom shower.

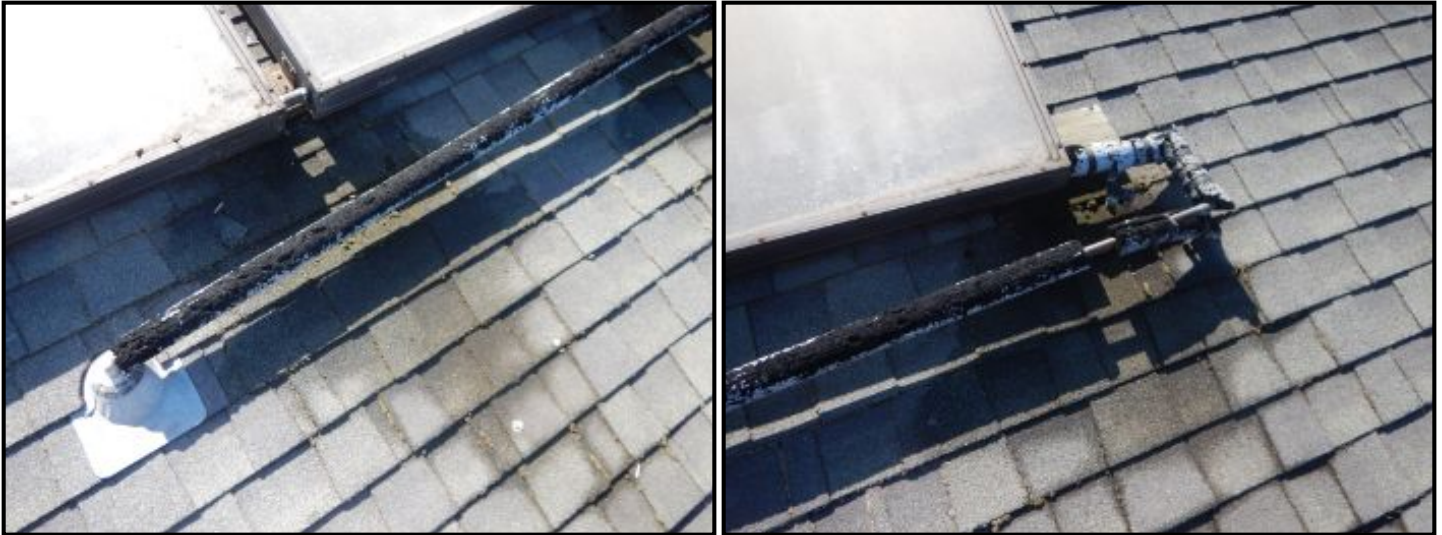
The roof top water heater solar panels are leaking. This system is outside the scope of the inspection. We recommend referring to the appropriate specialist for evaluation/recommendations.

Leaking from roof top water heater solar panels. Leaking from roof top water heater solar panels.

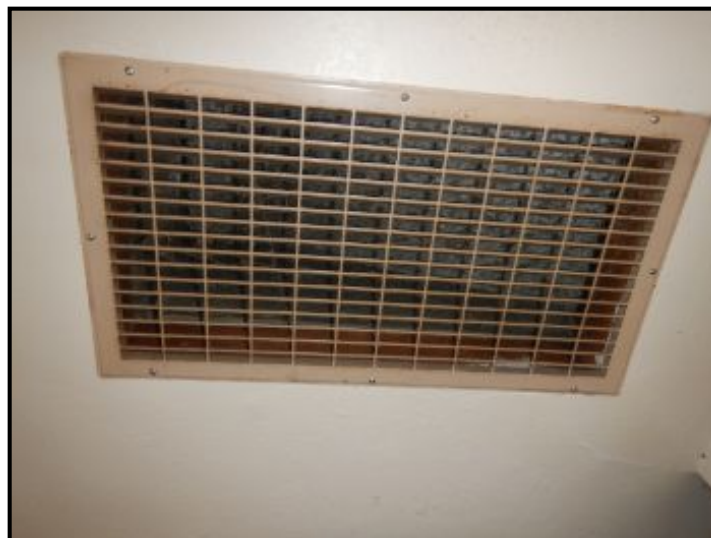
No filter installed at air return.

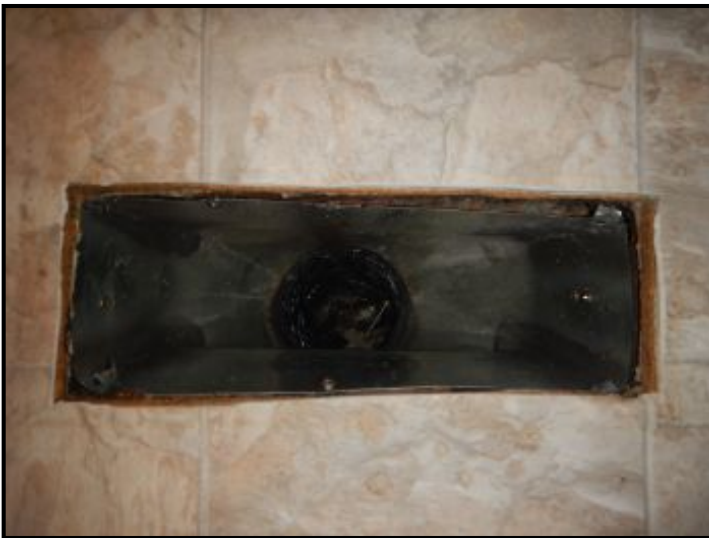
Seal gaps around the floor heat registers.
