Gage Inspection Services

Property Inspection Report

202 Adele Ave, Rohnert Park, CA 94928
Inspection prepared for: Faith Schon
Real Estate Agent: Mary Haufler - Sothebys

Date of Inspection: 6/26/2018 Time: 9:00 AM
Age of Home: 1958 Size: 1662
Order ID: 134

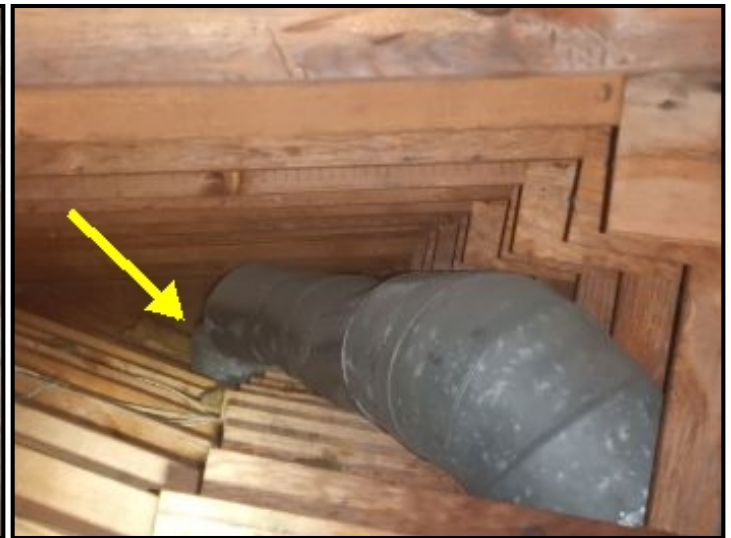
Disconnected air return in attic.

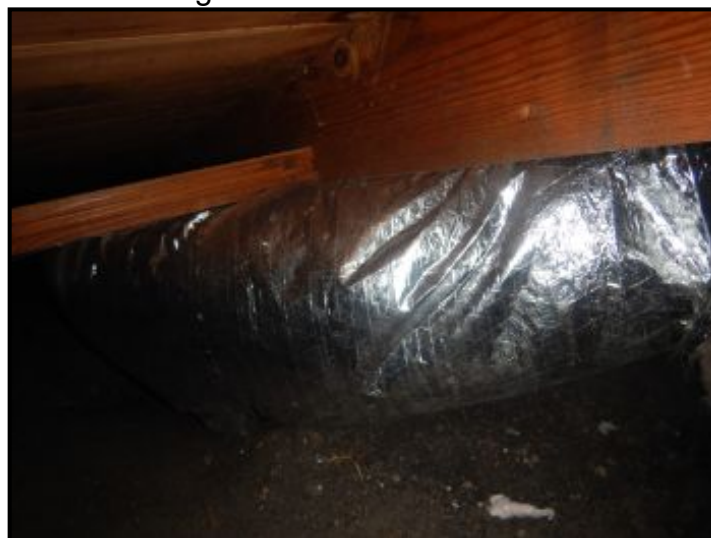
There are heating ducts that are sitting on the ground in the sub area. It is advised to strap the ducting to the floor area framing if possible to prevent contact with the ground and potential damage.

Heating ducts sitting on ground in sub area.

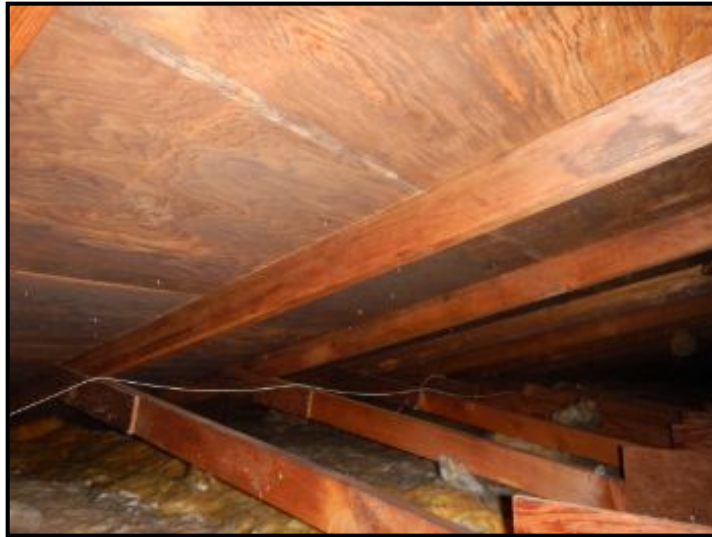
Discoloration was noted to wood members in the attic indicating a lack or ventilation. Recommend adding additional ventilation to the attic. Contact a qualified roofing contractor for evaluation/recommendations.

Discoloration to framing in attic.

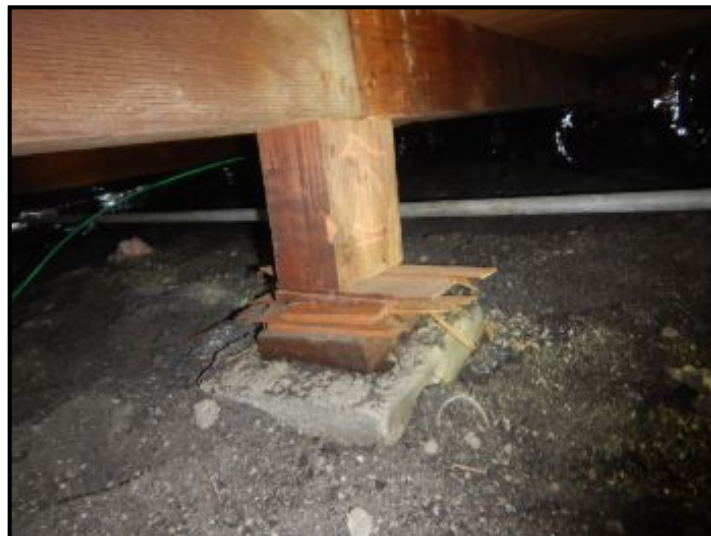
Shims were noted to wood posts on top of concrete piers in the sub area indicating past movement/settlement of the structure in the past. The post were not attached to the concrete pier. We recommend contacting a qualified contractor for evaluation/recommendations.

Shims used at concrete piers.
