Gage Inspection Services

Property Inspection Report

4721 Starbuck Ave, Santa Rosa, CA 95409
Inspection prepared for: Tim/Shannon Rountree
Real Estate Agent: Mary Haufler - Sothebys

Date of Inspection: 7/10/2018 Time: 9:00 AM
Order ID: 142

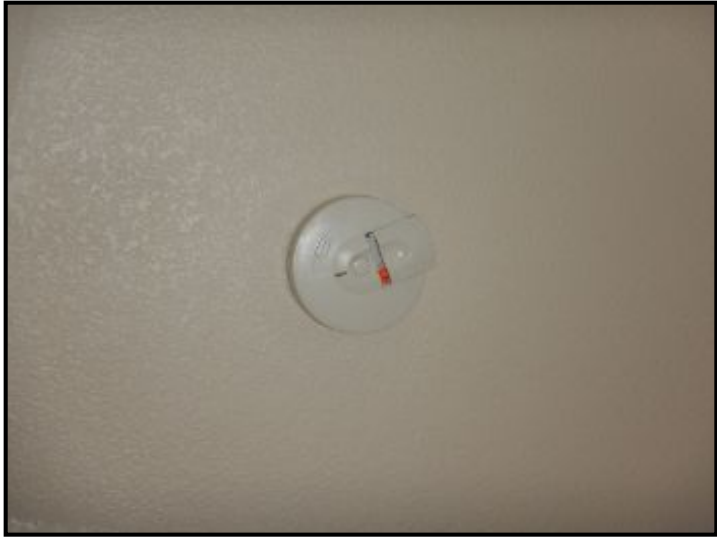
Inspection Details		
Page 12 Item: 10	Smoke Detectors	<p>Maintenance There is a missing battery for the smoke detector in the master bedroom. It is recommended to replace the battery and test for proper function.</p>

<p>Missing battery at smoke detector.</p>		
Exterior Structure		
Page 14 Item: 2	Siding Condition	<p>Attention The concrete steps have been installed above the siding and may cause future damage. It is recommended to provide a proper flashing to direct water away from this area or seal with an elastomeric or polyurethane caulking.</p>

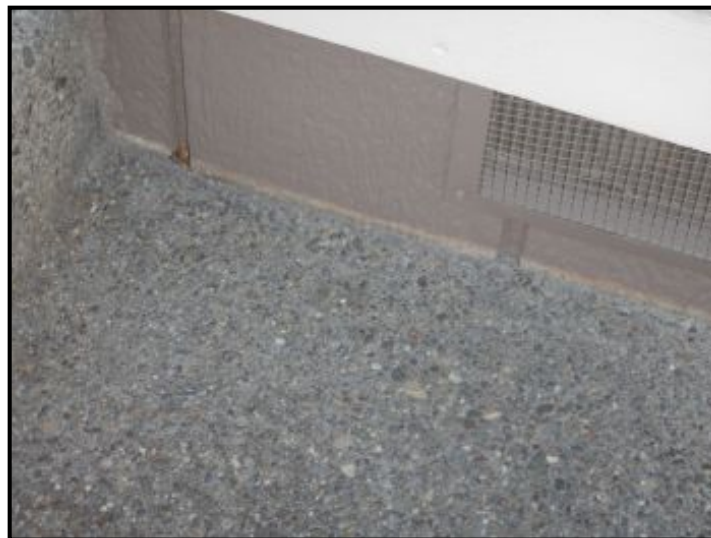
Siding installed behind concrete steps.

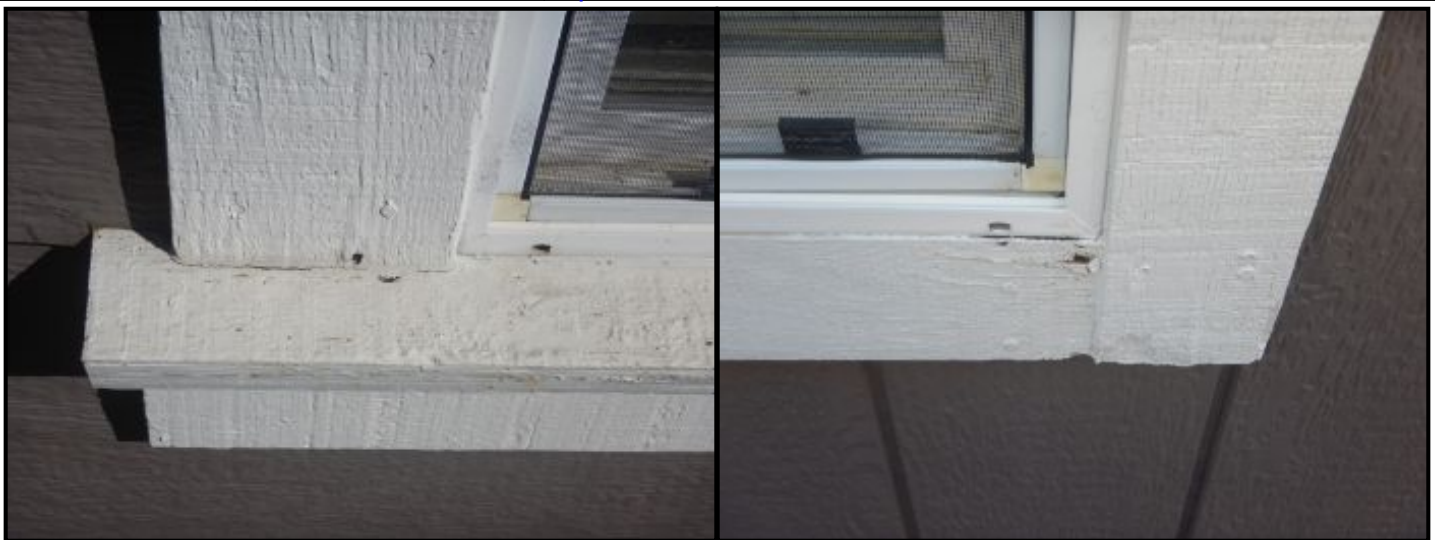
Page 15 Item: 7	Fascia Boards/Trim	<p>Maintenance Trim damage has been noted at the exterior of the home. We recommend referring to the pictures and contacting a qualified contractor to review the current pest report and make needed repairs.</p>
-----------------	--------------------	------------------------------------------------------------------------------------------------------------------------------------------------------------------------------------------------------------------------------------------------

Window trim damage at side of garage.

Window trim damage at side of home.

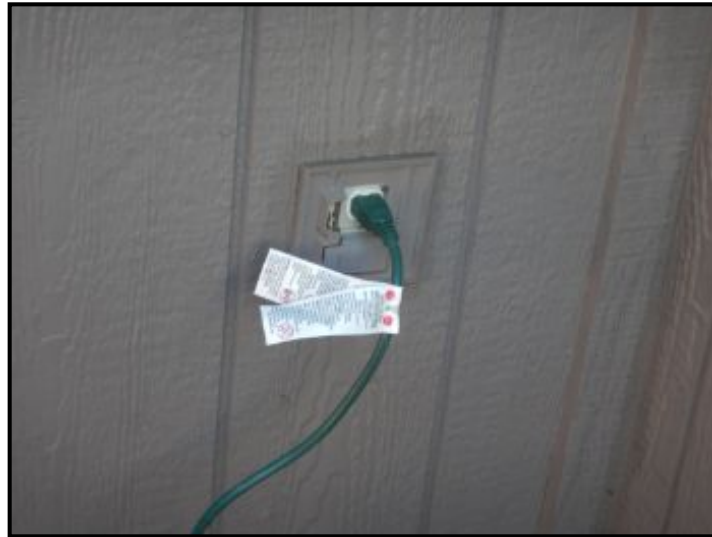
Page 17 Item: 5	Weather Protective Covers	<p>Maintenance There is a damaged weather protective cover at the rear patio. Replacement of the cover is recommended as a health and safety consideration.</p>
-----------------	---------------------------	---------------------------------------------------------------------------------------------------------------------------------------------------------------------------------------------

Damaged cover at rear patio.

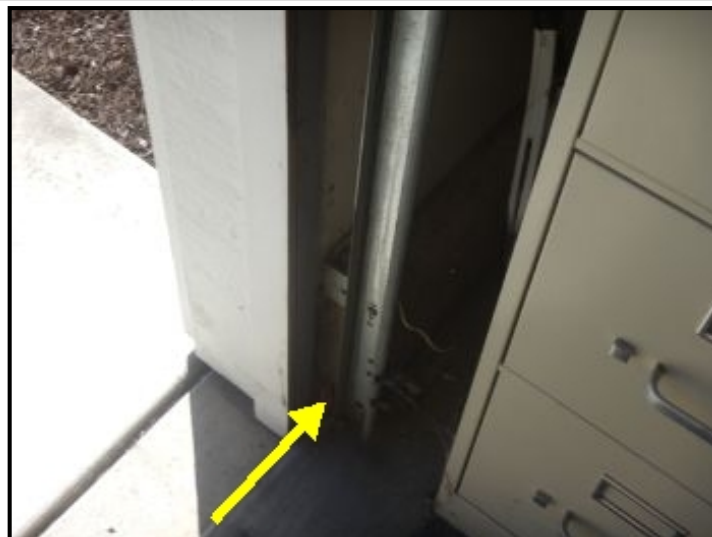
Page 19 Item: 5	Springs/Mounts	<p>Attention One of the tracks for the garage door rattles when the door is opening. The support hardware was noted to be loose. It is recommended to tighten the support bolts to prevent further wear.</p>
-----------------	----------------	------------------------------------------------------------------------------------------------------------------------------------------------------------------------------------------------------------------------------------------

Loose track at garage door.

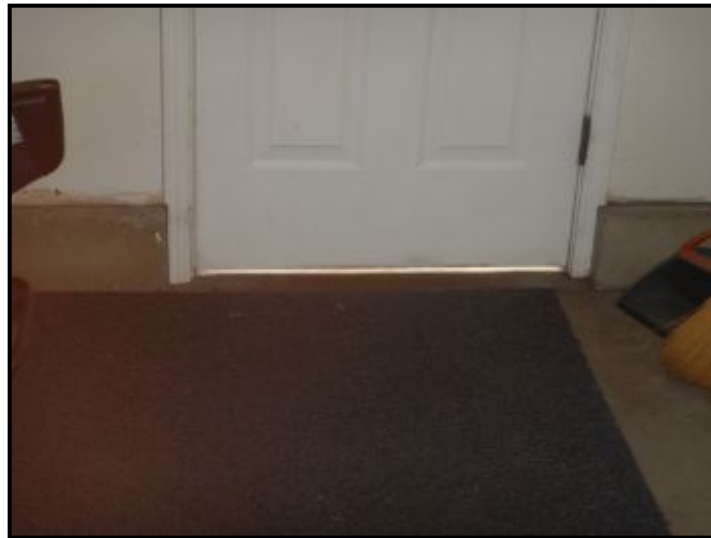
Page 20 Item: 10	Door(s) Garage-Building	<p>Attention There is a gap under the side service garage that can allow for rodent and moisture access. It is recommended to install a lower door sweep to close off this gap.</p>
------------------	-------------------------	-----------------------------------------------------------------------------------------------------------------------------------------------------------------------------------------------------------------

Gaps under side garage door.

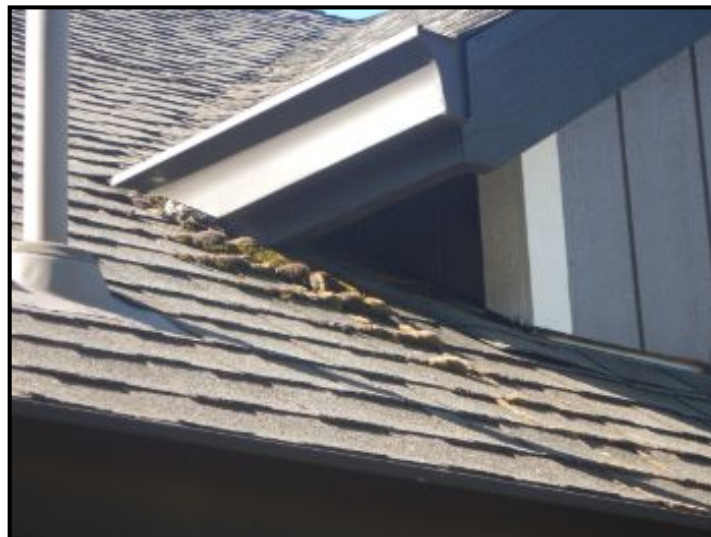
Page 21 Item: 3	Moss/Mildew	<p>Yes There is moss growth at the roof top. The inspector recommends removing the moss growth at some time in the future and treating the roof to prevent growth. Chemicals for preventing moss growth can be purchased at a local home improvement store. There are companies who will clean the roof and apply a material that will prevent moss growth for a number of years.</p>
-----------------	-------------	-------------------------------------------------------------------------------------------------------------------------------------------------------------------------------------------------------------------------------------------------------------------------------------------------------------------------------------------------------------------------------------------------------------------

Moss growth on roof top.

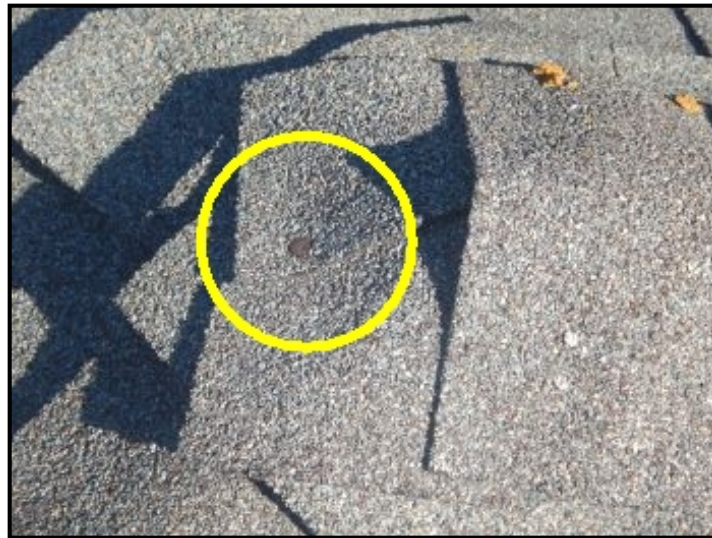
Page 21 Item: 7	Ridges	<p>Attention There are exposed fasteners at the ridge shingles. It is recommended to keep these areas properly caulked and sealed as a preventative measure. Contact a qualified roofing contractor for repairs.</p>
-----------------	--------	--------------------------------------------------------------------------------------------------------------------------------------------------------------------------------------------------------------------------------------------------

Seal fasteners at ridge shingles.

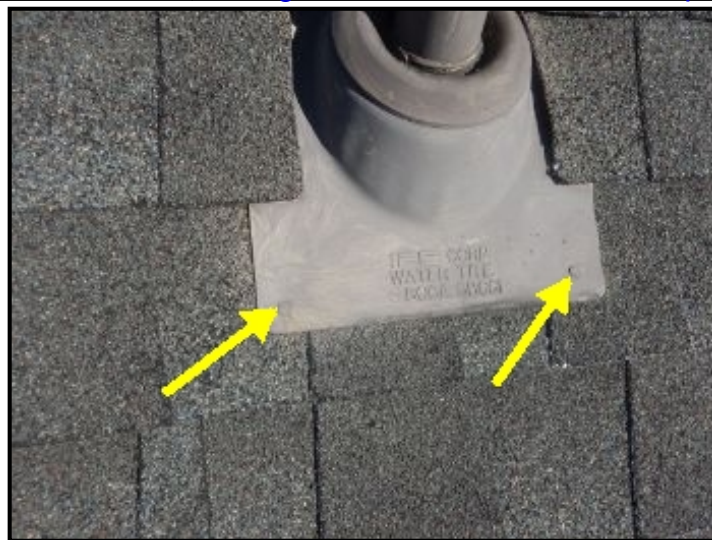
Page 22 Item: 9

There are some exposed fasteners at the roof top flashings. It is recommended to keep these areas properly caulked and sealed to prevent potential leaking points. Contact a qualified roofing contractor for evaluation/repairs.

Seal exposed fasteners at flashings.

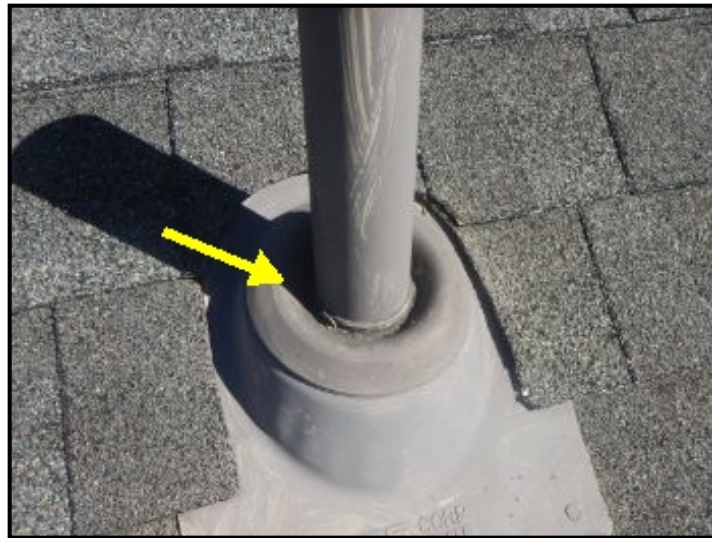
Page 22 Item: 10

Some of the plumbing vent storm collars have collapsed which can cause standing water and unnecessary wear to the storm collars. Minor repairs are recommended to properly shed water.

Collapsed storm collar at plumbing vents.

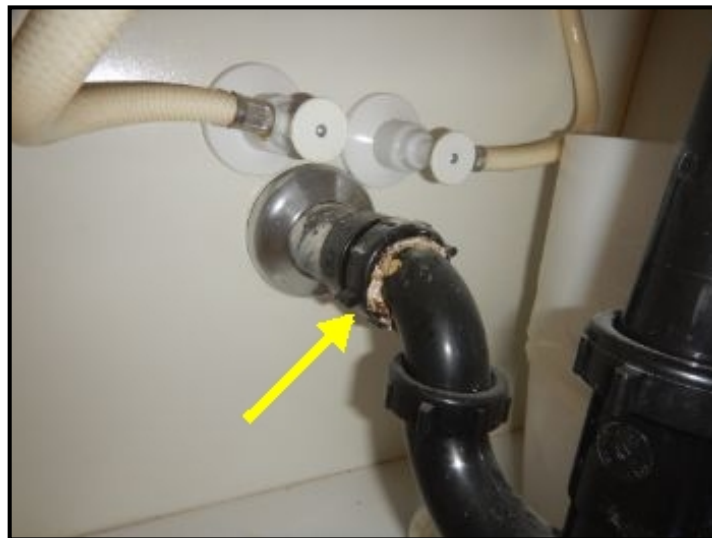
Page 27 Item: 8

The inspector has found evidence of a plumbing leak at the hall bathroom sink drain line. We advise the use of a qualified plumbing contractor to make final determination of the cause and to provide estimates for repairs.

Leaking at bathroom sink drain line.

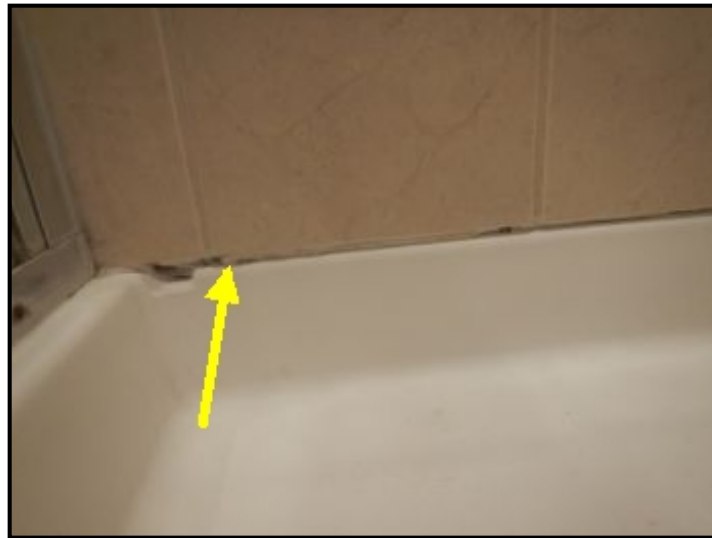
Minor grout voids were noted around the master bathroom shower tile wall. This is a condition that can lead to moisture intrusion and deterioration. Regrouting is recommended. These areas should be inspected and touched up on a regular basis as part of preventative home maintenance

Caulking touch ups needed.

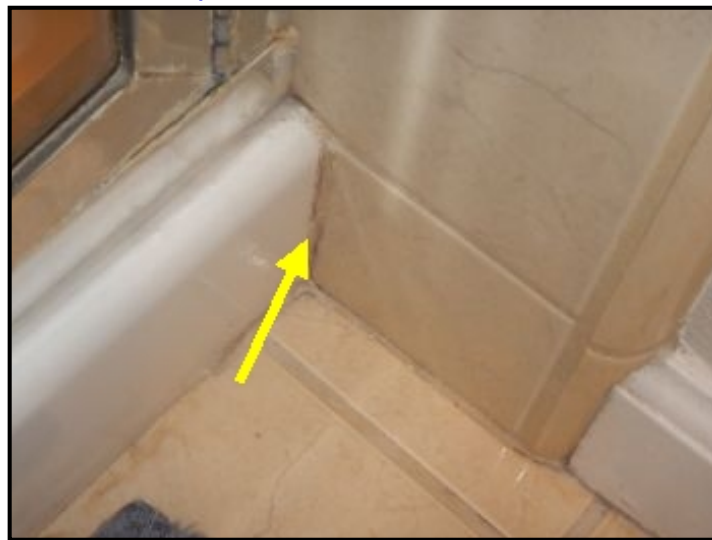
Page 38 Item: 10

Minor grout voids were noted at the tile floor to the base of the tub/shower at the master bathroom. it is recommended to keep these areas properly sealed to prevent moisture intrusion and potential damage. These areas should be inspected and touched up on a regular basis as part of preventative home maintenance.

Grout voids at exterior of shower.

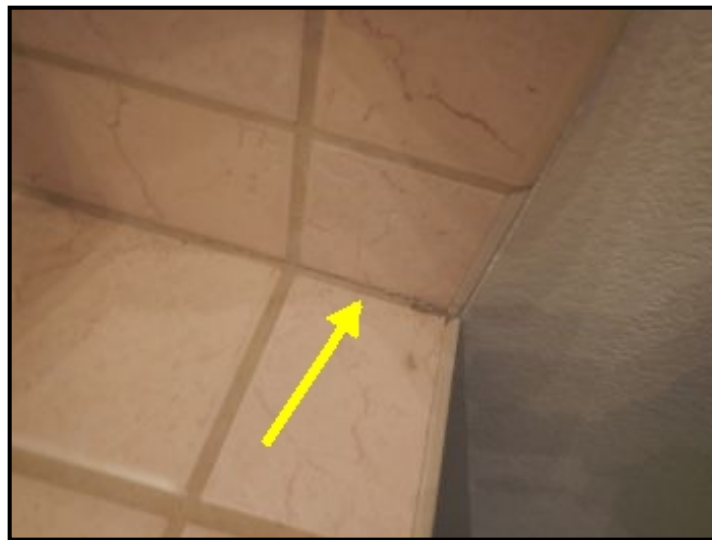
Page 39 Item: 20

There are caulking/grout voids noted at the hall bathroom counter top. Recommend re-sealing these areas to prevent moisture intrusion.

Cracking grout at bathroom counter top.

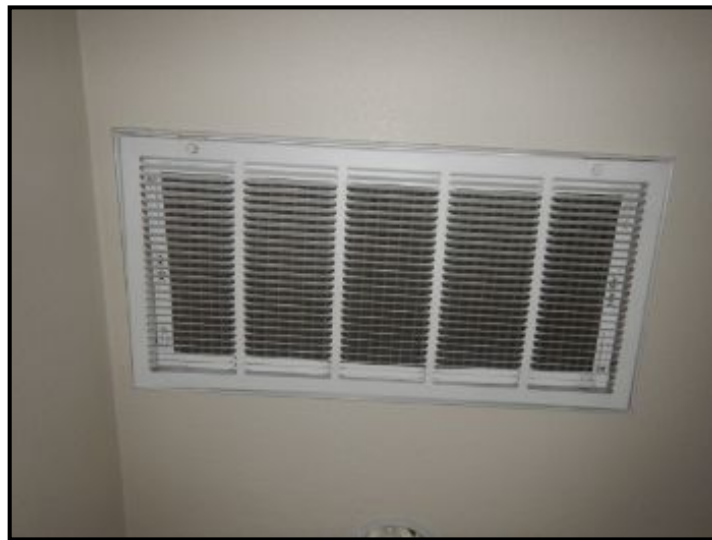
The furnace filter is in need of changing. This can restrict proper airflow and reduce the efficiency of the system. The inspector recommends changing or cleaning the filter on a regular basis as needed.

Replace air return filter.

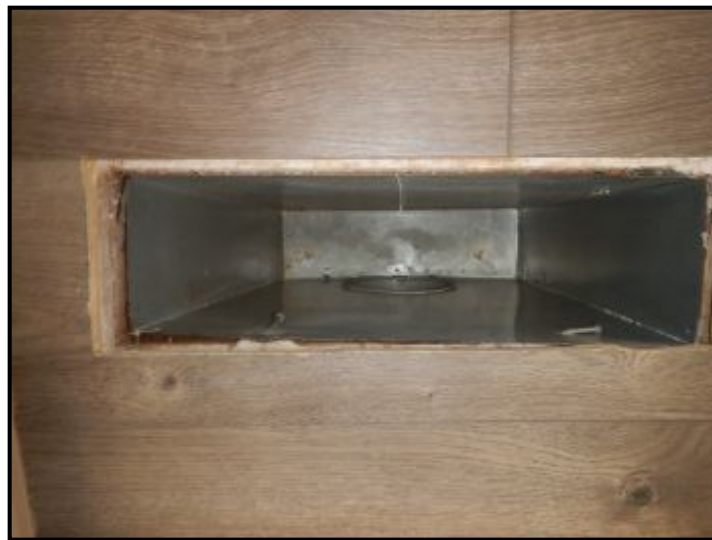
Page 42 Item: 10

There are gaps around the floor heat registers. It is recommended to seal around the registers with an HVAC foil tape to help with the heating/cooling efficiency of the home.

Recommend taping gaps around heat registers.

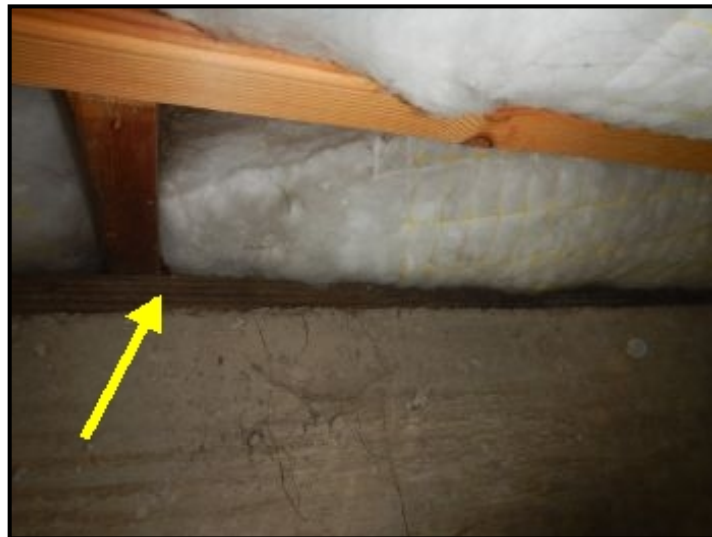
There is insulation that is blocking some of the under house vents. Recommend providing 24 inches of clearance from the vents to increase airflow.

Insulation blocking vents.

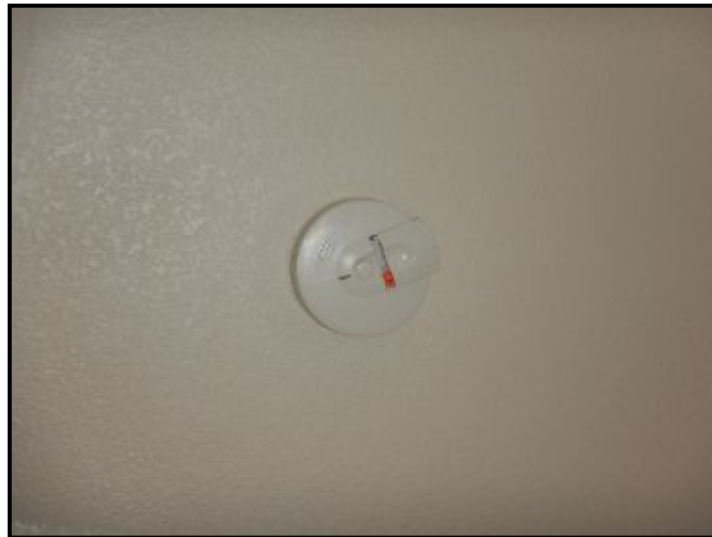
There is a missing battery for the smoke detector in the master bedroom. It is recommended to replace the battery and test for proper function.

Missing battery at smoke detector.

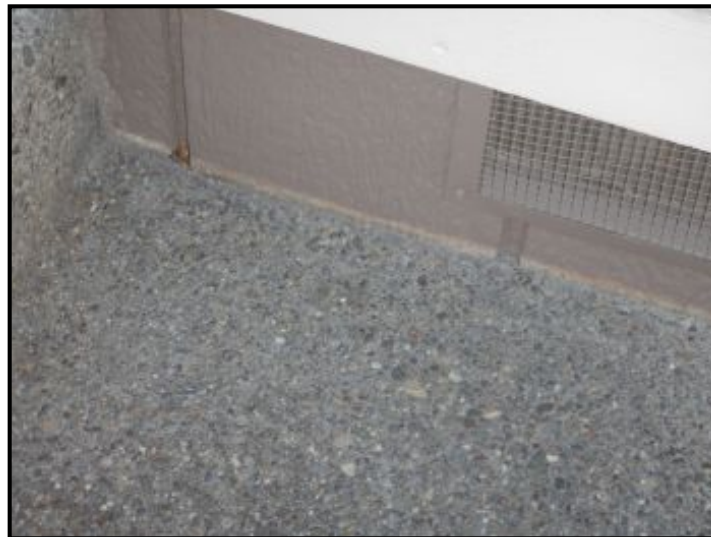
2. Siding Condition

The concrete steps have been installed above the siding and may cause future damage. It is recommended to provide a proper flashing to direct water away from this area or seal with an elastomeric or polyurethane caulking.

Siding installed behind concrete steps.

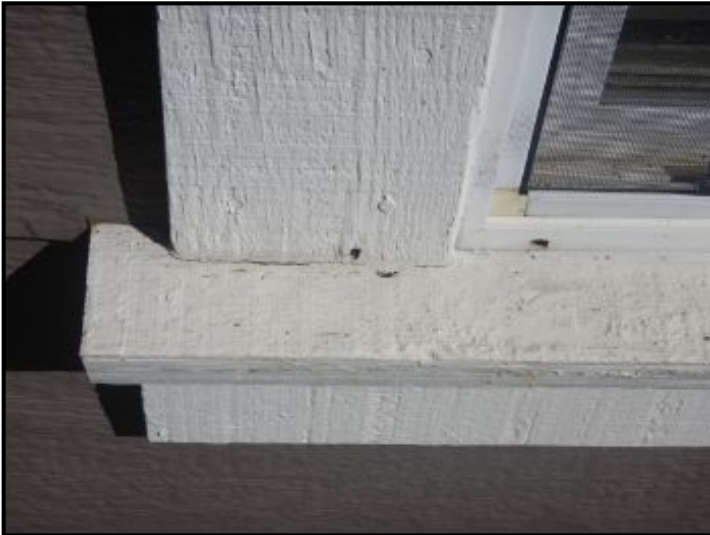
Trim damage has been noted at the exterior of the home. We recommend referring to the pictures and contacting a qualified contractor to review the current pest report and make needed repairs.

Window trim damage at side of garage.

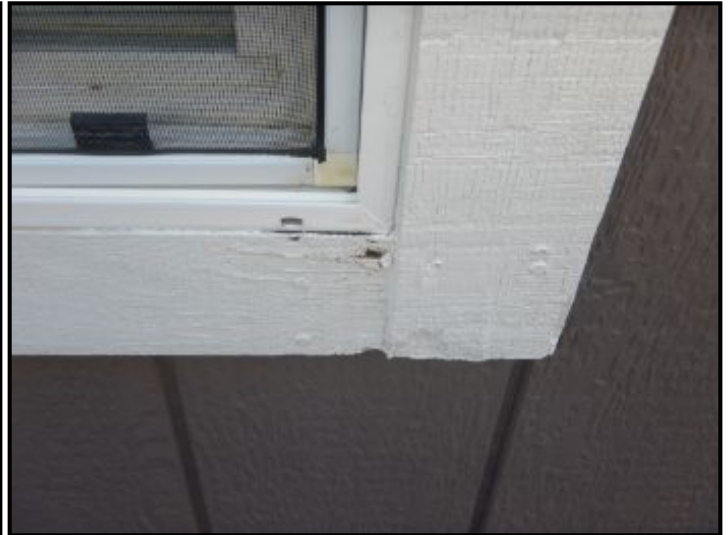
Window trim damage at side of home.

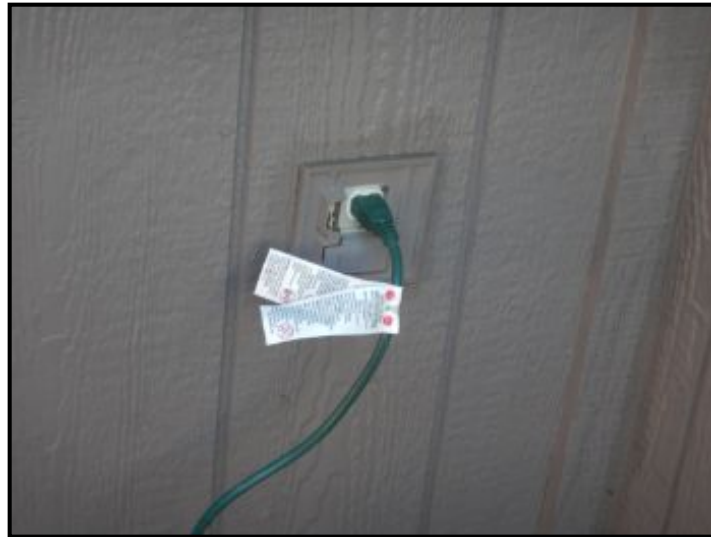
There is a damaged weather protective cover at the rear patio. Replacement of the cover is recommended as a health and safety consideration.

Damaged cover at rear patio.

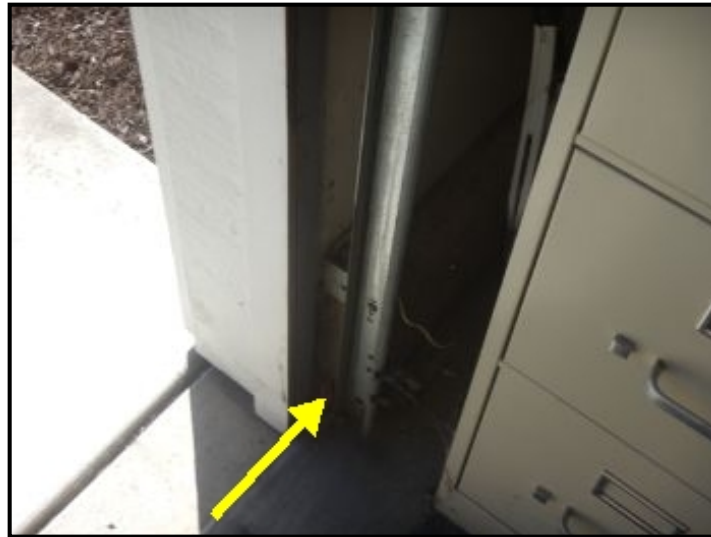
One of the tracks for the garage door rattles when the door is opening. The support hardware was noted to be loose. It is recommended to tighten the support bolts to prevent further wear.

Loose track at garage door.

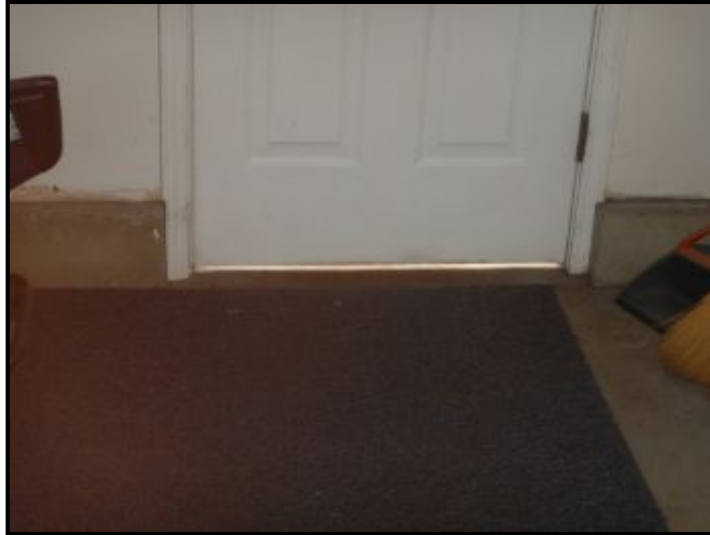
There is a gap under the side service garage that can allow for rodent and moisture access. It is recommended to install a lower door sweep to close off this gap.

Gaps under side garage door.

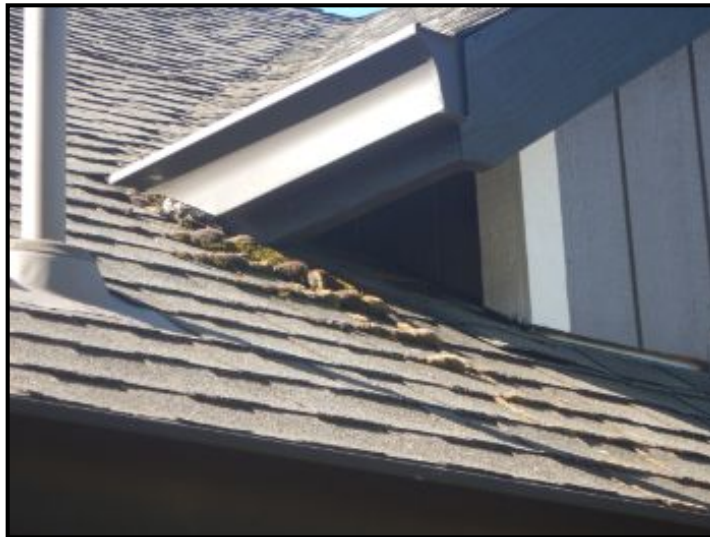
There is moss growth at the roof top. The inspector recommends removing the moss growth at some time in the future and treating the roof to prevent growth. Chemicals for preventing moss growth can be purchased at a local home improvement store. There are companies who will clean the roof and apply a material that will prevent moss growth for a number of years.

Moss growth on roof top.

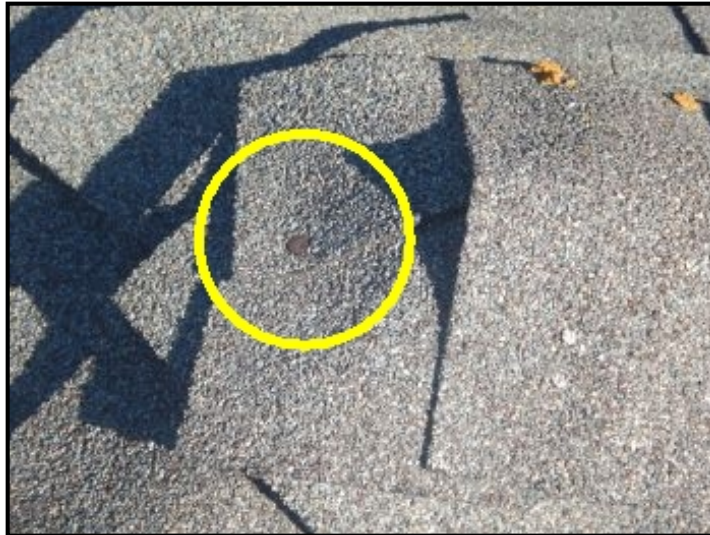
There are exposed fasteners at the ridge shingles. It is recommended to keep these areas properly caulked and sealed as a preventative measure. Contact a qualified roofing contractor for repairs.

Seal fasteners at ridge shingles.

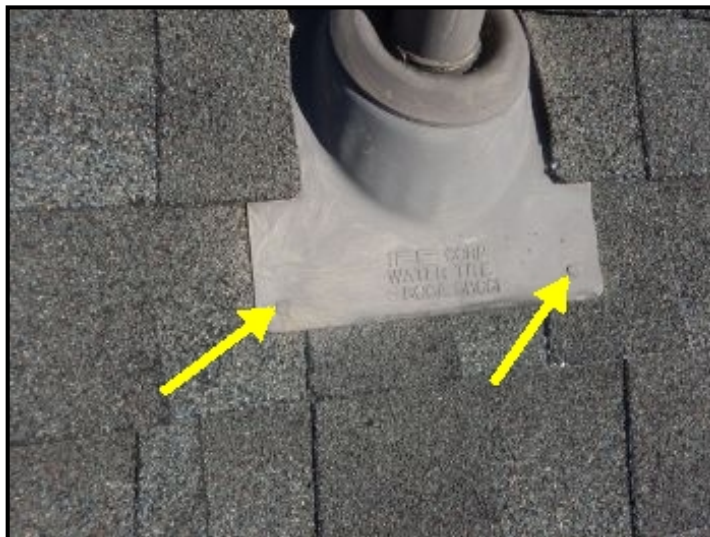
There are some exposed fasteners at the roof top flashings. It is recommended to keep these areas properly caulked and sealed to prevent potential leaking points. Contact a qualified roofing contractor for evaluation/repairs.

Seal exposed fasteners at flashings.

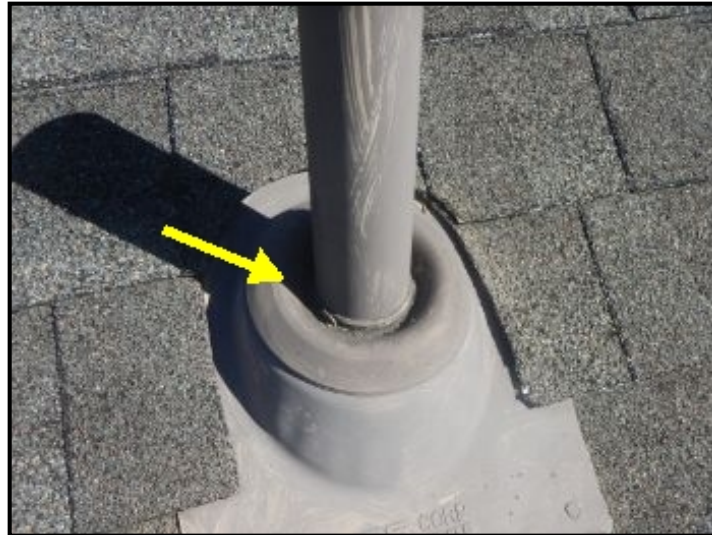
10. Vents/Chimneys/Covers

Some of the plumbing vent storm collars have collapsed which can cause standing water and unnecessary wear to the storm collars. Minor repairs are recommended to properly shed water.

Collapsed storm collar at plumbing vents.

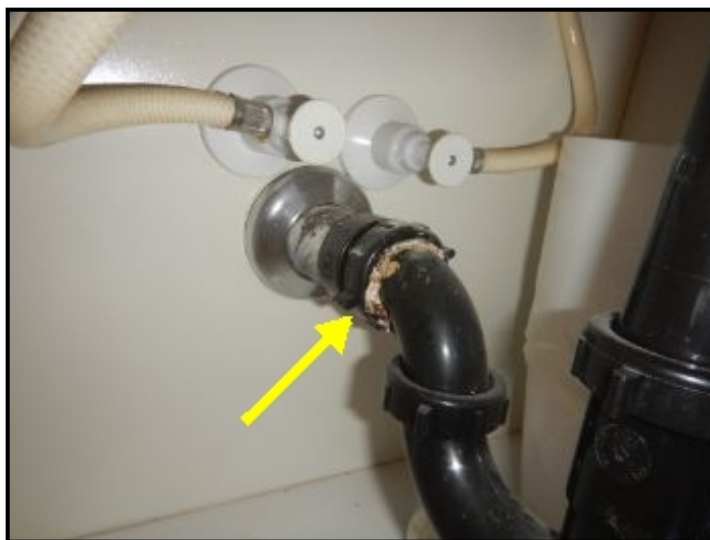
8. Evidence Of Leaks

The inspector has found evidence of a plumbing leak at the hall bathroom sink drain line. We advise the use of a qualified plumbing contractor to make final determination of the cause and to provide estimates for repairs.

Leaking at bathroom sink drain line.

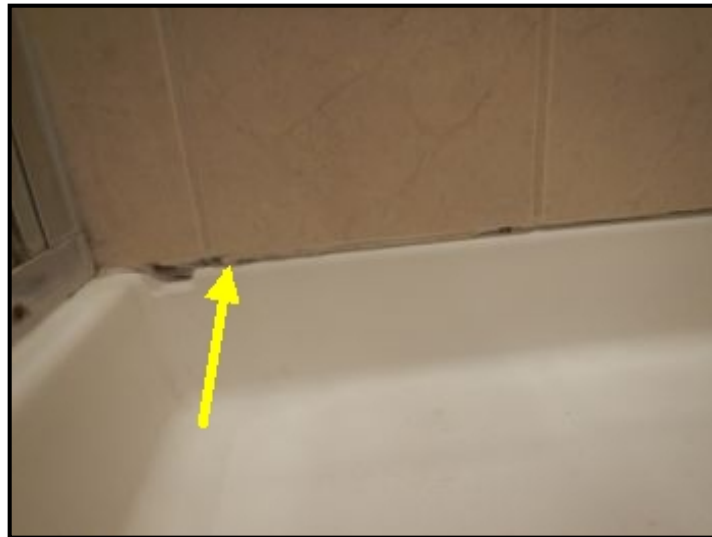
Minor grout voids were noted around the master bathroom shower tile wall. This is a condition that can lead to moisture intrusion and deterioration. Regrouting is recommended. These areas should be inspected and touched up on a regular basis as part of preventative home maintenance

Caulking touch ups needed.

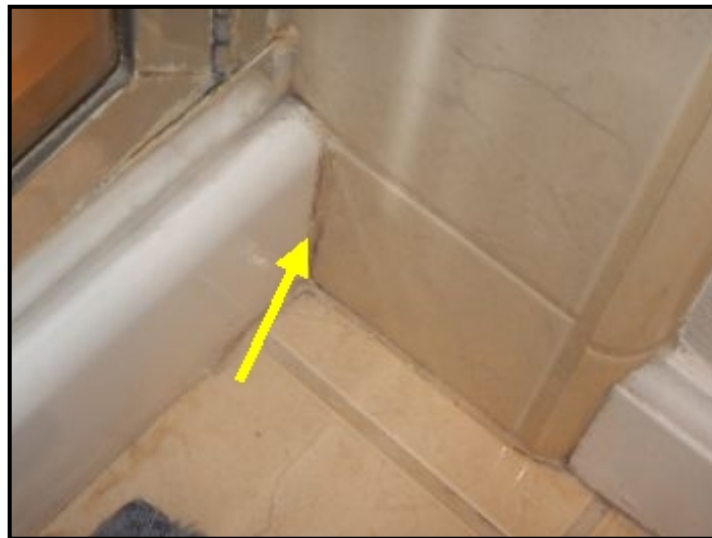
10. Caulking Water Exposed Areas

Minor grout voids were noted at the tile floor to the base of the tub/shower at the master bathroom. it is recommended to keep these areas properly sealed to prevent moisture intrusion and potential damage. These areas should be inspected and touched up on a regular basis as part of preventative home maintenance.

Grout voids at exterior of shower.

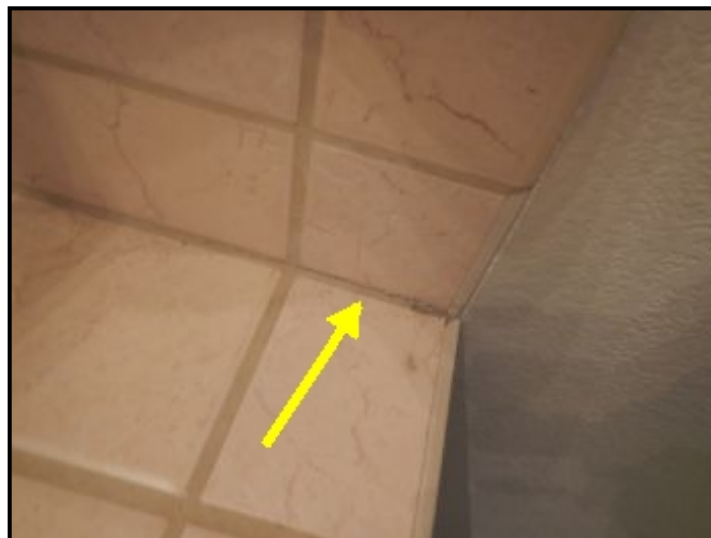
There are caulking/grout voids noted at the hall bathroom counter top. Recommend re-sealing these areas to prevent moisture intrusion.

Cracking grout at bathroom counter top.

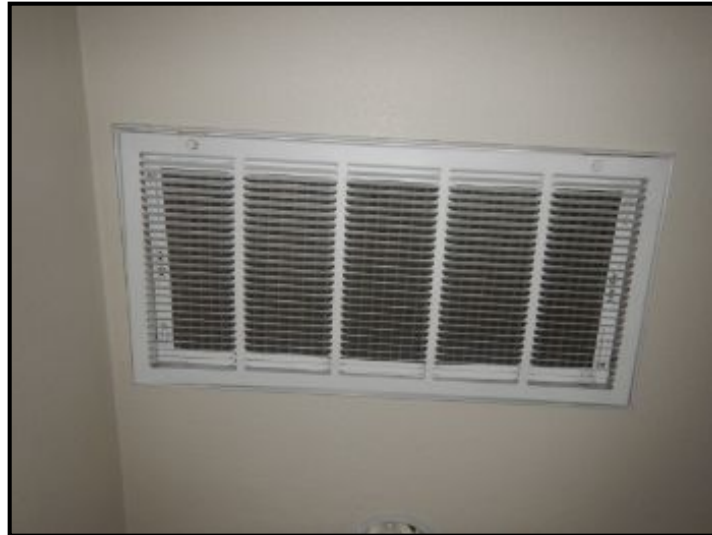
8. Filter Condition

The furnace filter is in need of changing. This can restrict proper airflow and reduce the efficiency of the system. The inspector recommends changing or cleaning the filter on a regular basis as needed.

Replace air return filter.

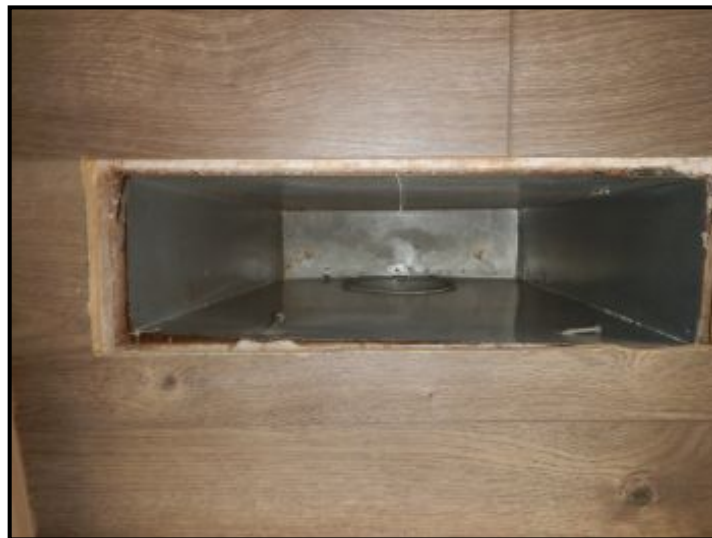
There are gaps around the floor heat registers. It is recommended to seal around the registers with an HVAC foil tape to help with the heating/cooling efficiency of the home.

Recommend taping gaps around heat registers.

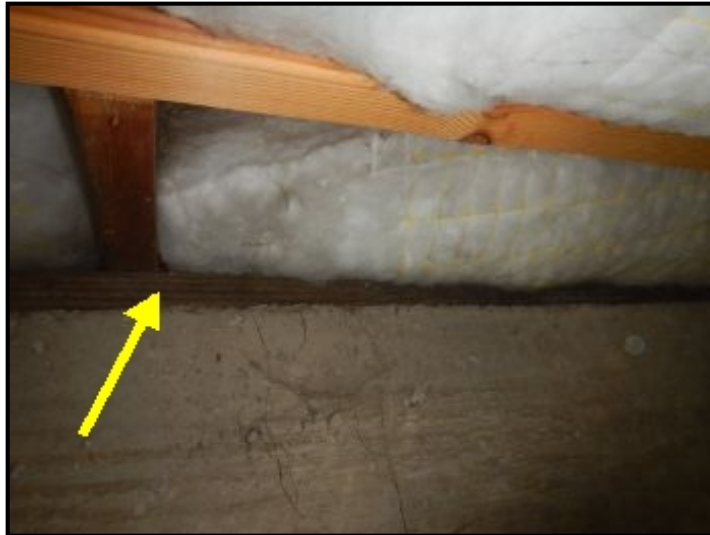
There is insulation that is blocking some of the under house vents. Recommend providing 24 inches of clearance from the vents to increase airflow.

Insulation blocking vents.
