WOOD DESTROYING PESTS AND ORGANISMS INSPECTION REPORT

Building No. 4721	Street Starbuck Ave.	City Santa Rosa	Zip 95409	Date of Inspection 07/10/18	Page 1 of 7
-----------------------------	--------------------------------	---------------------------	---------------------	---------------------------------------	-----------------------

Report # 4721st

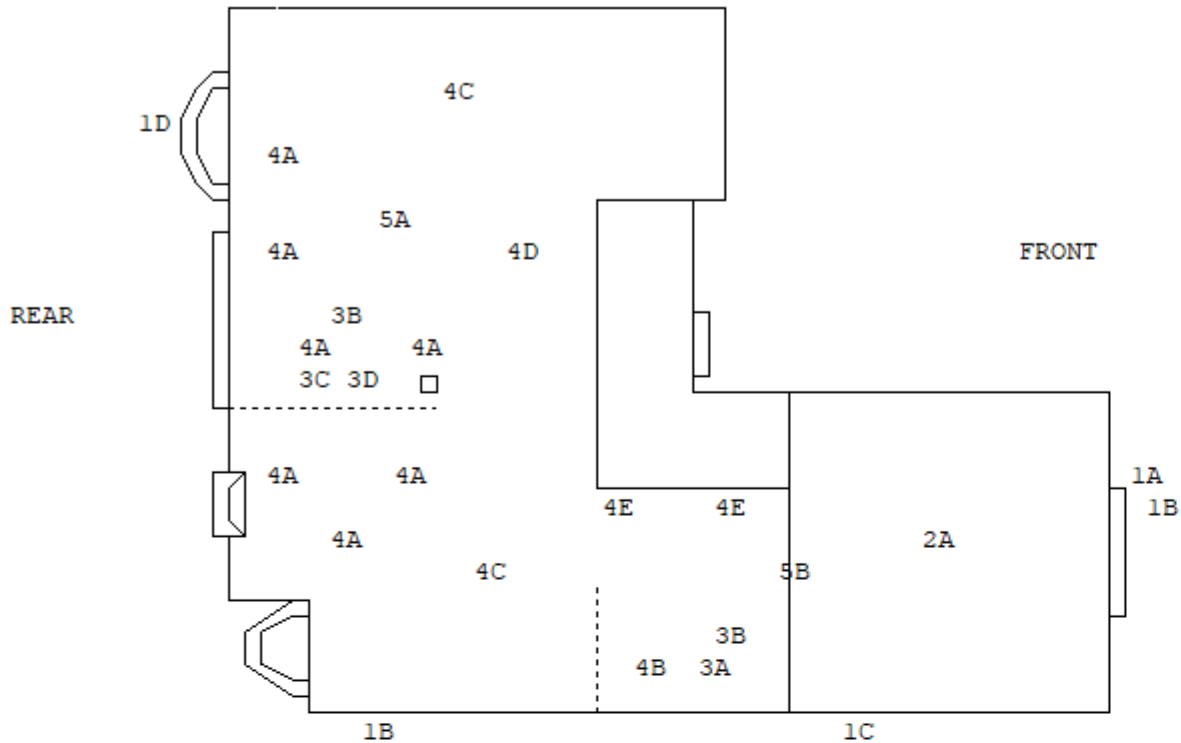
KEY: 1 - Exterior 2 - Garage 3 - Interior 4 - Substructure Area 5 - Attic Spaces
