Gage Inspection Services

Property Inspection Report

226 Alderbrook Dr, Santa Rosa, CA 95405
Inspection prepared for: Brittany/Scott Westerman
Real Estate Agent: Mary Hauffer - Sothebys

Date of Inspection: 8/14/2018 Time: 12:00 PM
Age of Home: 1947 Size: 1770
Order ID: 163

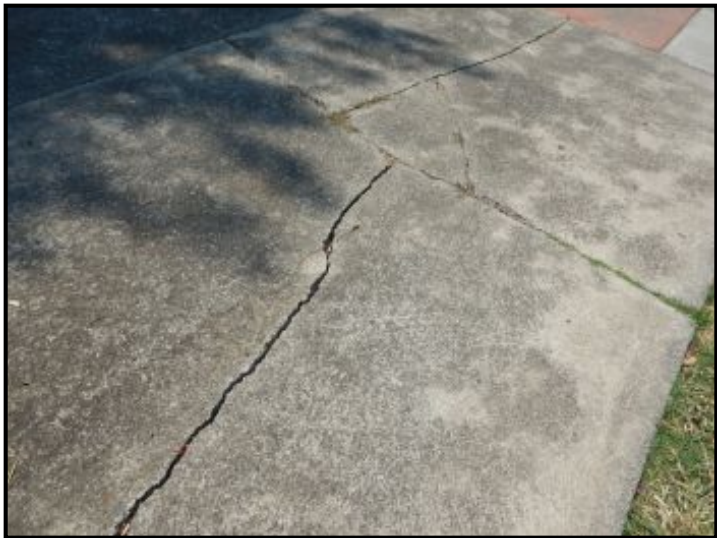
Site concrete and paving		
Page 16 Item: 1	Driveway/Parking	<p>Attention There is cracking at the concrete driveway. Though still functional the concrete areas should be monitored for further distortion and repaired or replaced as necessary to eliminate tripping hazards</p>

<p>Cracking concrete at driveway.</p>		
Page 16 Item: 2	Walkways	<p>Attention There is cracking at the concrete sidewalks. Though still functional the concrete areas should be monitored for further distortion and repaired or replaced as necessary to eliminate tripping hazards. Patching uneven concrete walkways can help prevent potential tripping hazards.</p>

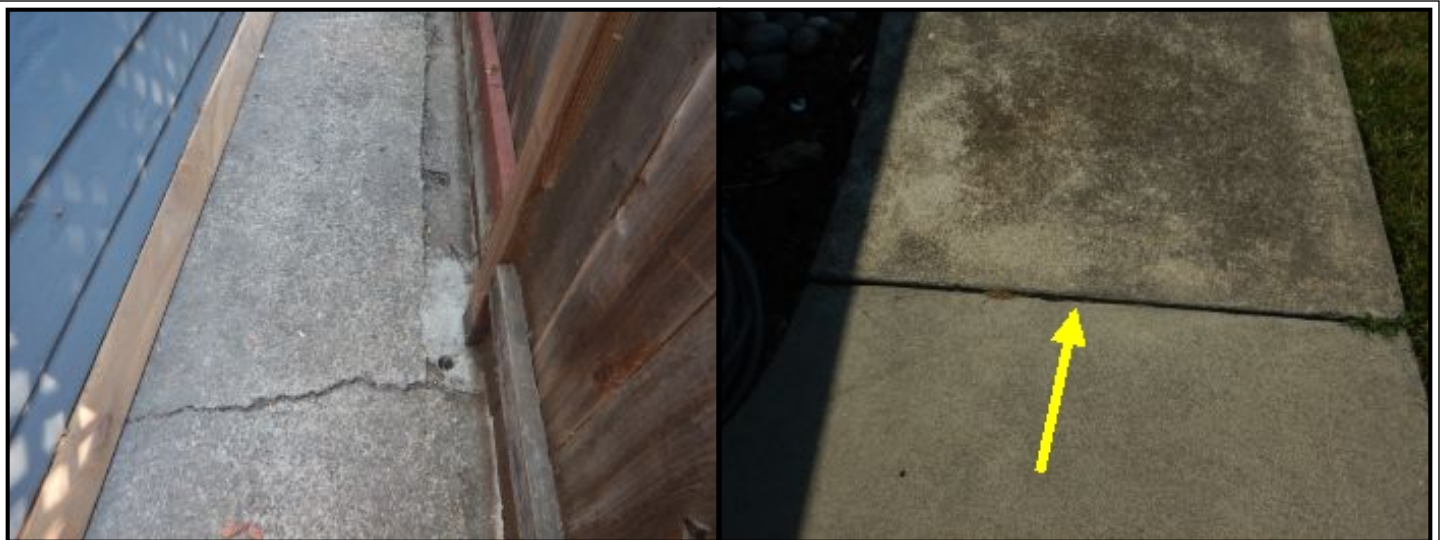
Cracking at concrete walkways.

Uneven concrete walkway.

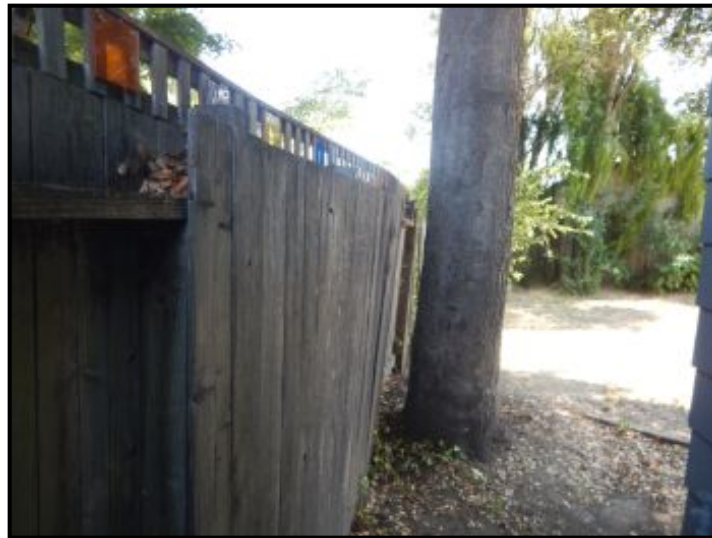
Page 21 Item: 1	Fences	<p>Attention Though upright at the time of the inspection the fencing is leaning at the side of the home. Future repair/replacement may will be needed. Contact the appropriate specialist for evaluation/repairs.</p>
-----------------	--------	--

Leaning fence at left side of home.

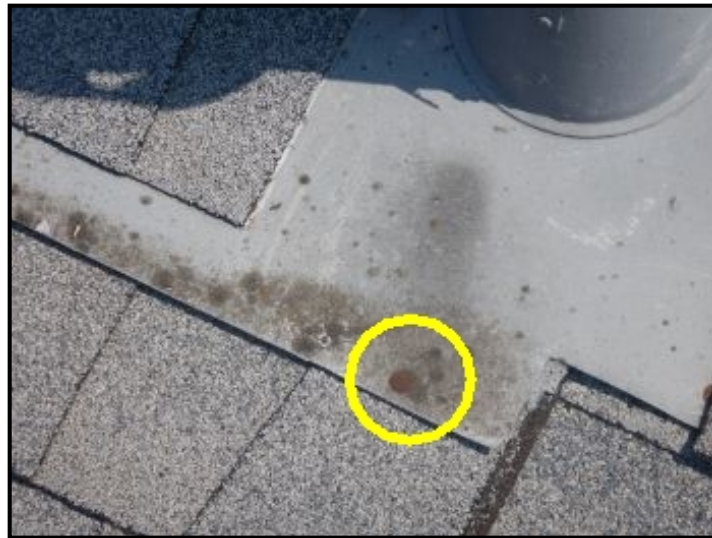
Seal exposed fasteners at roof top flashings.

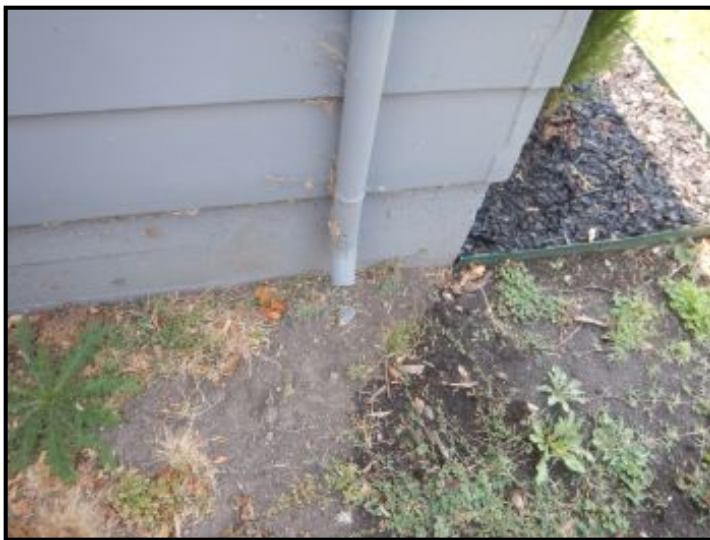
Run downspouts away from the home.

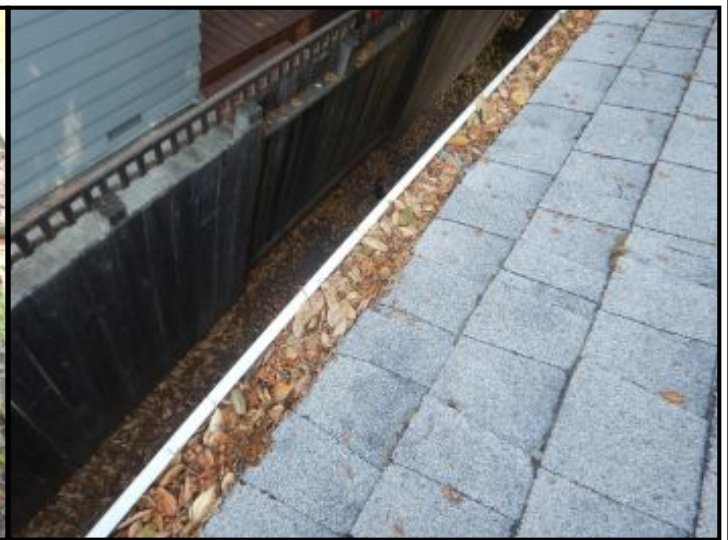
Debris build up in gutters.

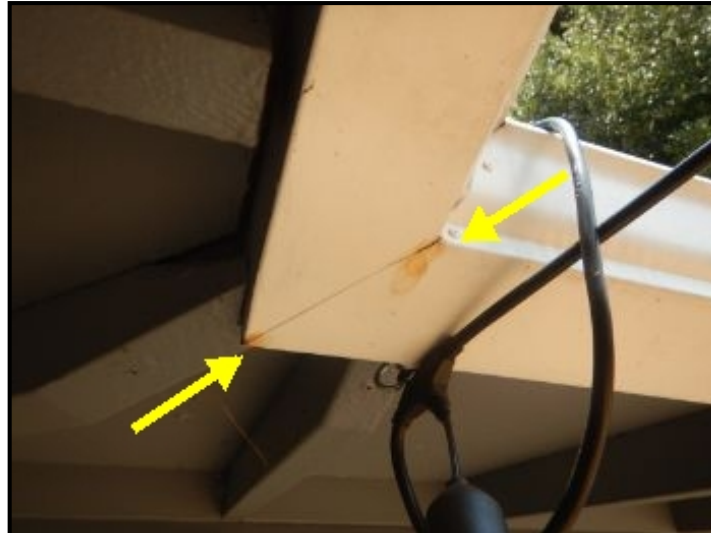
Staining at corner gutter seam.

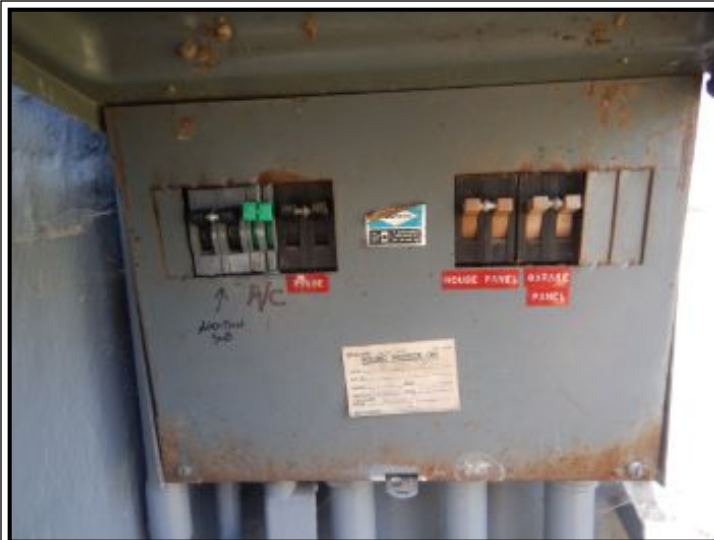
The main electrical panel is a Zinsco brand panel. Several reports of failure over time with this equipment has been report. Failures include excessive corrosion and loose connections at the bus bar. Many times there are poor breaker connections which can lead to arcing or sparking. We suggest consulting with a qualified and licensed electrician on this issue.

Zinsco panel installed.

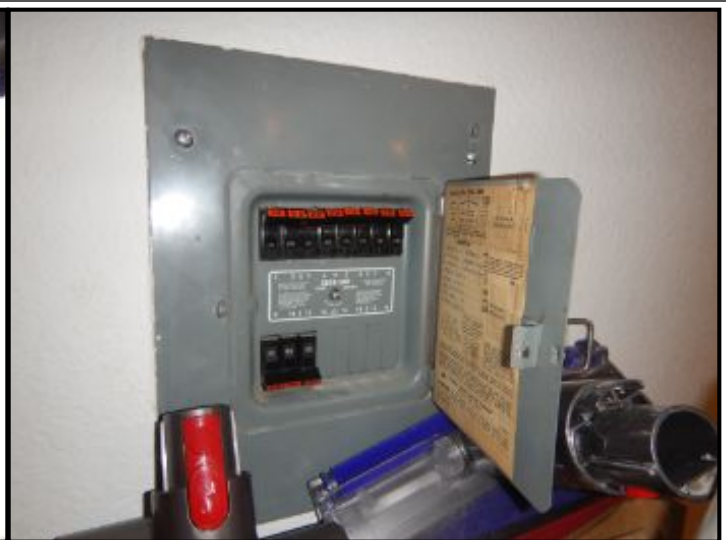
There is a Federal Pacigic Stab Lok brand panel in the garage. Due to the obsolete brand and history of past failures upgrading the panel is recommended. Contact a qualified electrician for evaluation/recommendations.

Federal Pacific panel installed.

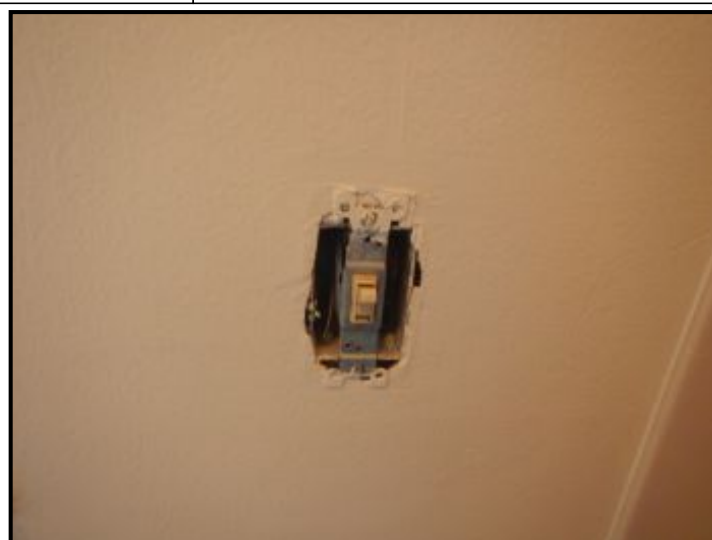
Missing cover plates at various areas.

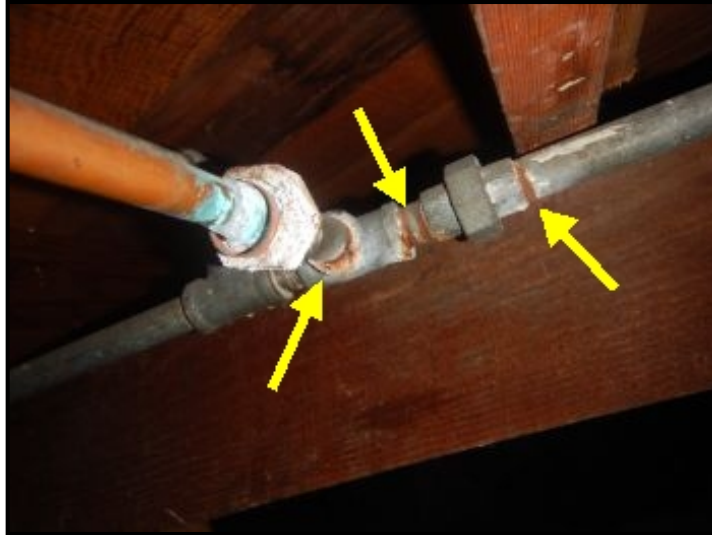
Page 30 Item: 6	Encrustations Evident	<p>Yes Encrustations (visible buildup of deposits) on the exterior of galvanized plumbing is an early indication of a developing deterioration of the pipes. Contact a qualified plumbing contractor for evaluation/recommendations.</p>
-----------------	-----------------------	--

Encrustations at older galvanized plumbing.

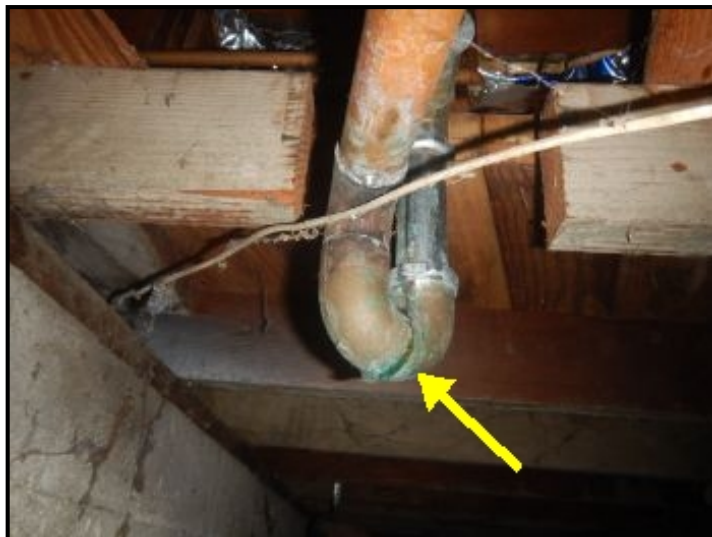
Page 31 Item: 8	Evidence Of Leaks	<p>Yes The inspector has found evidence of a plumbing leak. We advise the use of a qualified plumbing contractor to make final determination of the cause and to provide estimates for repairs. Location of the leak was a drain line in the sub area under the deck.</p>
-----------------	-------------------	---

Leaking at shower drain line.

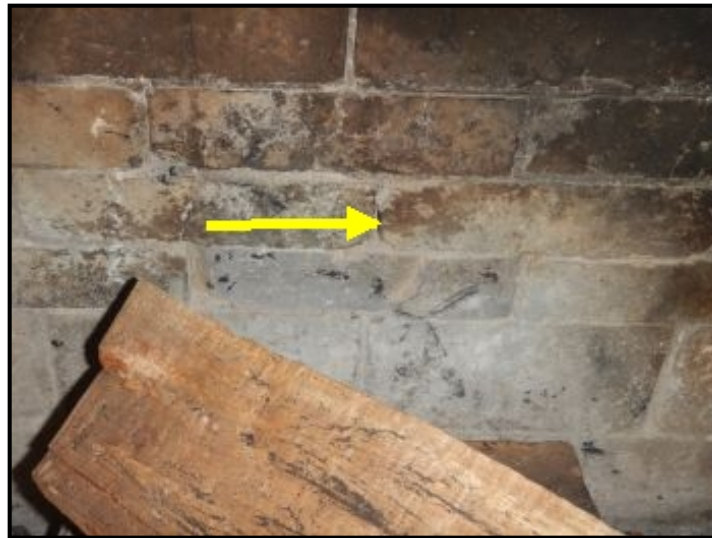
Page 35 Item: 1	Solid Fuel/Gas Logs/Gas Appliances	<p>Maintenance There is deterioration to the mortar joints at the interior of the fireplace. Before use we recommend contacting a qualified chimney specialist for evaluation/repairs.</p>
-----------------	------------------------------------	--

Deterioration of mortar joints at interior of fireplace.

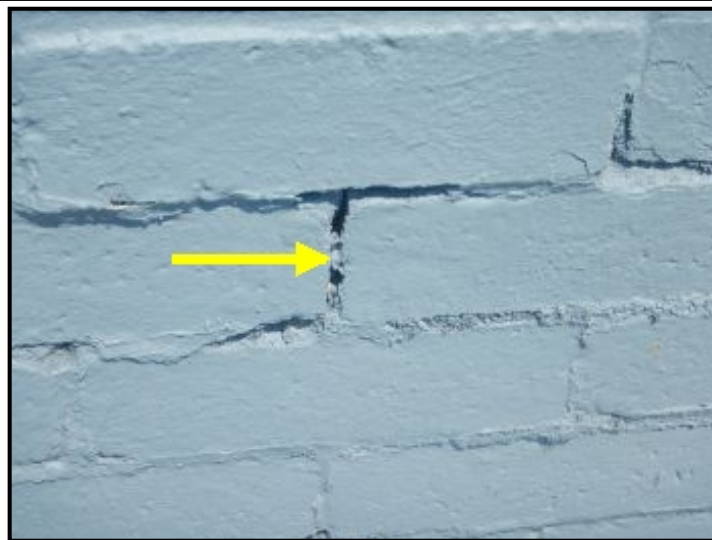
Page 35 Item: 3

There is cracking at the mortar joints of the chimney at the roof top. Recommend contacting the appropriate specialist for evaluation/recommendations.

Deterioration of mortar joints at chimney.

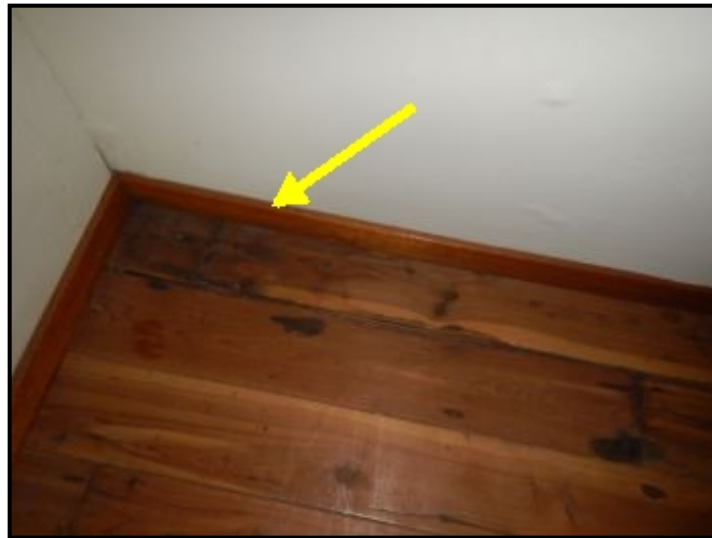
Moisture staining was noted in the master bathroom closet which is behind the shower area. The staining appears older and no major adverse conditions were noted. We recommend monitoring this area to determine if repairs are needed.

Moisture stains noted in bedroom closet.

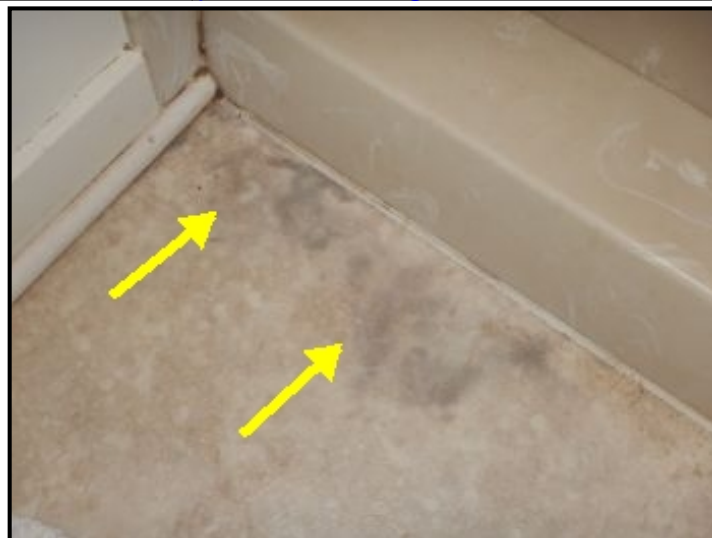
Page 42 Item: 2	Floors	<p>Attention There is moisture staining to the vinyl flooring in the master bathroom indicating past moisture intrusion. When tested with a moisture meter high levels of moisture was noted. No apparent damage was obvious. Measures should be taken to keeping the floors properly caulked and sealed to prevent potential damage.</p>
-----------------	--------	---

Suspect moisture intrusion under bathroom floor cover.

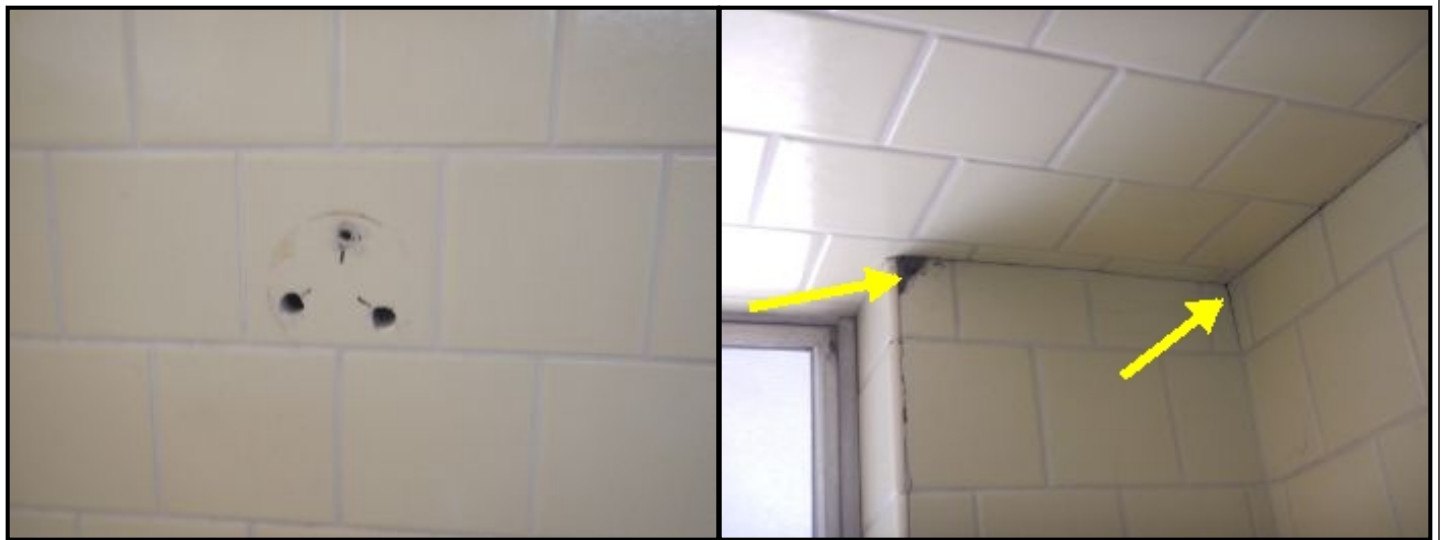
Page 43 Item: 9	Water Resistant Wall Cover	<p>Maintenance There are grout voids and cracked tiles around the hallway bathroom shower wall and caulking voids around the master bathroom shower wall. This is a condition that can allow for potential moisture intrusion. Repairs are advised to prevent potential moisture intrusion.</p>
-----------------	----------------------------	---

Holes at tile shower wall.

Grout voids/damaged tiles at shower wall.

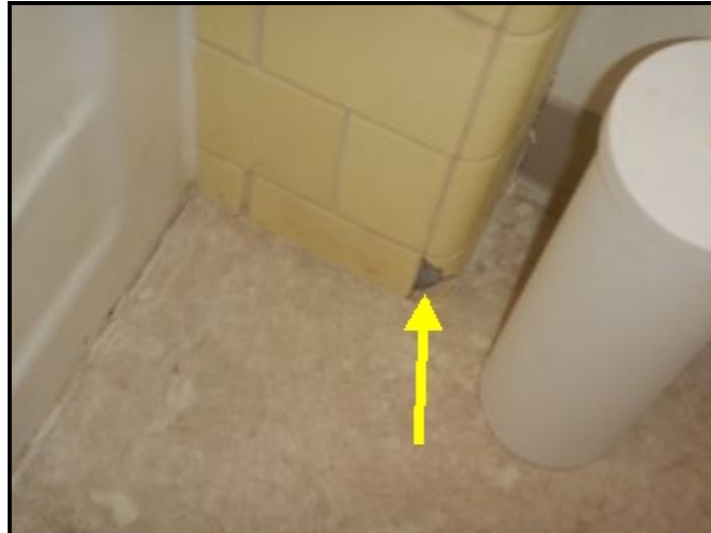
Damaged tile at shower wall.

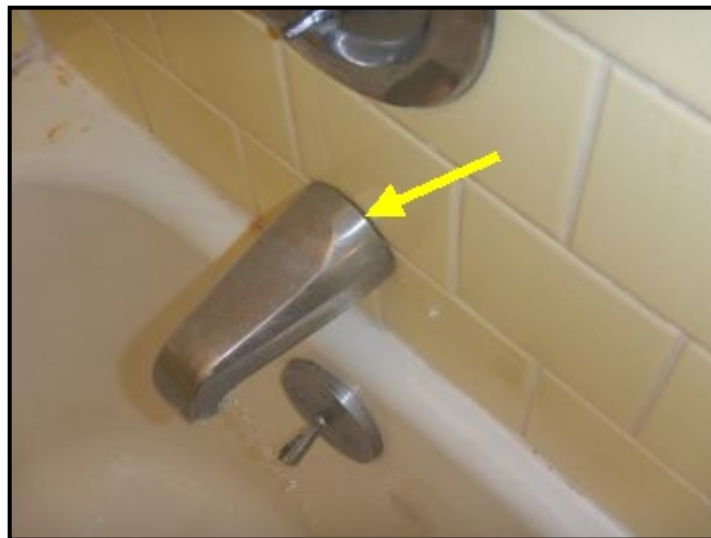
Page 43 Item: 10

There are gaps between the tub spout and shower walls exposing areas of potential moisture intrusion. it is recommended to caulk and seal these areas as a preventative measure. These areas should be inspected and touched up on a regular basis as part of preventative home maintenance.

Caulk and seal around tub spout.

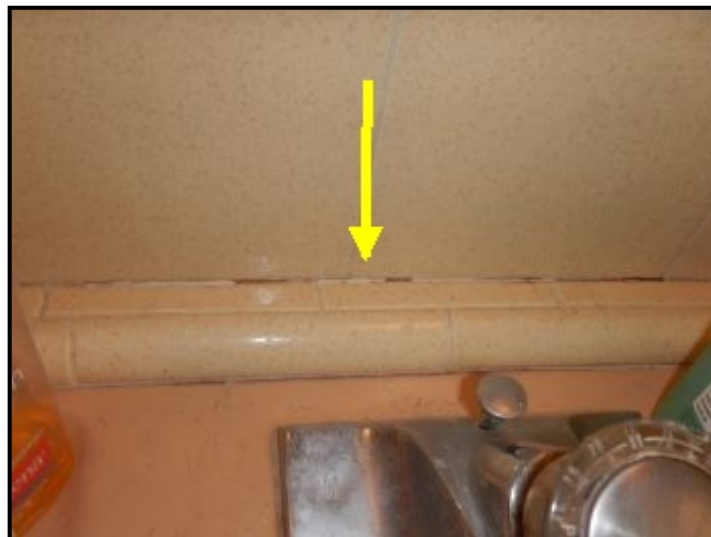
Page 45 Item: 20

There are caulking/grout voids noted at the master bathroom counter top. Recommend re-sealing these areas to prevent moisture intrusion.

Grout voids at bathroom counter top.

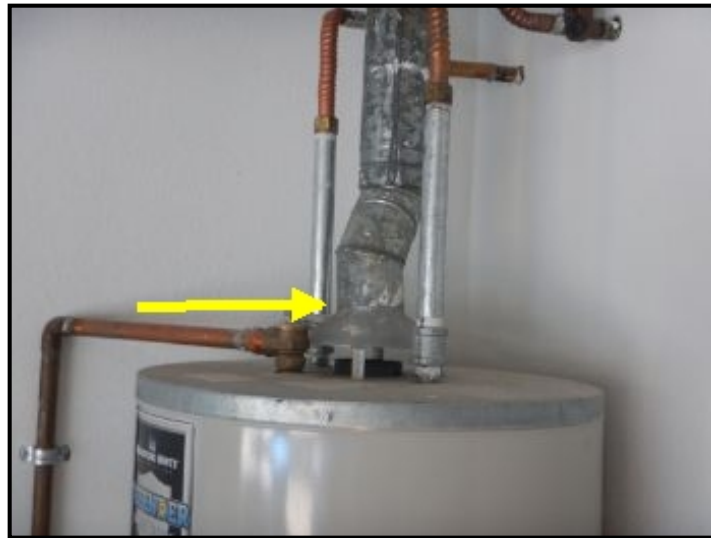
There are no screws securing the water heater flue to the flue hood. Industry standard require three screws on the water heater flue to secure the flue hood correctly. Contact a qualified plumbing contractor for evaluation.

No screws installed at flue/flue hood.

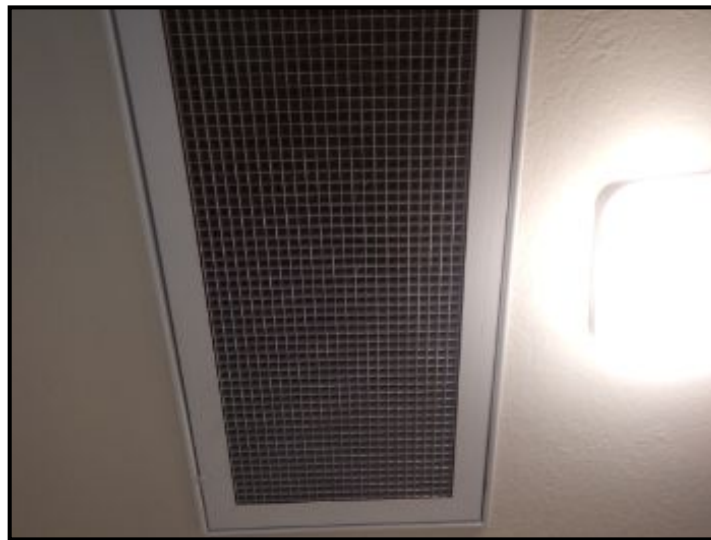
The furnace filter is in need of changing. This can restrict proper airflow and reduce the efficiency of the system. The inspector recommends changing or cleaning the filter on a regular basis as needed.

Replace air return filter.

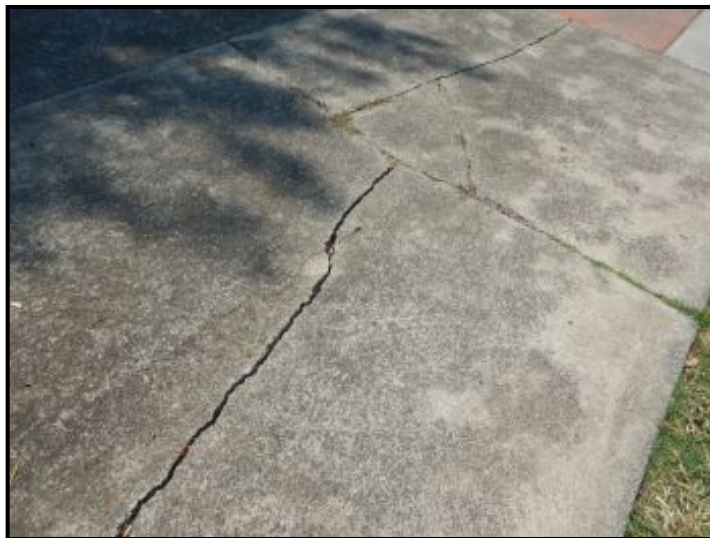
There is cracking at the concrete driveway. Though still functional the concrete areas should be monitored for further distortion and repaired or replaced as necessary to eliminate tripping hazards

Cracking concrete at driveway.

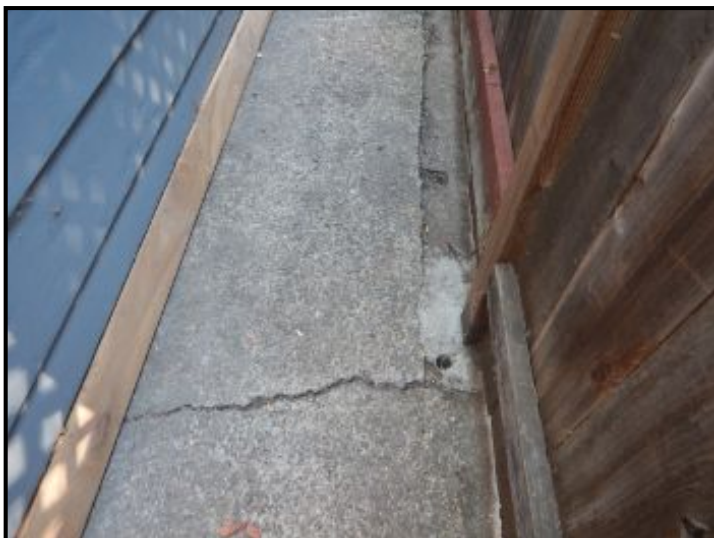
There is cracking at the concrete sidewalks. Though still functional the concrete areas should be monitored for further distortion and repaired or replaced as necessary to eliminate tripping hazards. Patching uneven concrete walkways can help prevent potential tripping hazards.

Cracking at concrete walkways.

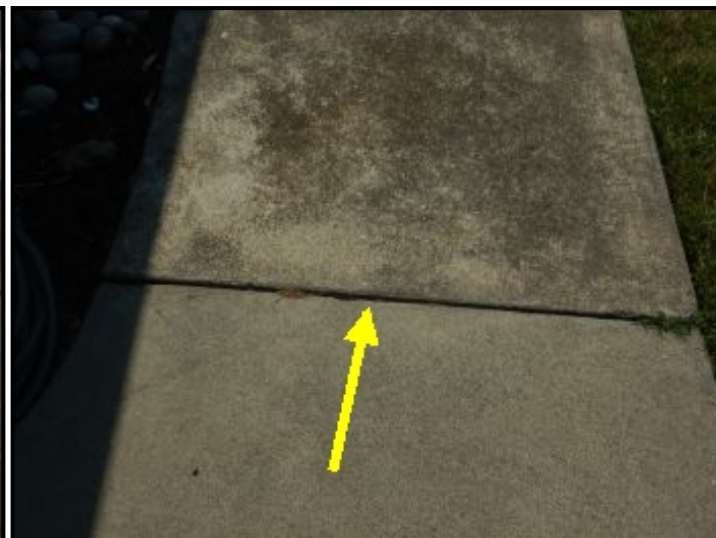
Uneven concrete walkway.

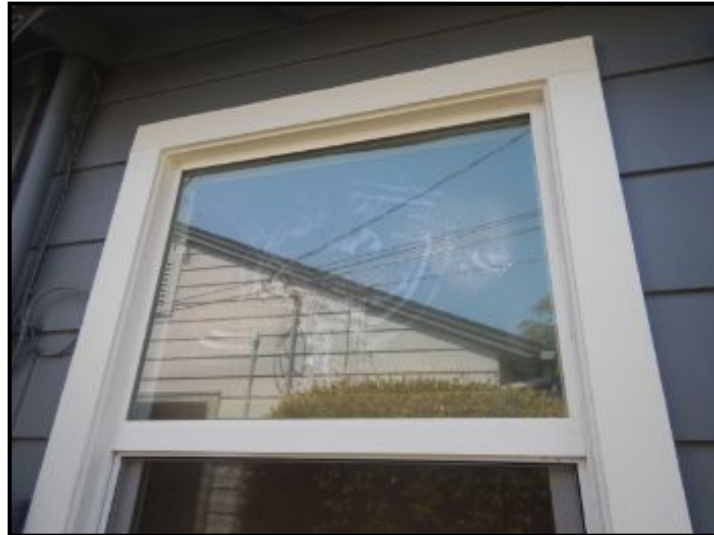
There is a double pane insulating window that have lost the vacuum seal between the panes of glass. The location is in the dining area. The conditions is identified by signs of fogging, a halo effect or condensation build up between the panes of glass. Recommend contacting a glass company for complete window evaluation and estimates for replacement. The deficiency on any other windows is sometimes only visible under certain climatic conditions. There are multiple older single pane windows in the home.

Lost seal at window.

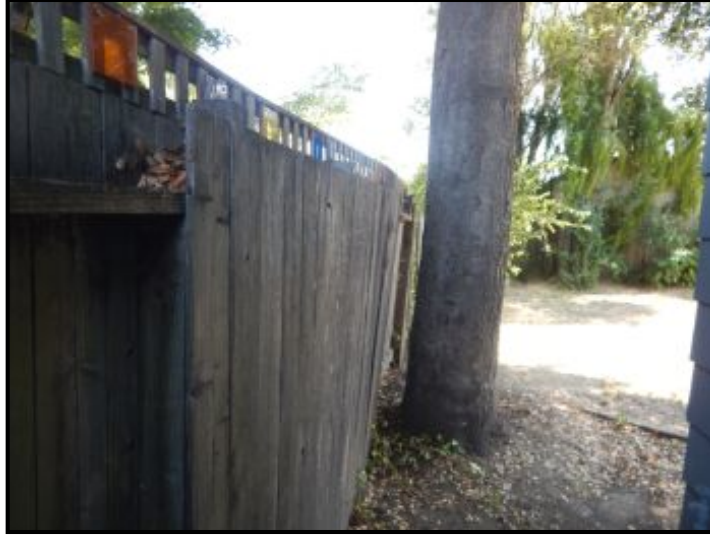
Though upright at the time of the inspection the fencing is leaning at the side of the home. Future repair/replacement may will be needed. Contact the appropriate specialist for evaluation/repairs.

Leaning fence at left side of home.

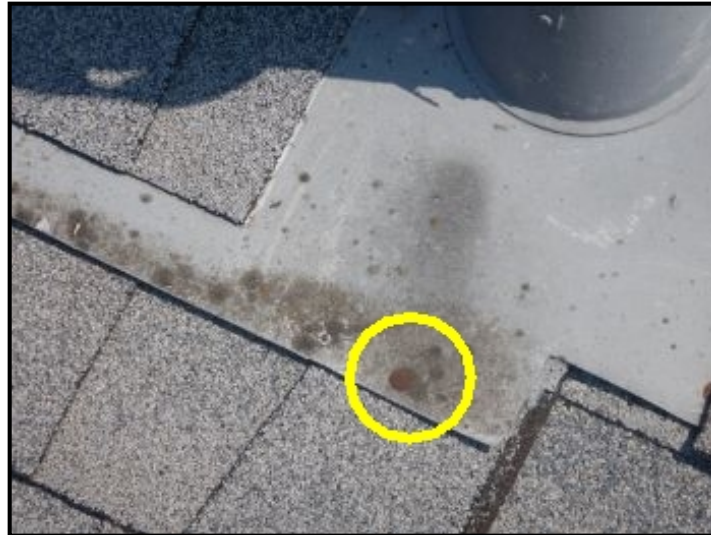
There are some exposed fasteners at the roof top flashings. It is recommended to keep these areas properly caulked and sealed to prevent potential leaking points. Contact a qualified roofing contractor for evaluation/repairs.

Seal exposed fasteners at roof top flashings.

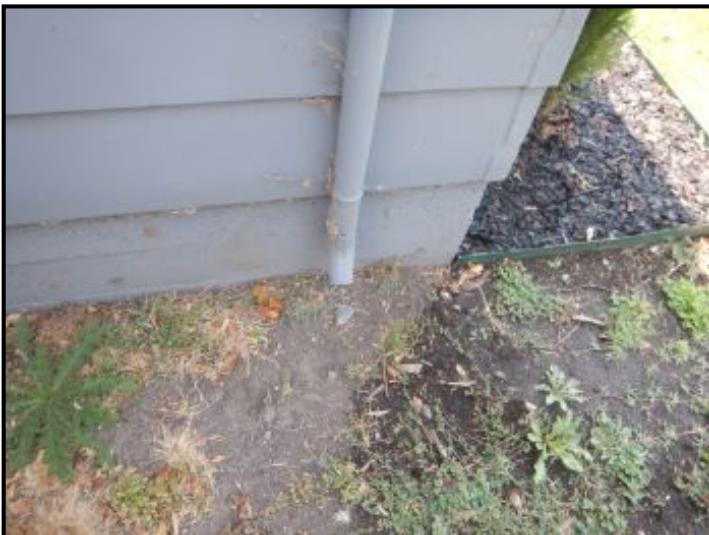
There are downspout that are draining at the foundation perimeter which can allow for water penetration into the crawl space. Recommend installing drain pipe extender or splash blocks to help divert water away from the structure.

Run downspouts away from the home.

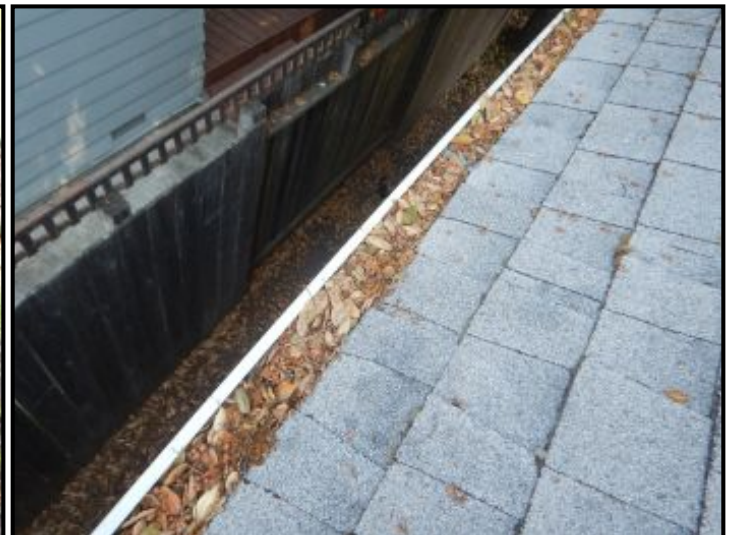
There is debris build up in the gutters that should be removed. Debris can clog the gutters, down spouts and drain system if not cleaned out. cleaning the gutters on an annual basis is recommended for proper care and maintenance of the gutter system.

Debris build up in gutters.

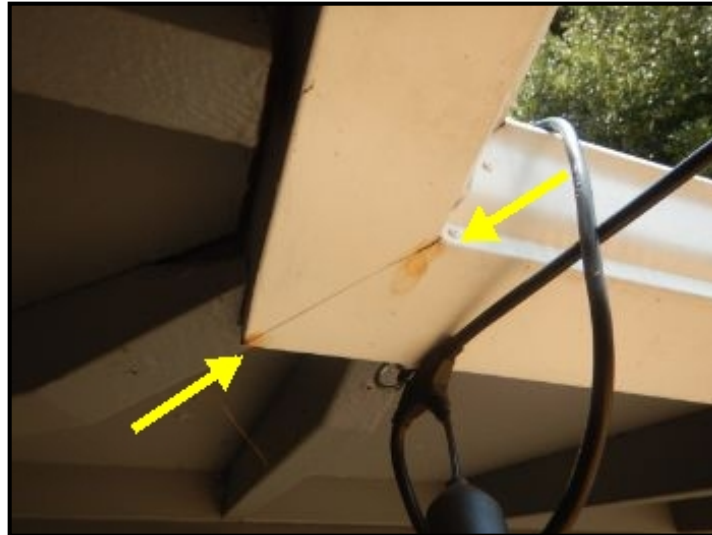
There is moisture staining at the gutter seam at the rear deck indicating leaking . It is recommended to caulk and seal the interior seams as needed to properly protect the structure and maintain intended drainage.

Staining at corner gutter seam.

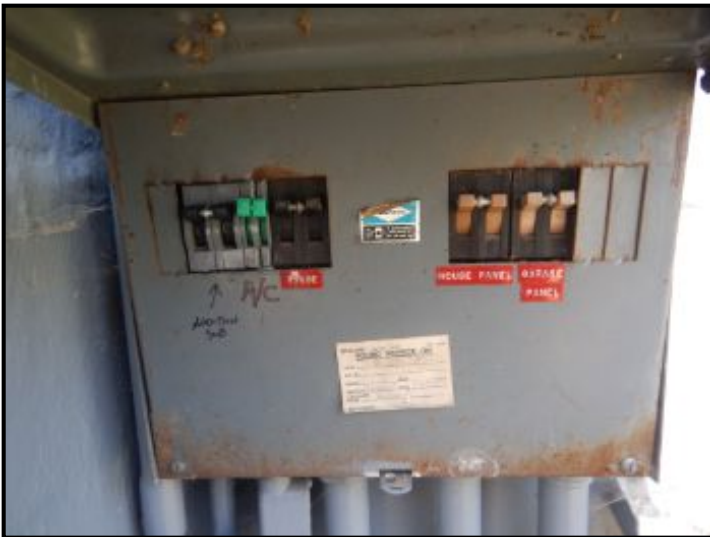
The main electrical panel is a Zinsco brand panel. Several reports of failure over time with this equipment has been report. Failures include excessive corrosion and loose connections at the bus bar. Many times there are poor breaker connections which can lead to arcing or sparking. We suggest consulting with a qualified and licensed electrician on this issue.

Zinsco panel installed.

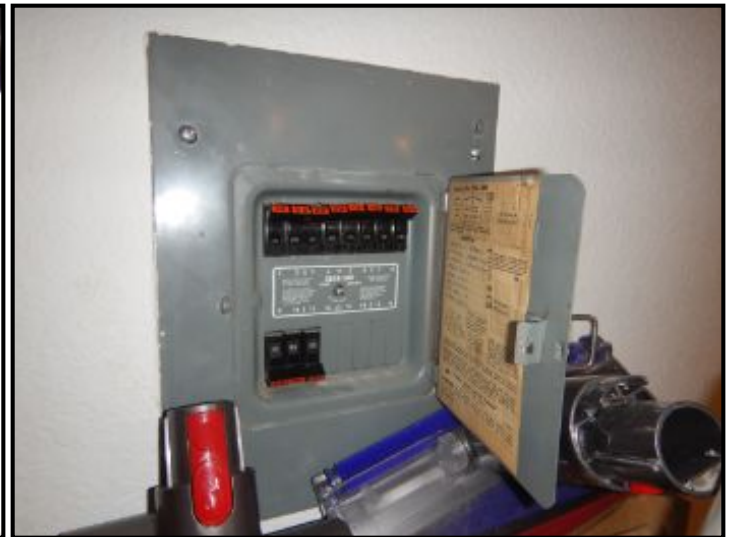
There is a Federal Pacific Stab Lok brand panel in the garage. Due to the obsolete brand and history of past failures upgrading the panel is recommended. Contact a qualified electrician for evaluation/recommendations.

Federal Pacific panel installed.

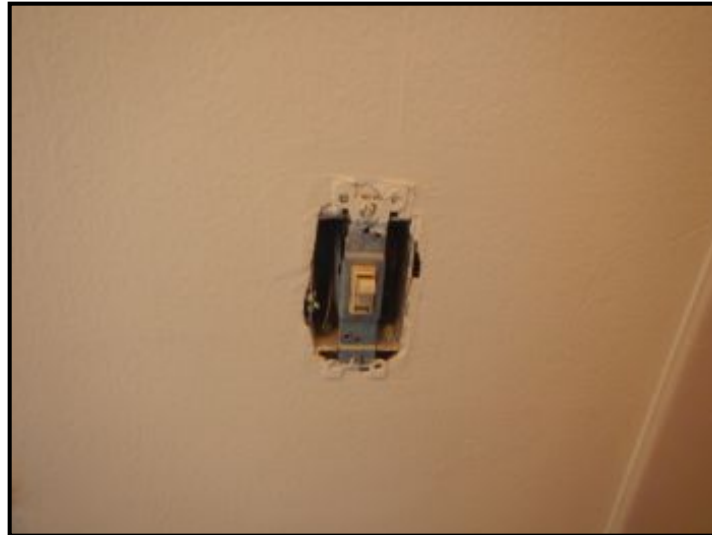
All damaged or missing cover plates should be replaced with new cover plates to restore proper function and reduce the risk of electrical shorts and hazardous shocks. There are various missing cover plates in the living room and master bedroom/bathroom.

Missing cover plates at various areas.

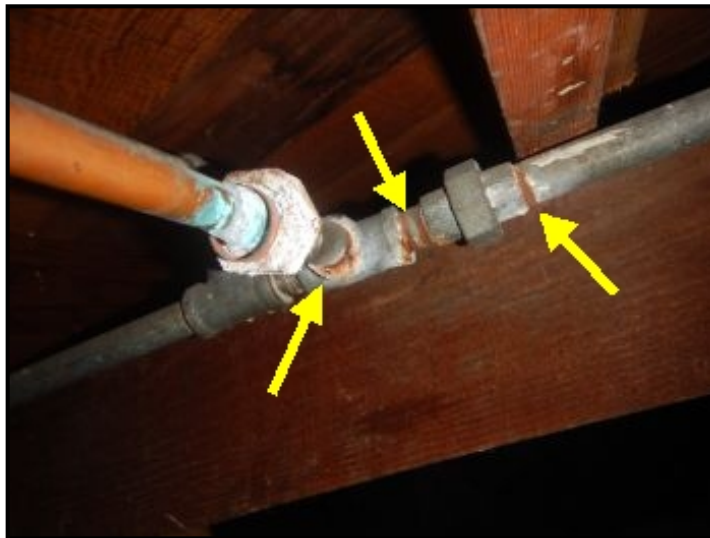
Encrustations (visible buildup of deposits) on the exterior of galvanized plumbing is an early indication of a developing deterioration of the pipes. Contact a qualified plumbing contractor for evaluation/recommendations.

Encrustations at older galvanized plumbing.

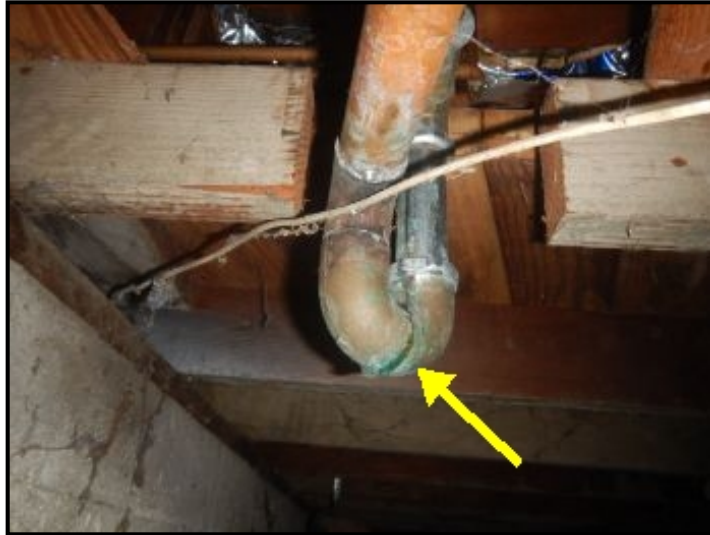
The inspector has found evidence of a plumbing leak. We advise the use of a qualified plumbing contractor to make final determination of the cause and to provide estimates for repairs. Location of the leak was a drain line in the sub area under the deck.

Leaking at shower drain line.

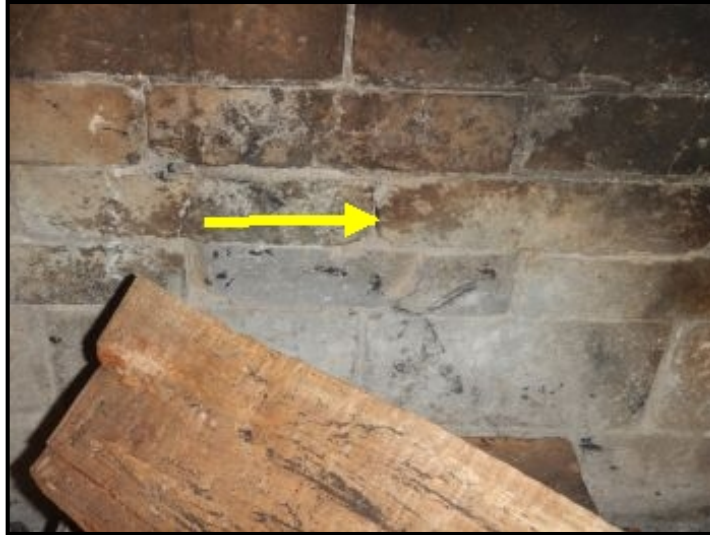
There is deterioration to the mortar joints at the interior of the fireplace. Before use we recommend contacting a qualified chimney specialist for evaluation/repairs.

Deterioration of mortar joints at interior of fireplace.

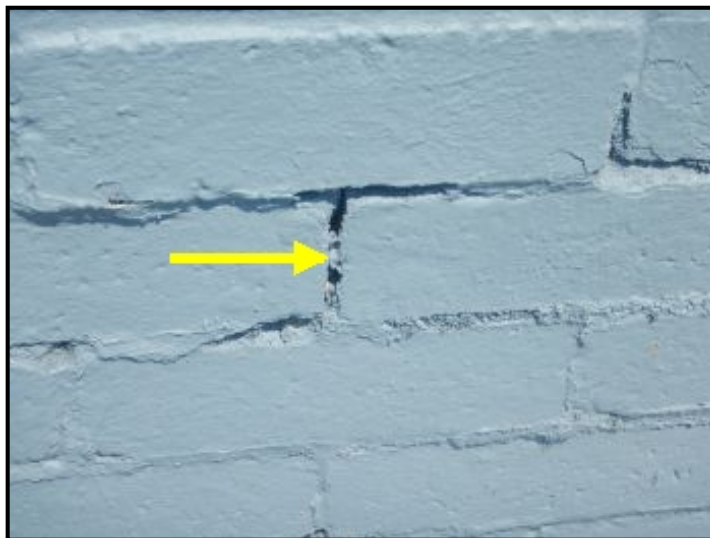
3. Exterior Chimney Condition

There is cracking at the mortar joints of the chimney at the roof top. Recommend contacting the appropriate specialist for evaluation/recommendations.

Deterioration of mortar joints at chimney.

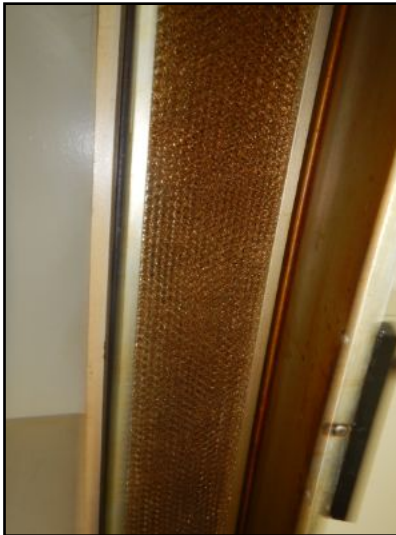
The grease filter(s) on the exhaust fan needs to be replaced or cleaned. This should be done on a regular basis as part of preventative home maintenance.

Clean/replace stove top filter.

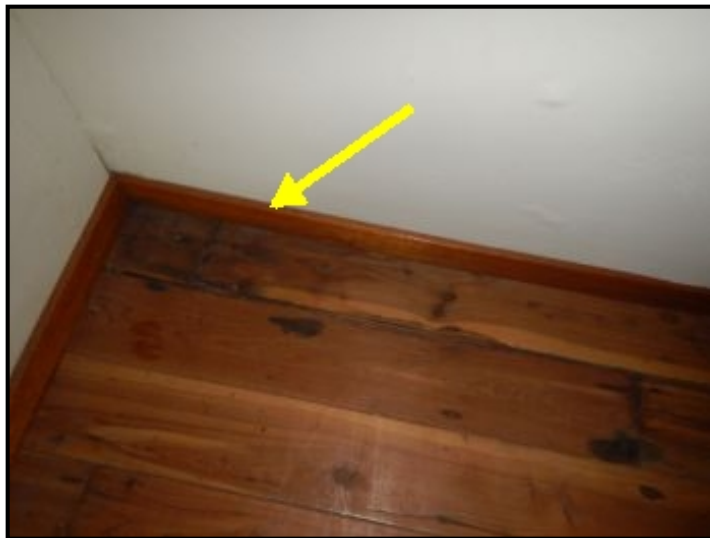
Moisture staining was noted in the master bathroom closet which is behind the shower area. The staining appears older and no major adverse conditions were noted. We recommend monitoring this area to determine if repairs are needed.

Moisture stains noted in bedroom closet.

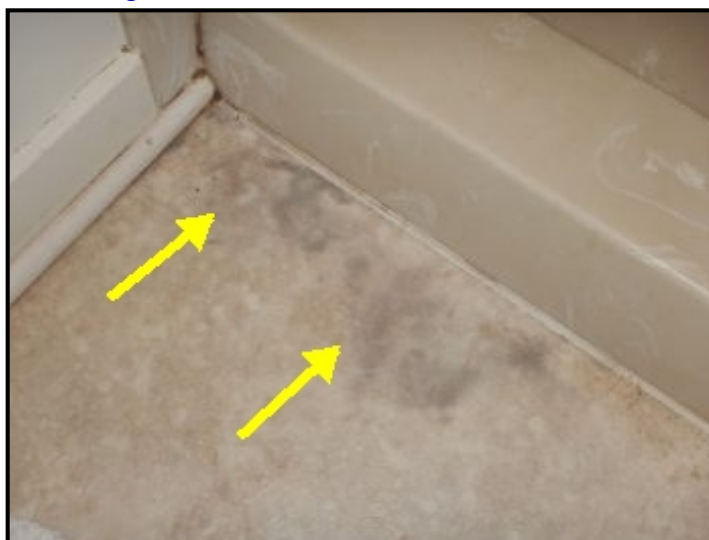
There is moisture staining to the vinyl flooring in the master bathroom indicating past moisture intrusion. When tested with a moisture meter high levels of moisture was noted. No apparent damage was obvious. Measures should be taken to keeping the floors properly caulked and sealed to prevent potential damage.

Suspect moisture intrusion under bathroom floor cover.

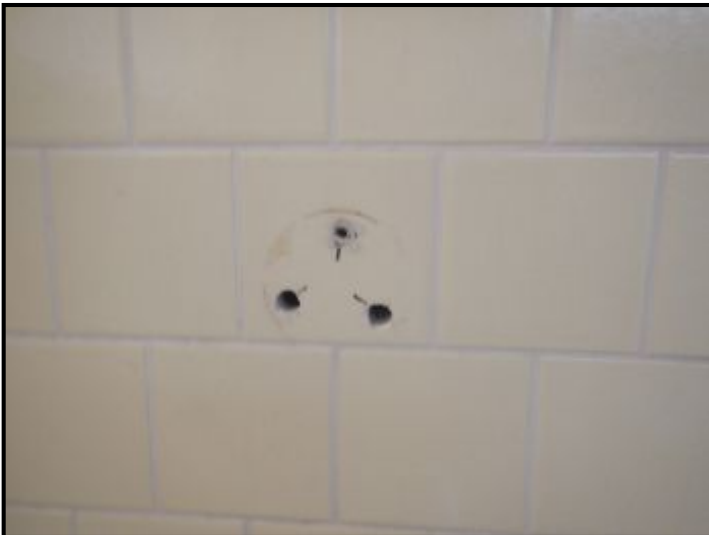
There are grout voids and cracked tiles around the hallway bathroom shower wall and caulking voids around the master bathroom shower wall. This is a condition that can allow for potential moisture intrusion. Repairs are advised to prevent potential moisture intrusion.

Holes at tile shower wall.

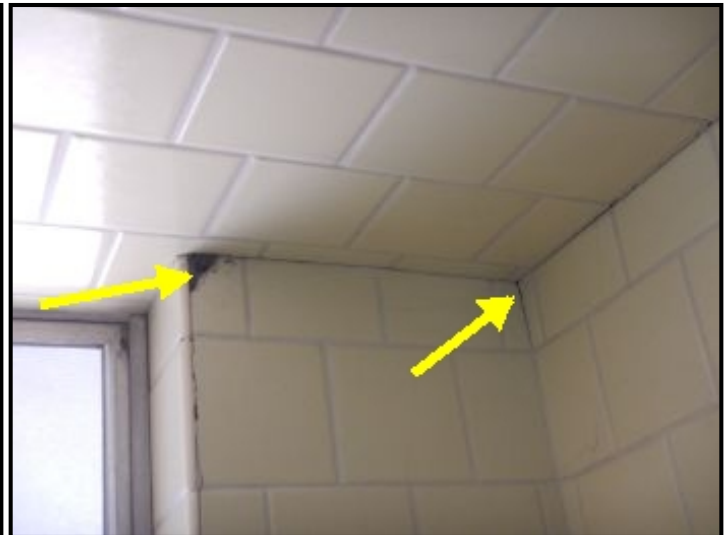
Grout voids/damaged tiles at shower wall.

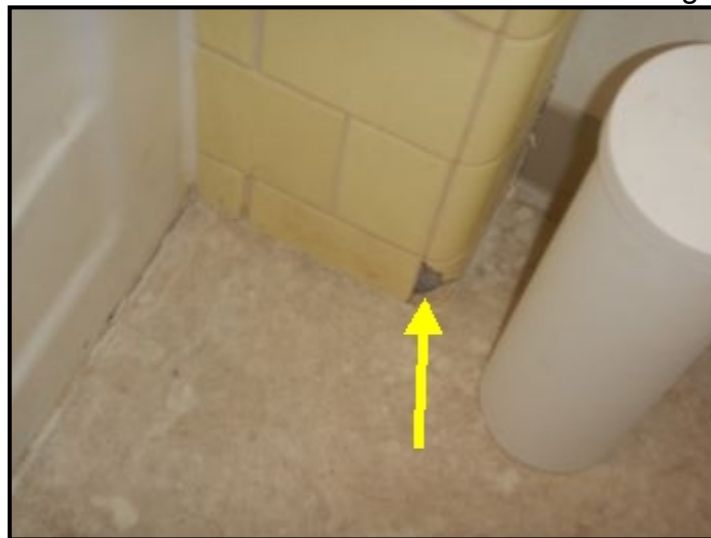
Damaged tile at shower wall.

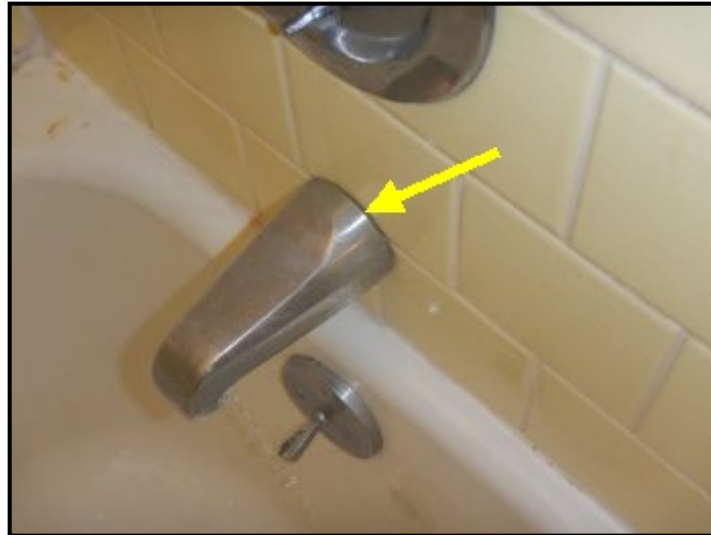
10. Caulking Water Exposed Areas

There are gaps between the tub spout and shower walls exposing areas of potential moisture intrusion. It is recommended to caulk and seal these areas as a preventative measure. These areas should be inspected and touched up on a regular basis as part of preventative home maintenance.

Caulk and seal around tub spout.

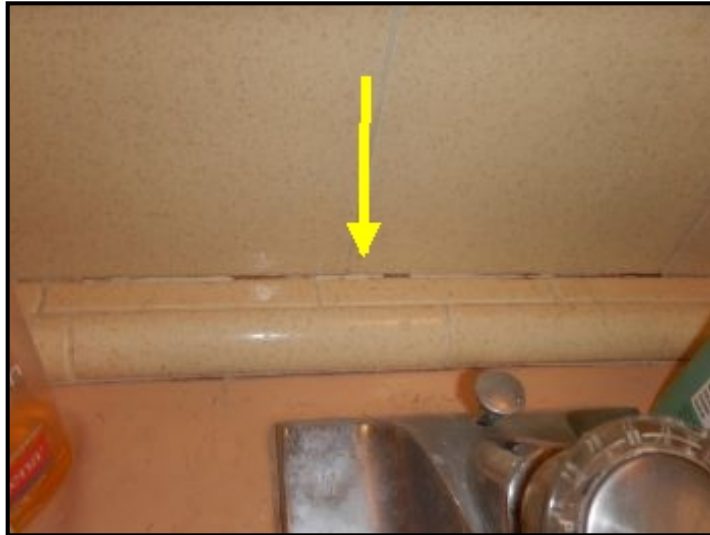
There are caulking/grout voids noted at the master bathroom counter top. Recommend re-sealing these areas to prevent moisture intrusion.

Grout voids at bathroom counter top.

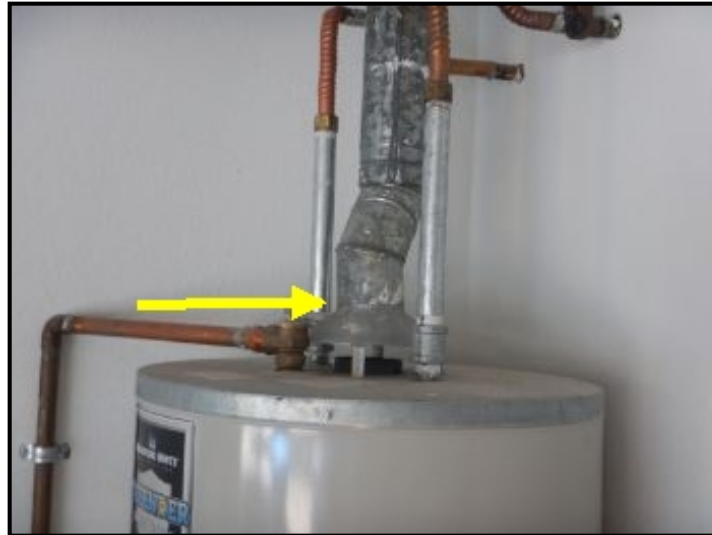
There are no screws securing the water heater flue to the flue hood. Industry standard require three screws on the water heater flue to secure the flue hood correctly. Contact a qualified plumbing contractor for evaluation.

No screws installed at flue/flue hood.

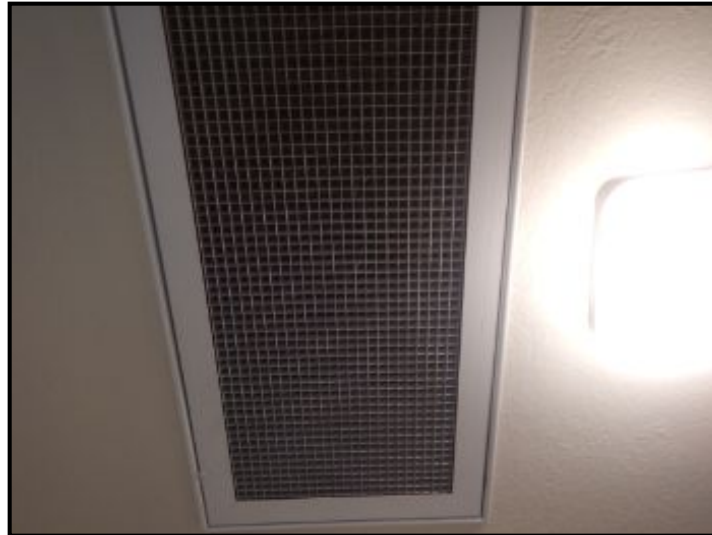
The furnace filter is in need of changing. This can restrict proper airflow and reduce the efficiency of the system. The inspector recommends changing or cleaning the filter on a regular basis as needed.

Replace air return filter.
