Gage Inspection Services Property Inspection Report

546 Aslan Lair Ct, Santa Rosa, CA 95404 Inspection prepared for: Dauksts Valdis Real Estate Agent: Mary Haufler - Sothebys

Date of Inspection: 9/27/2018 Time: 9:00 AM Order ID: 196

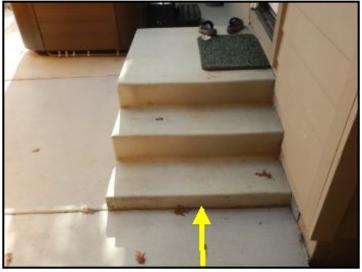
Site concrete and	Site concrete and paving		
Page 10 Item: 3	Steps	Attention Typically the maximum difference in riser height or tread depth for any stairway is 3/8". Current construction standards require that risers not exceed 7/34 inches in height and that tread depth be no less than 10". The current steps could cause a potential tripping hazard at the left side of the home. Repairs are advised as a safety consideration.

Inconsistent riser height at steps.

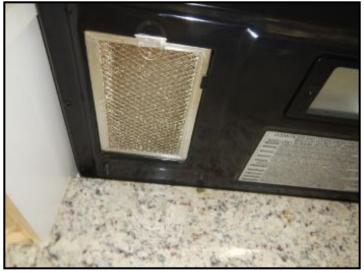
Clean stove top exhaust filters.

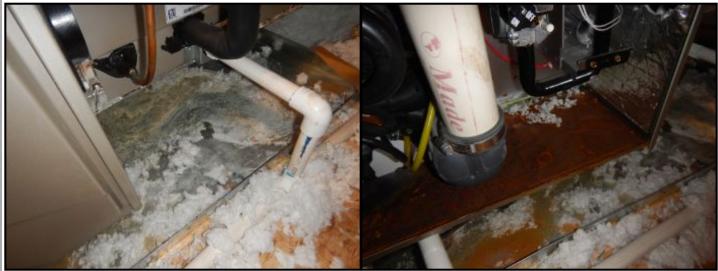
Page 36 Item: 2LocationThere is moisture staining at the interior of the furnace cabinet as well as the drip pan indicating a past moisture issue. The furnace was tested at the time of the inspection and no current active leak was noted. Recommend monitoring this area.			
	Page 36 Item: 2		as well as the drip pan indicating a past moisture issue. The furnace was tested at the time of the inspection and no current active leak was noted. Recommend monitoring this

Moisture staining at furnace drip pan.

Moisture staining/rust at interior of furnace cabinet.

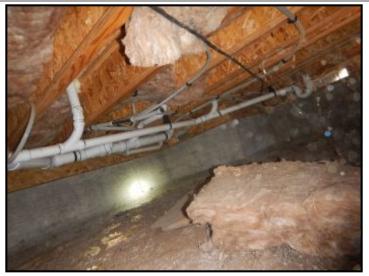
Fallen insulation in sub area.

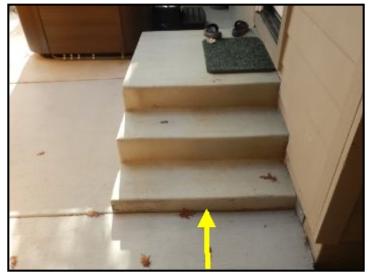
Typically the maximum difference in riser height or tread depth for any stairway is 3/8". Current construction standards require that risers not exceed 7/34 inches in height and that tread depth be no less than 10". The current steps could cause a potential tripping hazard at the left side of the home. Repairs are advised as a safety consideration.

Inconsistent riser height at steps.

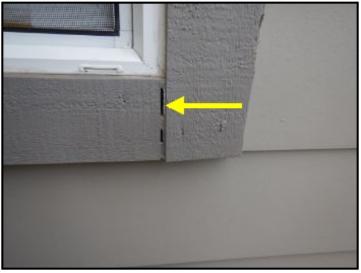
There are some gaps around the exterior window trims. Touching up the structure caulking around the tops and sides of the windows and door trim should be performed yearly as a part of routine maintenance. The caulking keeps rain water from penetrating behind the siding material and causing premature deterioration of the material.

Caulk/seal gaps at exterior trim.

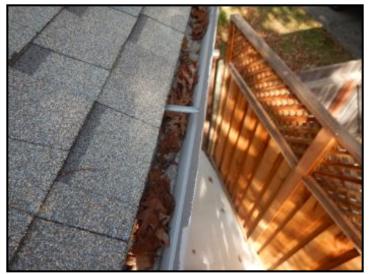
There is minor debris build up in the gutters that should be removed. Debris can clog the gutters, down spouts and drain system if not cleaned out. cleaning the gutters on an annual basis is recommended for proper care and maintenance of the gutter system.

Minor debris in gutters.

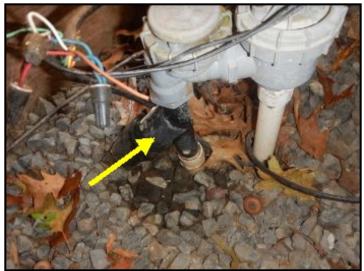
The inspector has found evidence of a plumbing leak. We advise the use of a qualified plumbing contractor to make final determination of the cause and to provide estimates for repairs. Location of the leak was an exterior irrigation line.

Leaking at exterior irrigation line.

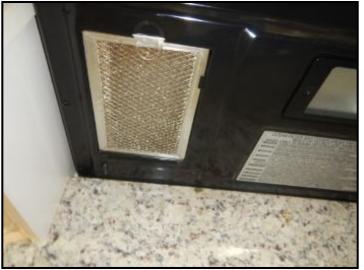
The grease filter(s) on the exhaust fan needs to be replaced or cleaned. This should be done on a regular basis as part of preventative home maintenance.

Clean stove top exhaust filters.

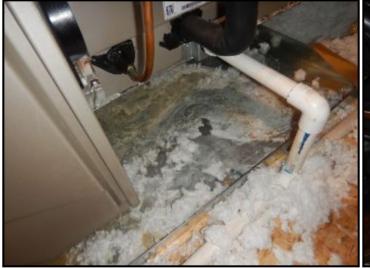
The cover of the furnace in the attic was taped closed, therefore not removed. There is moisture staining at the interior of the furnace cabinet as well as the drip pan indicating a past moisture issue. The furnace was tested at the time of the inspection and no current active leak was noted. Recommend monitoring this area.

Moisture staining at furnace drip pan.

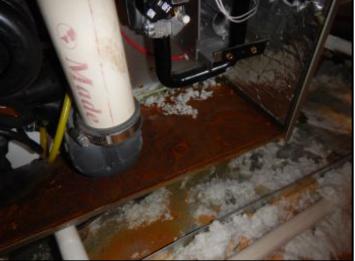
Moisture staining/rust at interior of furnace cabinet.

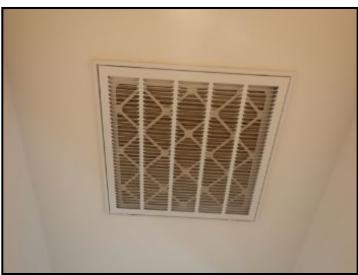
The furnace filter is in need of changing. This can restrict proper airflow and reduce the efficiency of the system. The inspector recommends changing or cleaning the filter on a regular basis as needed.

Replace air return filter.

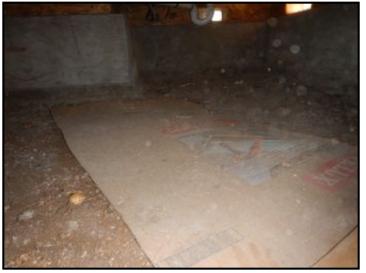
There is **cellulose** debris in sub the area which can attract wood destroying organisms that should be removed. Recommend referring to the current pest report for further commendations.

Debris in sub area.

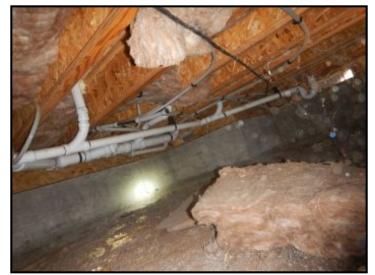
There are fiberglass battens in the crawl through area that have fallen. We recommend reinstalling them as needed. If they have become wet or damaged they should be replaced.

Fallen insulation in sub area.
