WOOD DESTROYING PESTS AND ORGANISMS INSPECTION REPORT

Building No. 4342	Street Princeton Way	City Santa Rosa	Zip 95405	Date of Inspection 10/02/18	Page 1 of 7
-----------------------------	--------------------------------	---------------------------	---------------------	---------------------------------------	-----------------------

Report # 4342prince

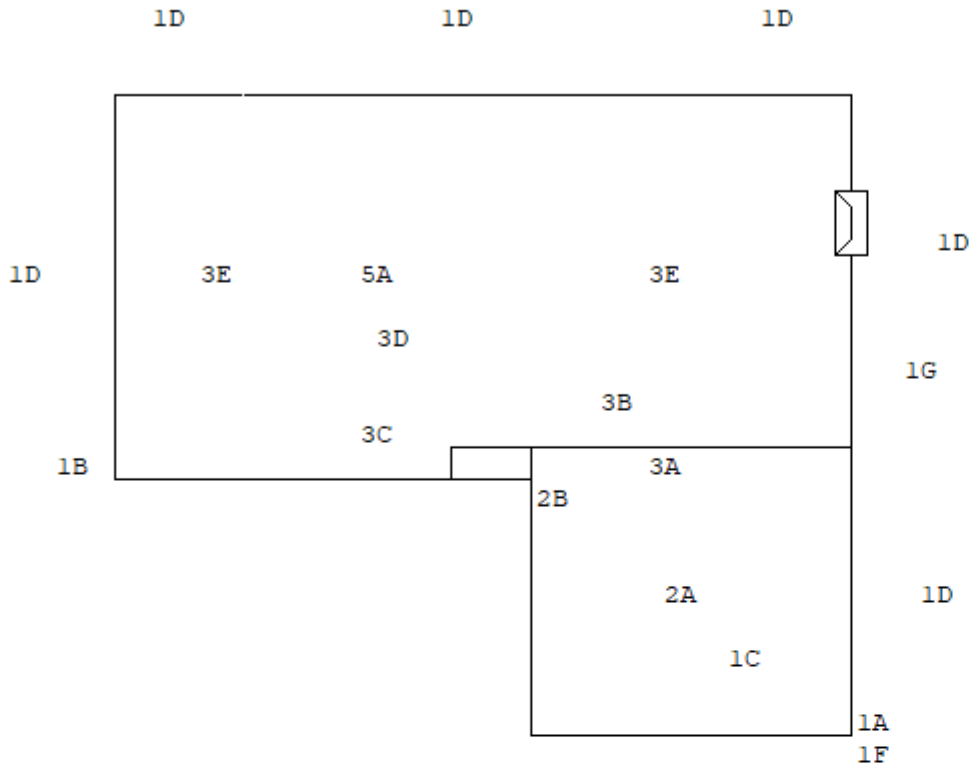
KEY: 1 - Exterior 2 - Garage 3 - Interior 4 - Substructure Area 5 - Attic Spaces

Subterranean Termites <input type="checkbox"/>	Drywood Termites <input type="checkbox"/>	Fungus / Dryrot <input checked="" type="checkbox"/>	Other Findings <input checked="" type="checkbox"/>
Further Inspection <input checked="" type="checkbox"/> If any of the above boxes are checked, it indicates that there were visible problems in accessible areas. Read the report for details on checked items.
