# *Gage Inspection Services*

## Property Inspection Report

121 Mary Paige Ln, Santa Rosa, CA 95404  
Inspection prepared for: David Phillips  
Real Estate Agent: Mary Haufler - Sothebys

Date of Inspection: 3/27/2018 Time: 9:00 AM  
Order ID: 66

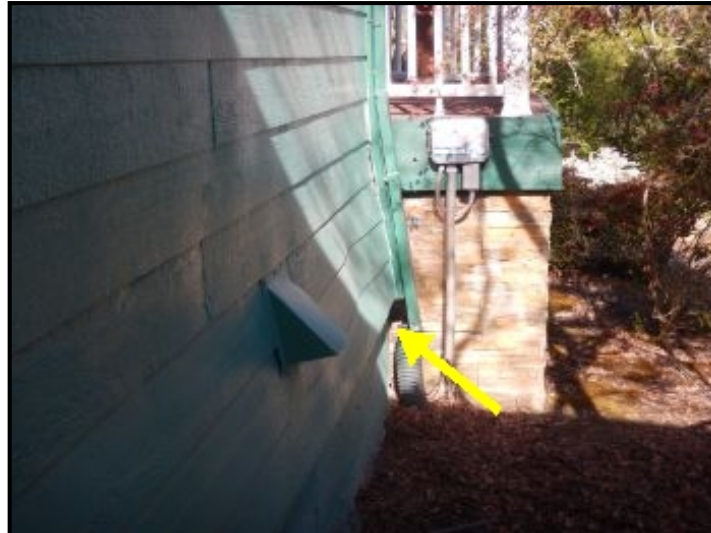
Page 28 Item: 2	Siding Condition	<p><b>Maintenance</b></p> <p>Siding damage was noted to areas at the exterior of the home. We recommend referring to the pictures and contacting a qualified contractor to review the current pest report and make needed repairs.</p> <p>There is warped/bulging siding at the right side of the home. This appears to be caused by a structural issue. Recommend contacting a qualified contractor for evaluation/recommendations.</p>
-----------------	------------------	--

Bulging siding at the right side of the home.

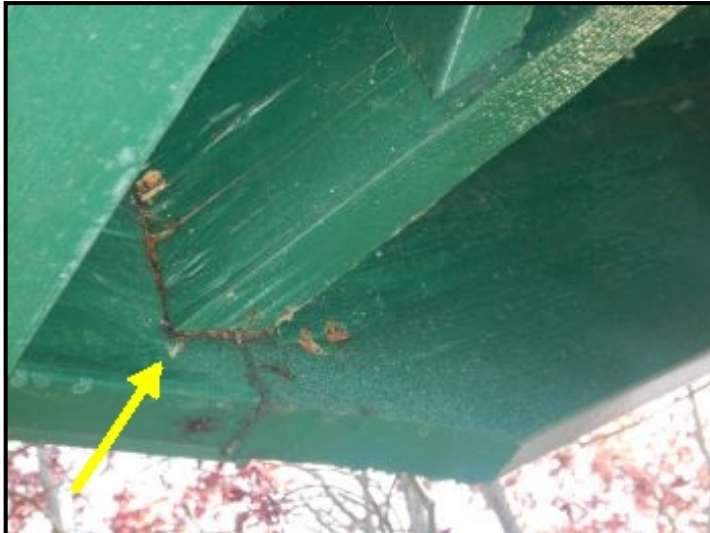
Page 30 Item: 7	Fascia Boards/Trim	<b>Maintenance</b> Trim damage has been noted at the exterior of the home. We recommend referring to the pictures and contacting a qualified contractor to review the current pest report and make needed repairs.
-----------------	--------------------	---

Fascia damage at right side of home.

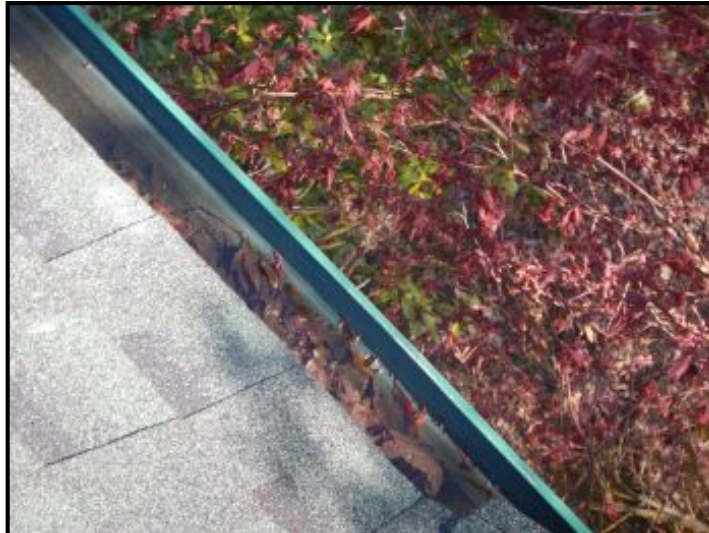
There is debris build up in the gutters that should be removed as well as standing water at the right side of the home. Debris can clog the gutters, down spouts and drain system if not cleaned out. cleaning the gutters on an annual basis is recommended for proper care and maintenance of the gutter system.

Standing water/debris in right side gutter.

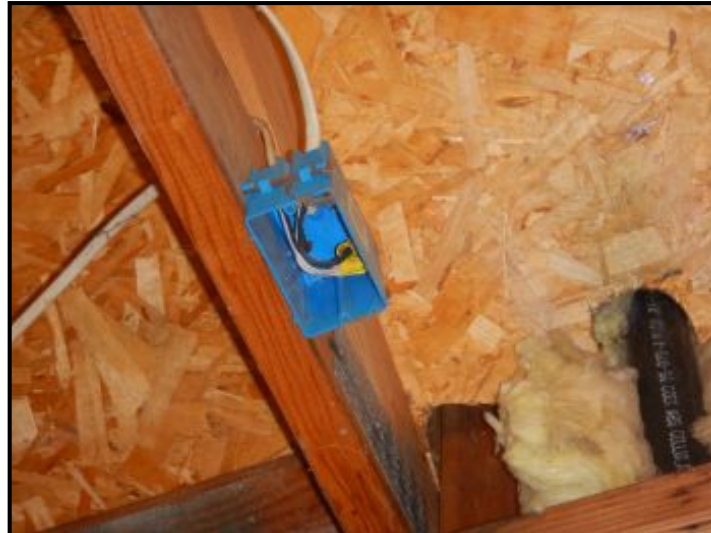
Missing junction box cover in garage.

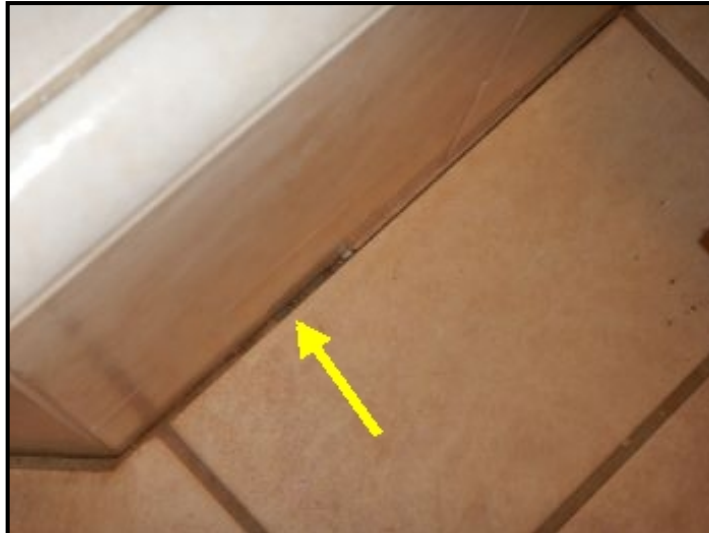
Page 56 Item: 9	Water Resistant Wall Cover	<p><b>Maintenance</b></p> <p>Grout voids were noted around the hallway bathroom shower tile wall as well as the tile floors at the base of the master bathroom tub and shower. This is a condition that can lead to moisture intrusion and deterioration. Regrouting is recommended. These areas should be inspected and touched up on a regular basis as part of preventative home maintenance</p>
-----------------	----------------------------	---

Grout voids at base of master bathroom tub.

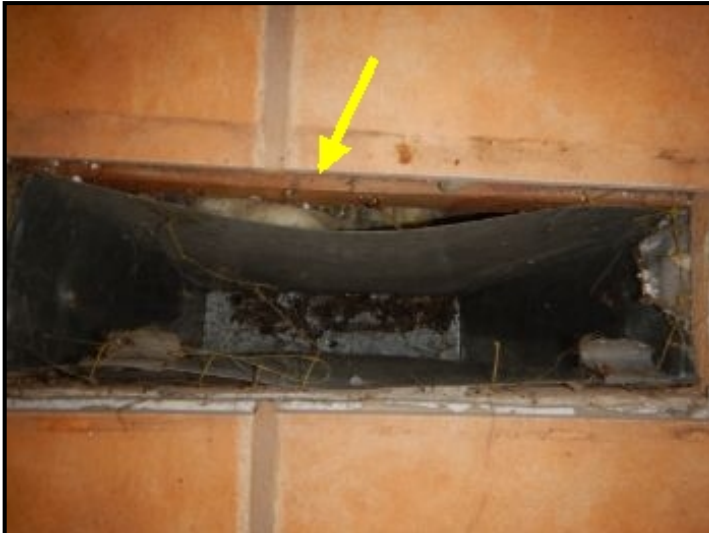
Seal floor heat registers as needed.

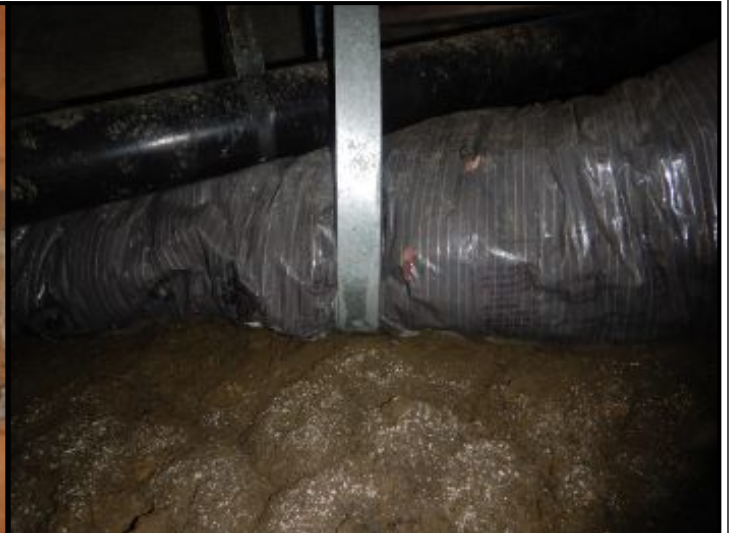
Heating duct sitting on the ground in the sub area.

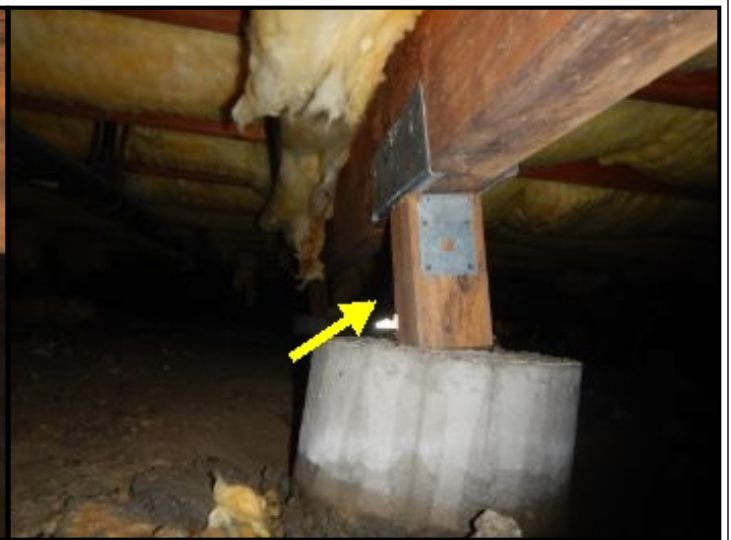
Leaning support blocks in sub area.

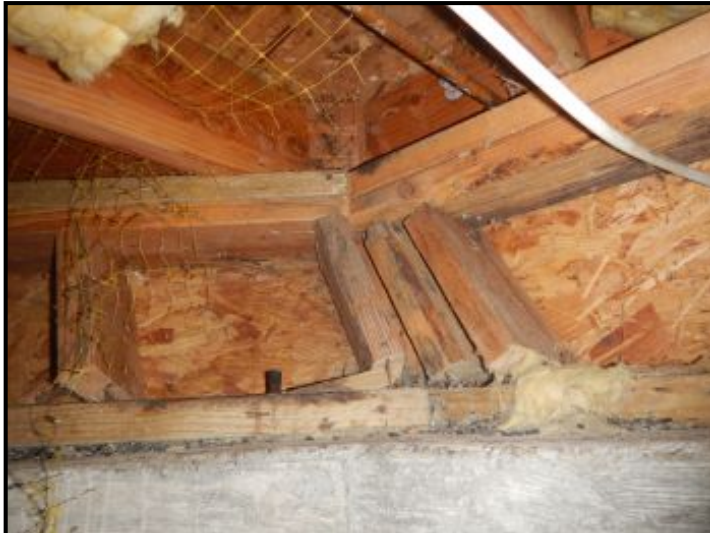
Leaning wood members in sub area.

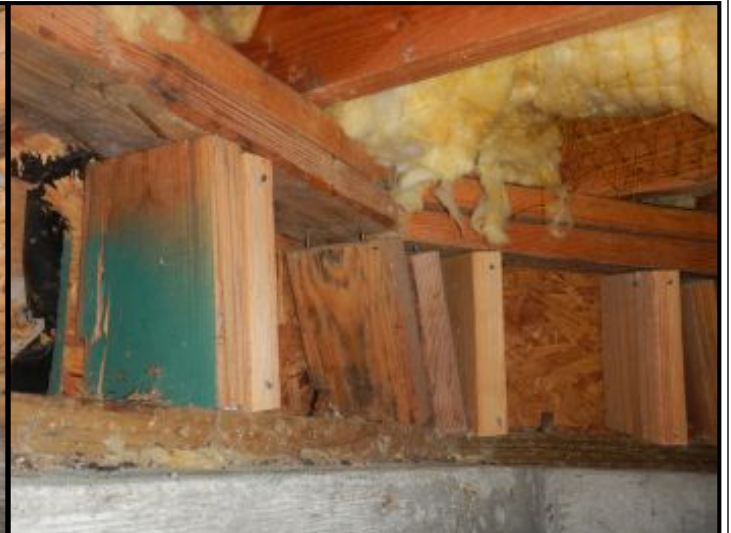
Leaning wood members in sub area.

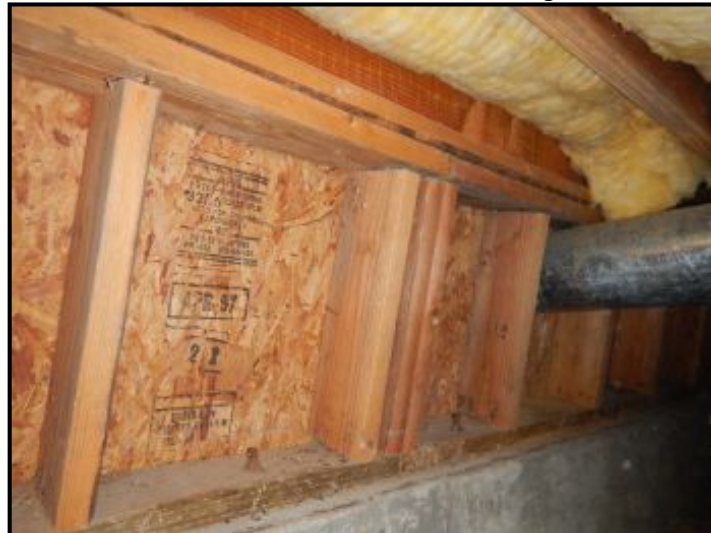
Leaning wood members in sub area.

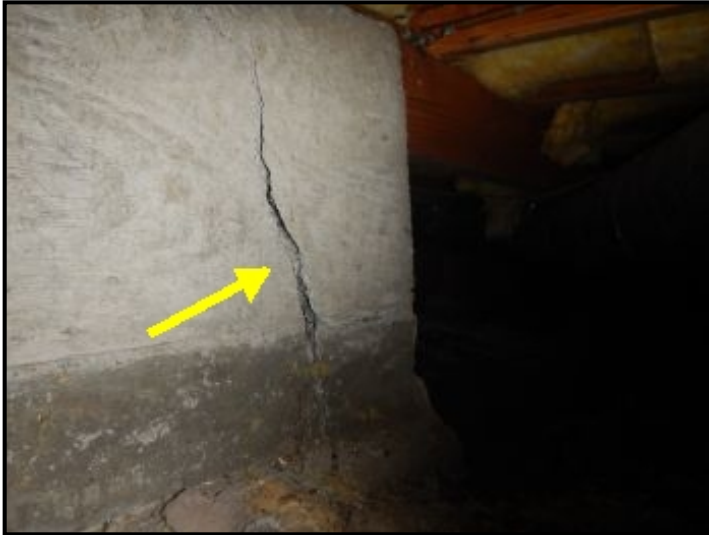
Page 69 Item: 12	Separation Over 1/4"	<b>Yes</b> There are cracks in the foundation that are in excess of 1/4 inch in separation or displacement. This indicates a condition in excess of normal expansion/movement. Contact a qualified foundation specialist for evaluation/recommendations.
------------------	----------------------	---

Excessive cracking at foundation wall.

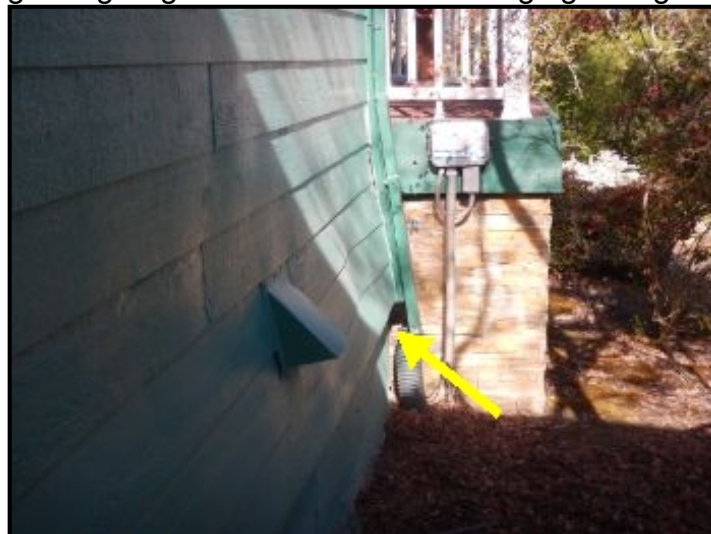
Bulging siding at the right side of the home.

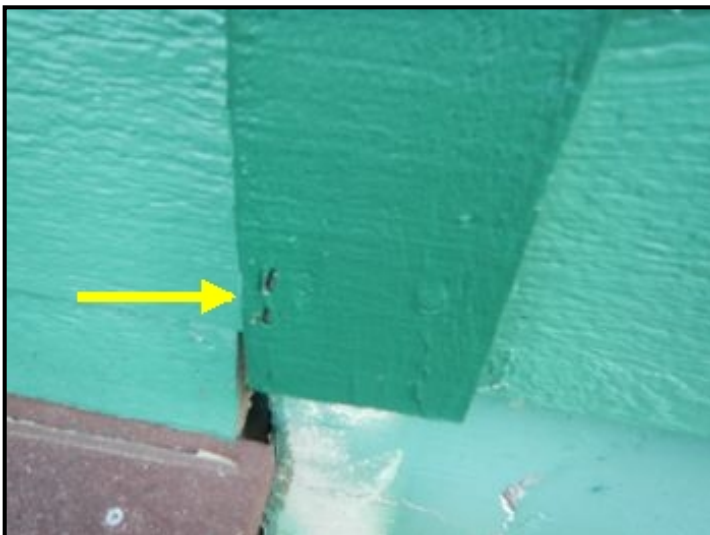
Trim damage at the left side of the home.

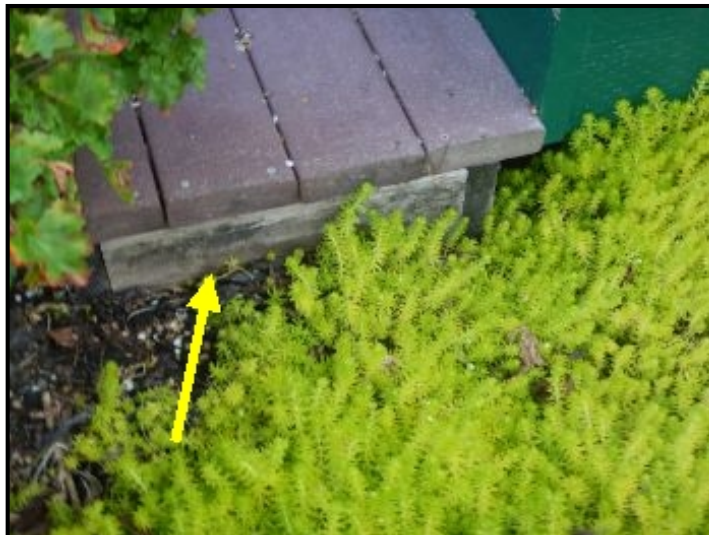
The inspection has revealed earth to wood contact to the steps at the rear deck. There should be no contact between the earth and the exterior wood members. Recommend providing at least 4-6 inches of clearance between the earth and wood material as a preventative maintenance measure

Earth/wood contact at rear deck steps.

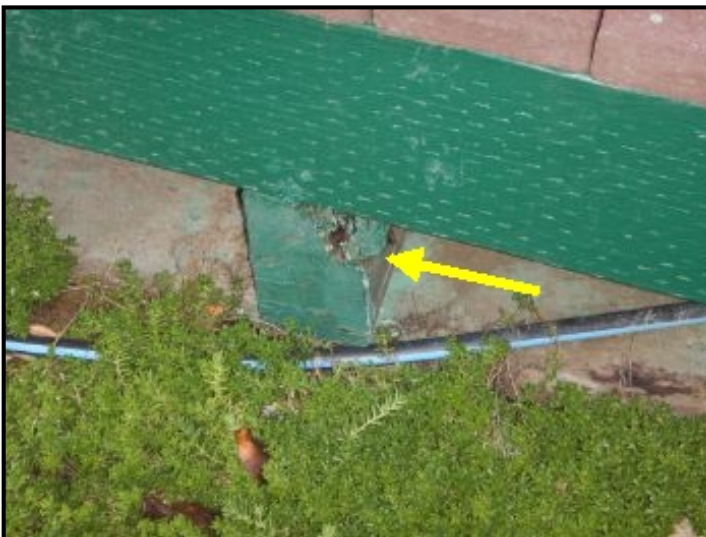
There was damage noted to the ends of girders at the rear deck. We recommend referring to the current pest report for further comment/recommendations.

Damage to ends of girders at rear decks.

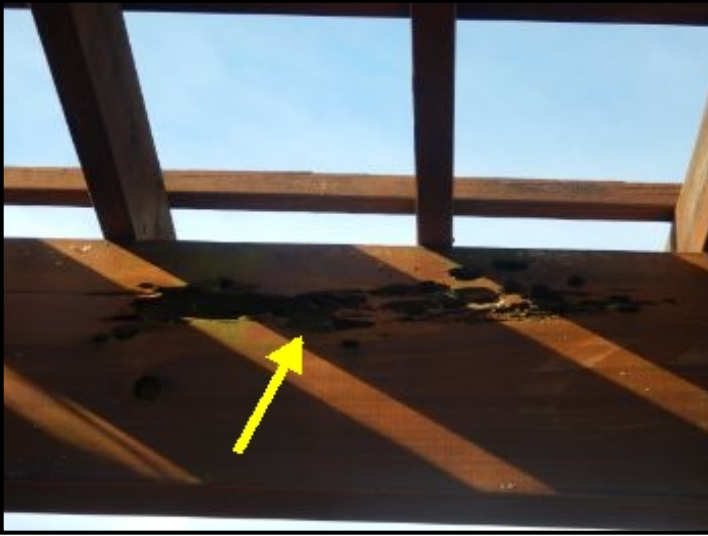
There was wood damage noted to multiple areas to the exterior trellis. Recommend referring to the current pest report for further comment/recommendations.

Damage noted to various areas of trellis.

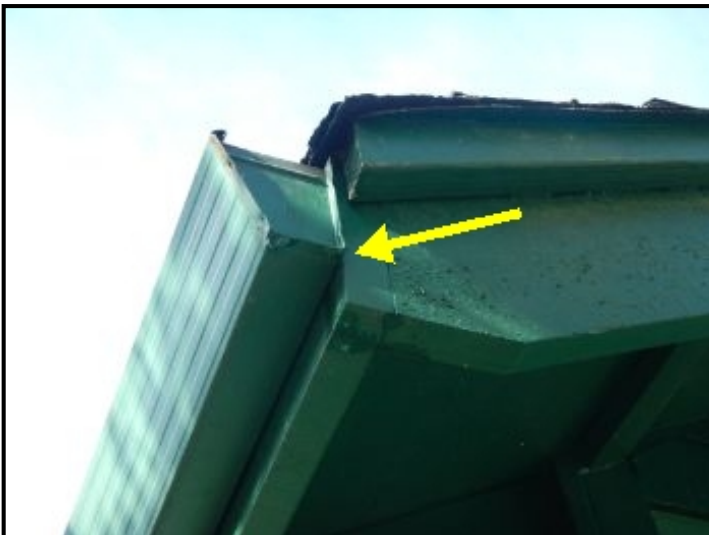
The gutters over the garage door are leaking. Contact the appropriate trades person for evaluation and recommendations for repairs.

Leaking gutter over garage.

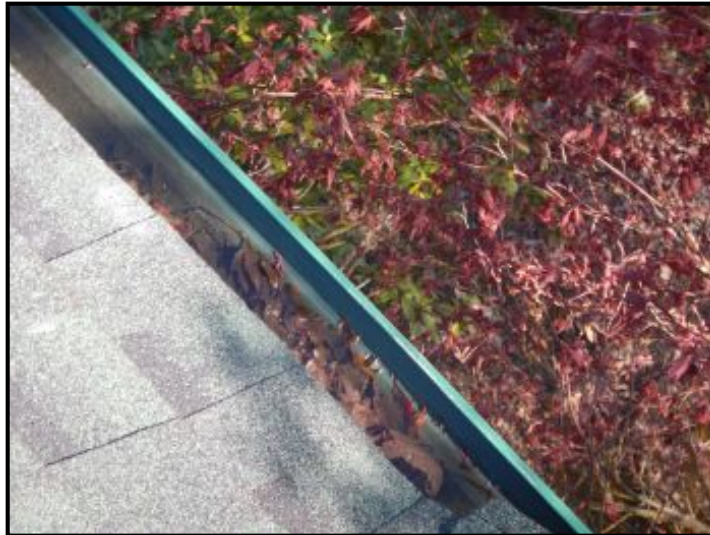
There is debris build up in the gutters that should be removed as well as standing water at the right side of the home. Debris can clog the gutters, down spouts and drain system if not cleaned out. cleaning the gutters on an annual basis is recommended for proper care and maintenance of the gutter system.

Standing water/debris in right side gutter.

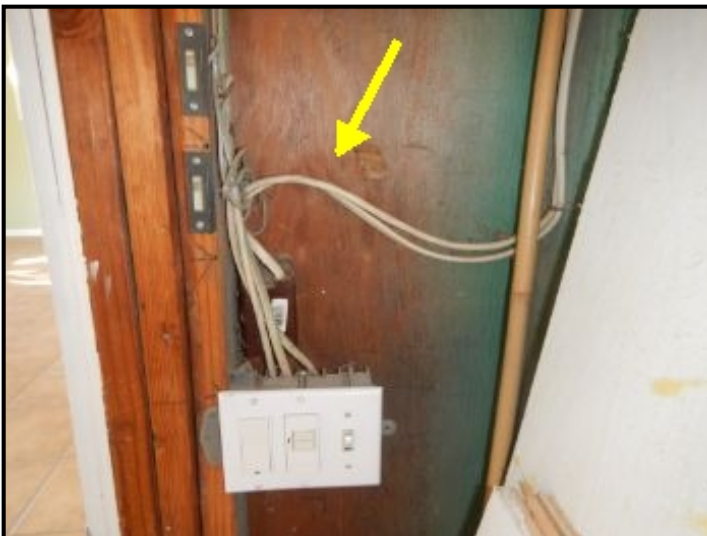
Unprotected non metallic sheathed cable was noted at the garage. Electrical cable is subject to physical damage and is typically installed in attics and inside walls. Repairs should be made to properly protect the wiring system inside conduit. Contact a qualified electrician for repairs.

Unprotected electrical at the garage.

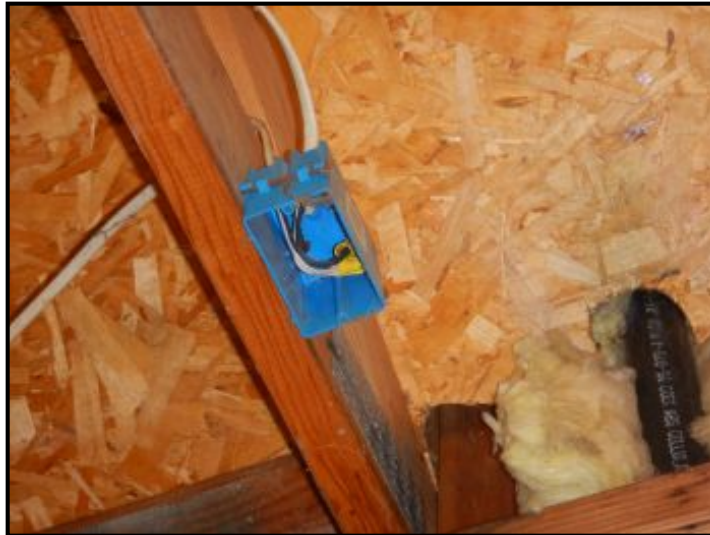
All spliced wires should do so inside of an appropriate covered junction box. There are spliced wires that do not meet this requirement in the garage. We suggest adding the appropriate sized junction boxes with covers as needed.

Missing junction box cover in garage.

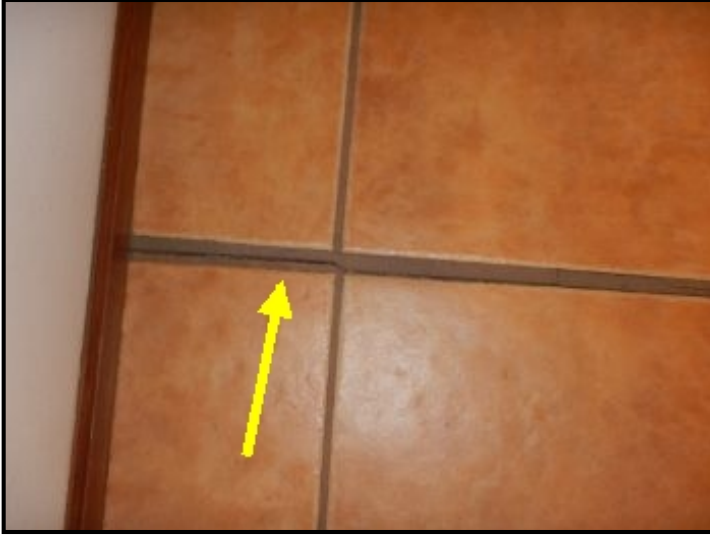
There are cracked tiles at the main hallway of the home. Recommend contacting a qualified tile specialist for evaluation/repairs.

Cracking grout at hallway tile.

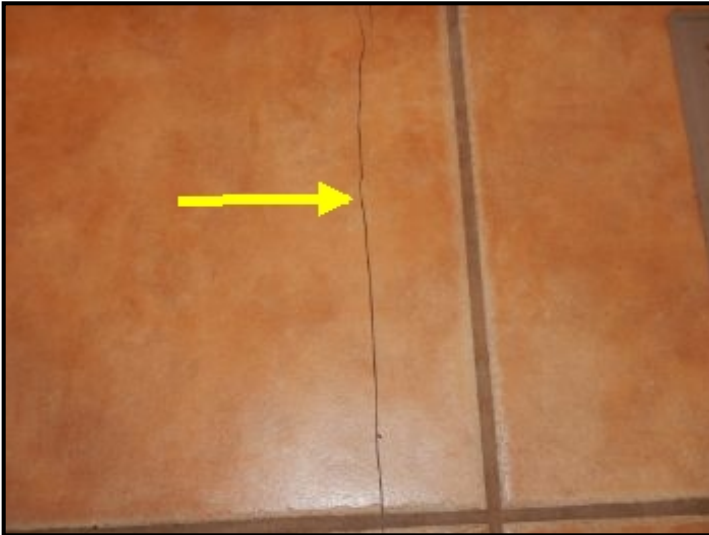
There are cracked floor tiles and grout at both bathrooms. Repairs are advised to maintain a proper water proof seal. Contact a qualified tile specialist for evaluation.

Cracked tiles at bathroom floor.

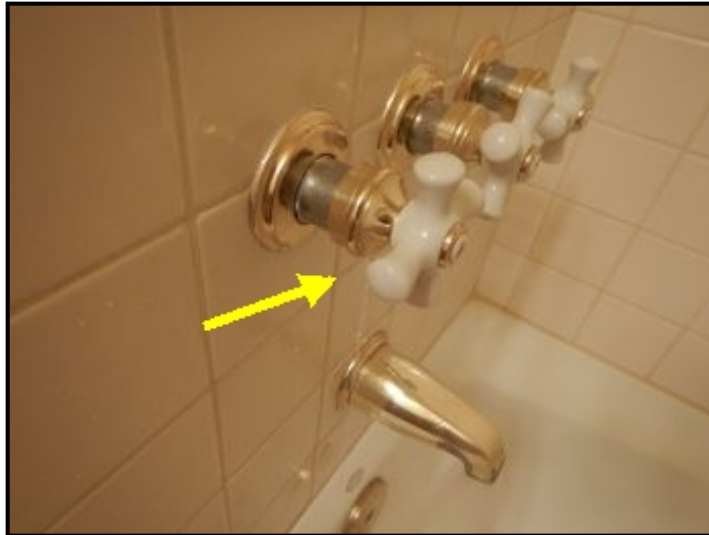
The hot water fixture at the hall bathroom shower is leaking during operation. Contact a qualified plumbing contractor for evaluation/repairs.

Leaking shower fixture at hall bathroom.

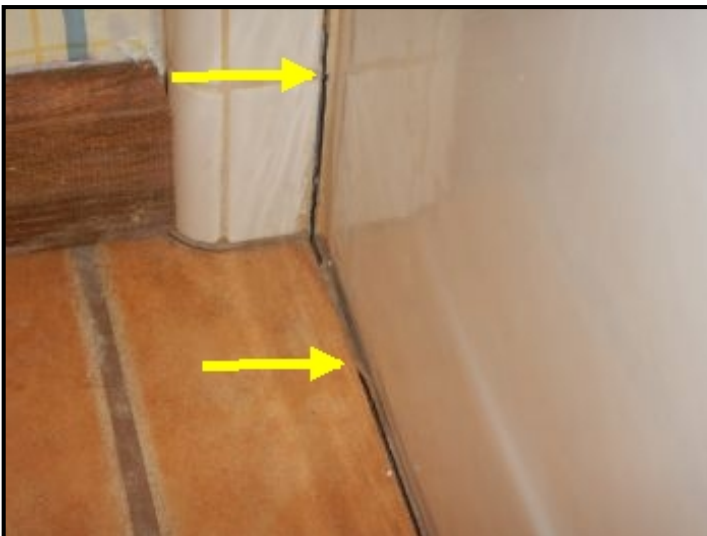
Grout voids were noted around the hallway bathroom shower tile wall as well as the tile floors at the base of the master bathroom tub and shower. This is a condition that can lead to moisture intrusion and deterioration. Regrouting is recommended. These areas should be inspected and touched up on a regular basis as part of preventative home maintenance

Grout voids at tub/wall in hall bathroom.

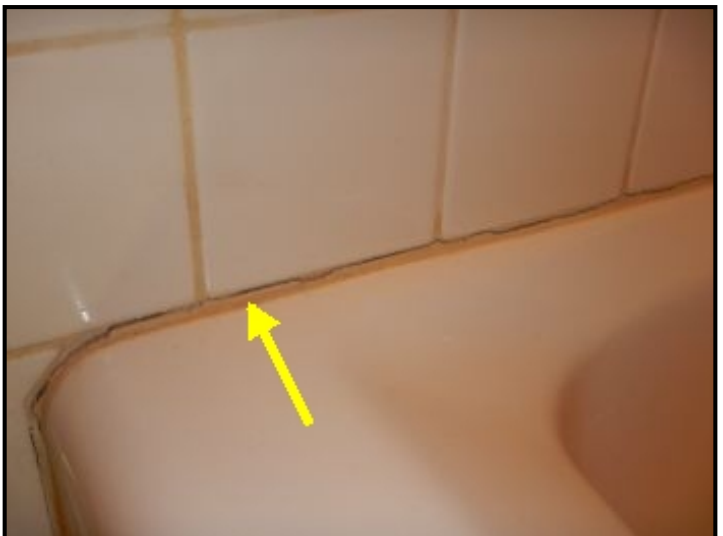
Grout voids around tub at hallway bathroom.

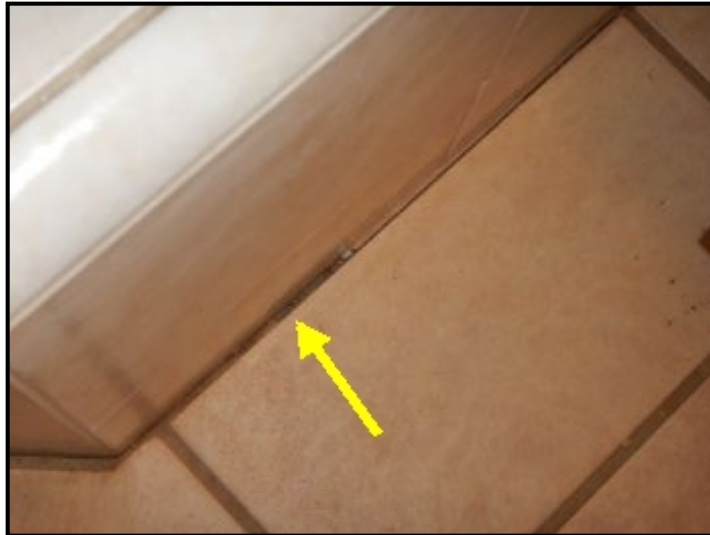
Grout voids at base of master bathroom tub.

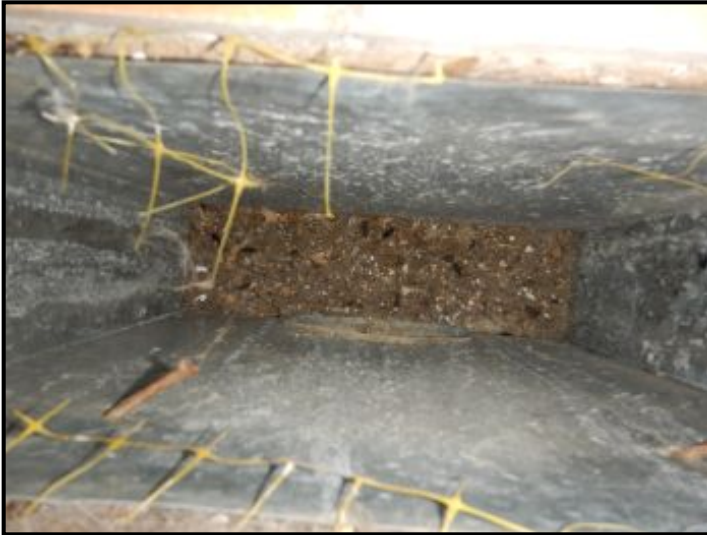
The floor heat register in the dining area is rusted/corroded. Future repair/replacement is recommended to maintain intended service. Contact a qualified HVAC contractor for repairs. There are gaps around the floor heat registers. It is recommended to seal around the registers with an HVAC foil tape to help with the heating/cooling efficiency of the home. There is debris build up noted in most of the floor heat registers. Recommend ducting cleaning. Contact a qualified HVAC contractor for evaluation. There are heating ducts that are sitting on the ground in the sub area. It is advised to strap the ducting to the floor area framing if possible to prevent contact with the ground and potential damage.

Debris build up in heat registers.

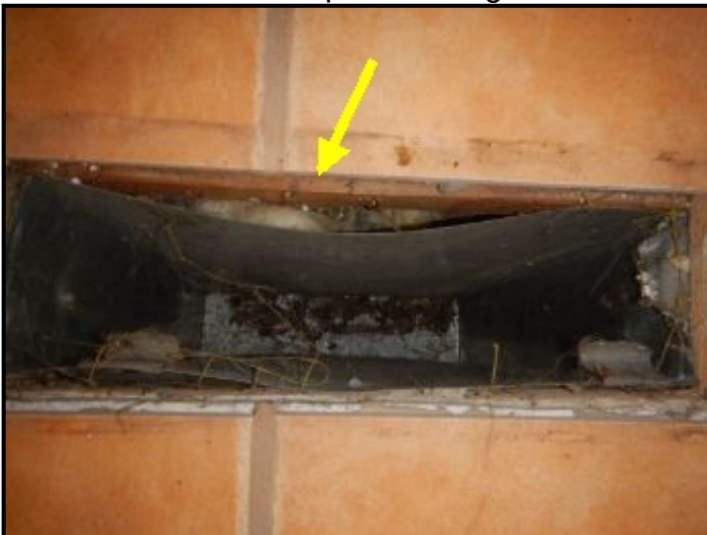
Seal floor heat registers as needed.

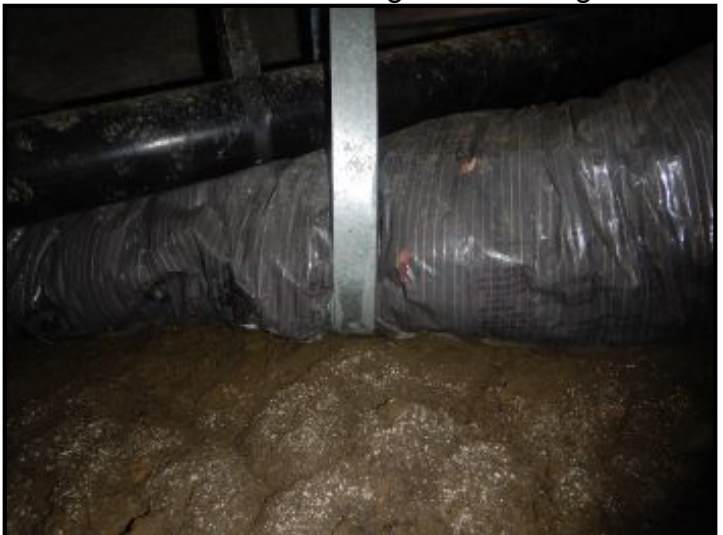
Heating duct sitting on the ground in the sub area.

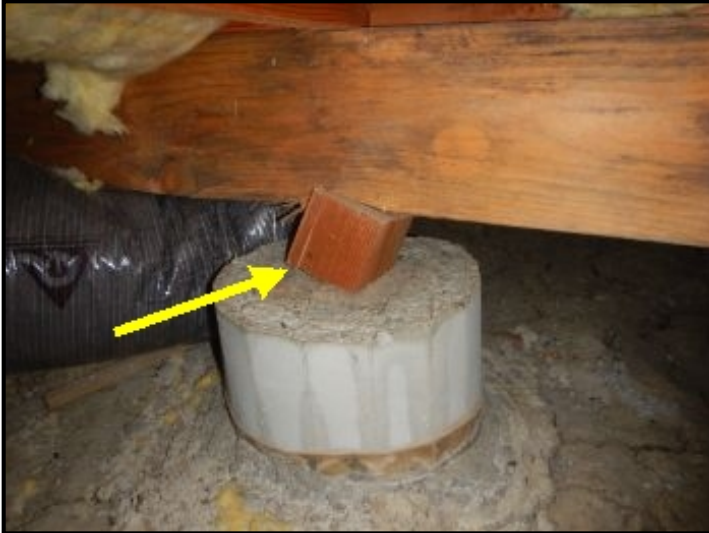
There is an excessive amount of movement noted to wood supports in the rear right section of the sub area of the home. There are leaning support blocks, a twisted girder, leaning wall studs and lifted sill plates. We recommend contacting a qualified structural engineer for further evaluation and recommendations for repairs.

Leaning wood blocks in sub area.

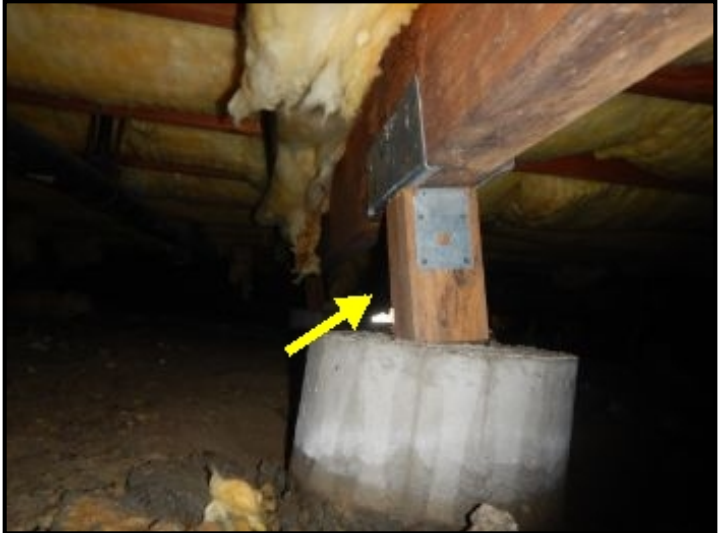
Leaning support blocks in sub area.

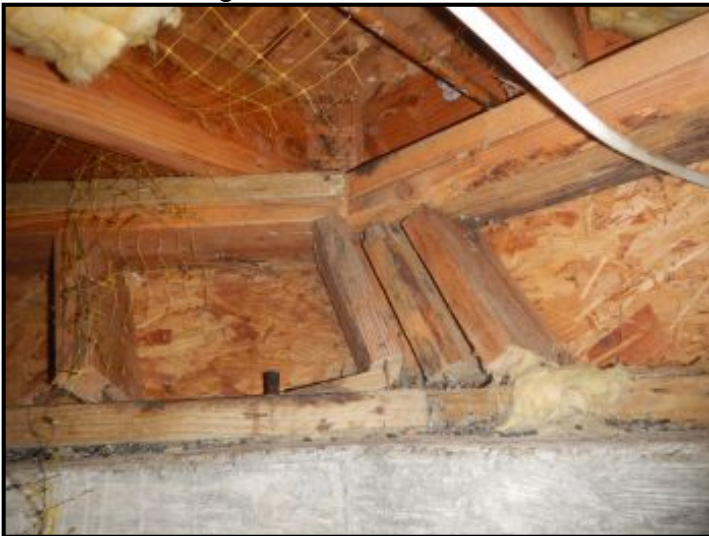
Leaning wood members in sub area.

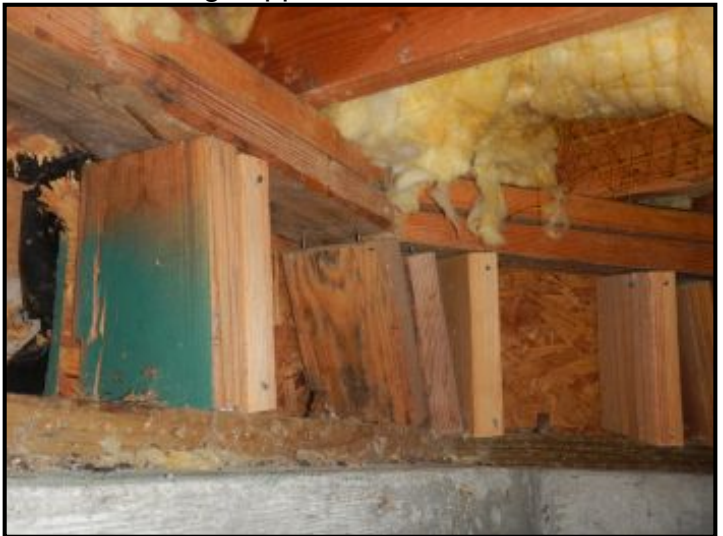
Leanign wood members in sub area.

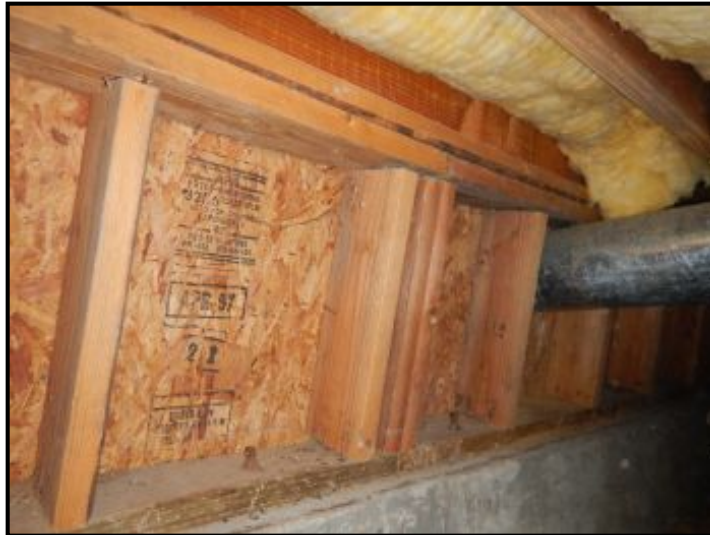
Leaning wood members in sub area.
