# WOOD DESTROYING PESTS AND ORGANISMS INSPECTION REPORT

Building No. <b>121</b>	Street <b>Mary Paige Lane</b>	City <b>Santa Rosa</b>	Zip <b>95404</b>	Date of Inspection <b>03/27/18</b>	Page <b>1 of 10</b>
----------------------------	----------------------------------	---------------------------	---------------------	---------------------------------------	------------------------

General Description: <b>Single story, frame, rustic siding, decking garage attached.</b>	Inspection Tag Posted: <b>Attic</b>
	Other Tags Posted: <b>None noted</b>

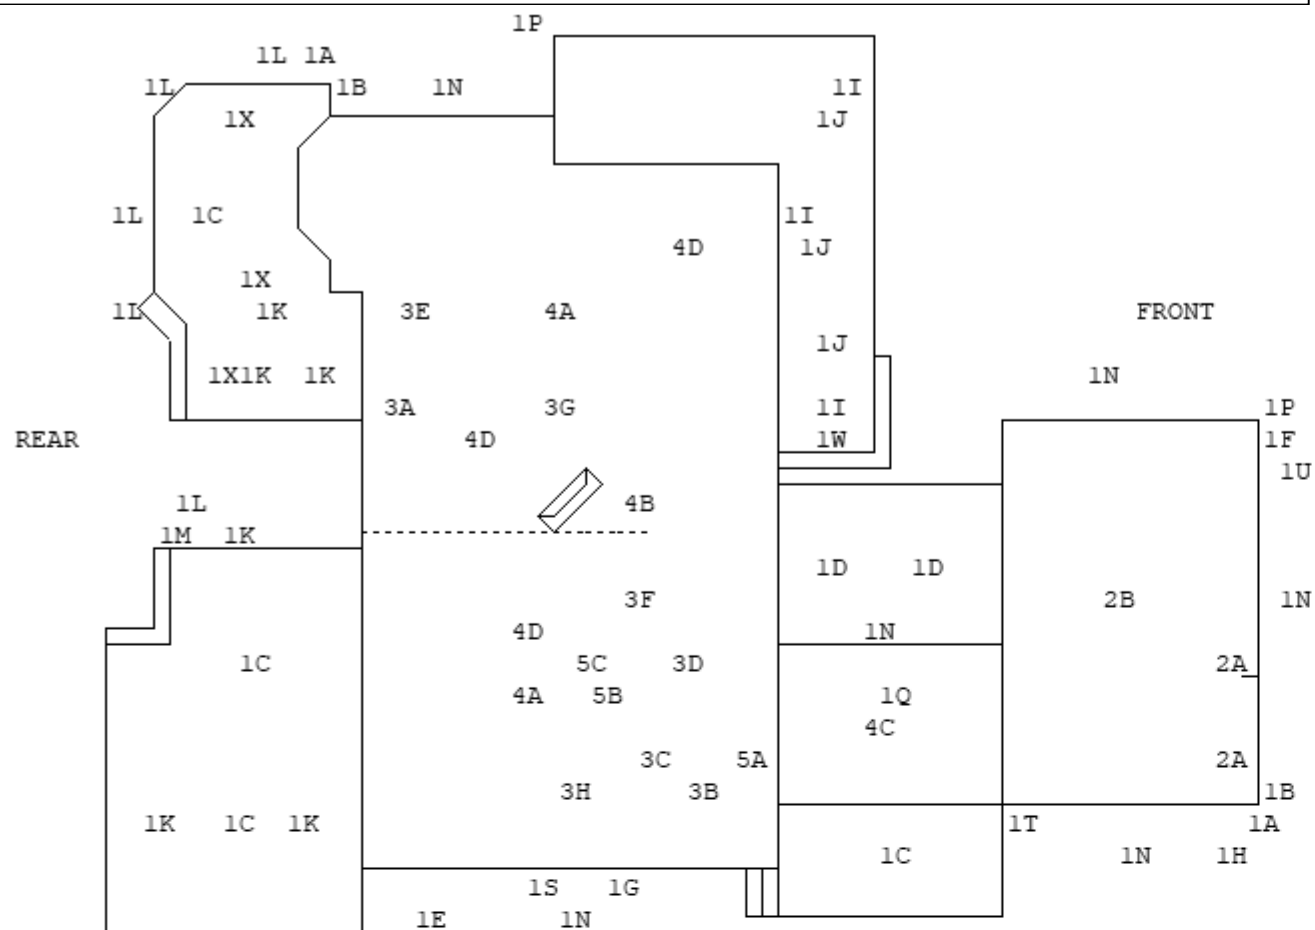
An inspection has been made of the structure(s) shown on the diagram in accordance with the Structural Pest Control Act. Detached porches, detached steps, detached decks and any other structures not on the diagram were not inspected. Diagram is not to scale. Locations are only approximate.

KEY: 1 - Exterior    2 - Garage    3 - Interior    4 - Substructure Area    5 - Attic Spaces

The bottom of the diagram is the front of the structure, and the top of the diagram is the rear of the structure, unless noted otherwise on the diagram. The diagram is not a scale drawing, only a representation of the structure outline.
