WOOD DESTROYING PESTS AND ORGANISMS INSPECTION REPORT

Building No. 202	Street Adele	City Rohnert Park	Zip 94928	Date of Inspection 06/26/18	Page 1 of 8
----------------------------	------------------------	-----------------------------	---------------------	---------------------------------------	-----------------------

General Description: Single story, frame, vinyl siding, garage attached.	Inspection Tag Posted: Attic
	Other Tags Posted: Yes

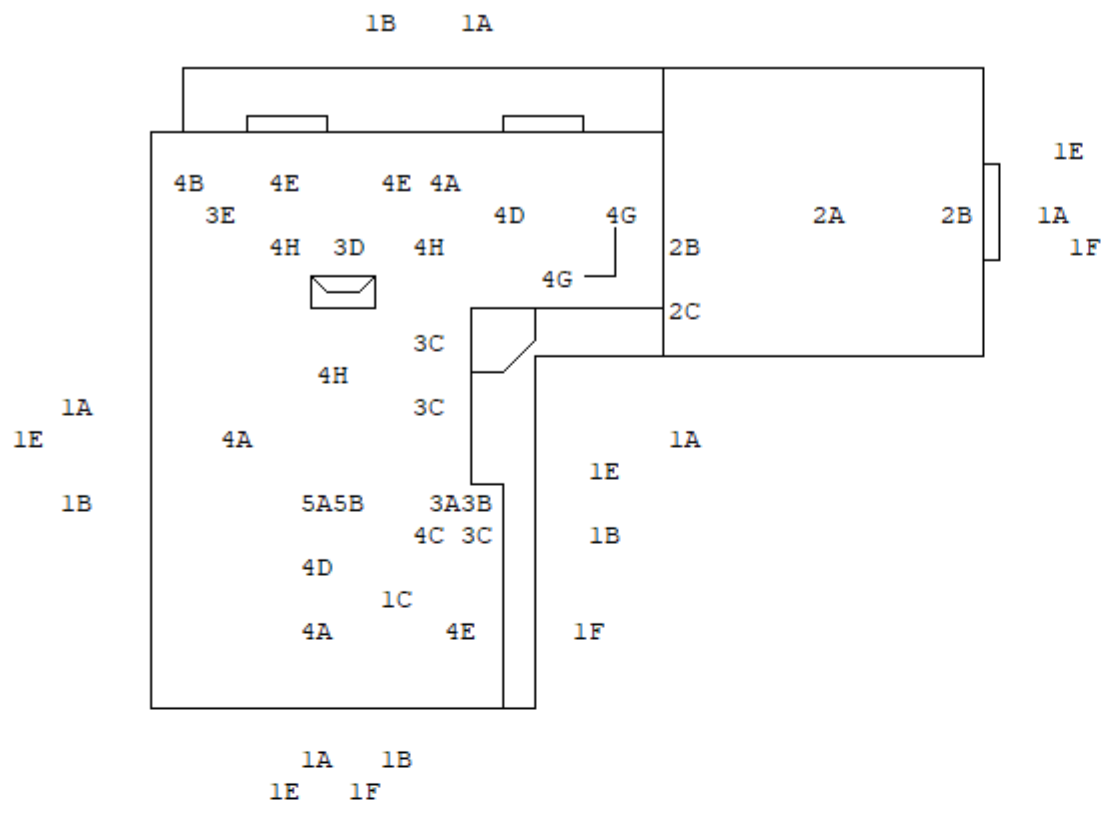
An inspection has been made of the structure(s) shown on the diagram in accordance with the Structural Pest Control Act. Detached porches, detached steps, detached decks and any other structures not on the diagram were not inspected. Diagram is not to scale. Locations are only approximate.

KEY: 1 - Exterior 2 - Garage 3 - Interior 4 - Substructure Area 5 - Attic Spaces

The bottom of the diagram is the front of the structure, and the top of the diagram is the rear of the structure, unless noted otherwise on the diagram. The diagram is not a scale drawing, only a representation of the structure outline.
